# Historic Bridge Management Plan for the Gulf Outlet Canal Bridge

**Recall Number: 001630**

**Structure Number: 02361480201061**

August 2016

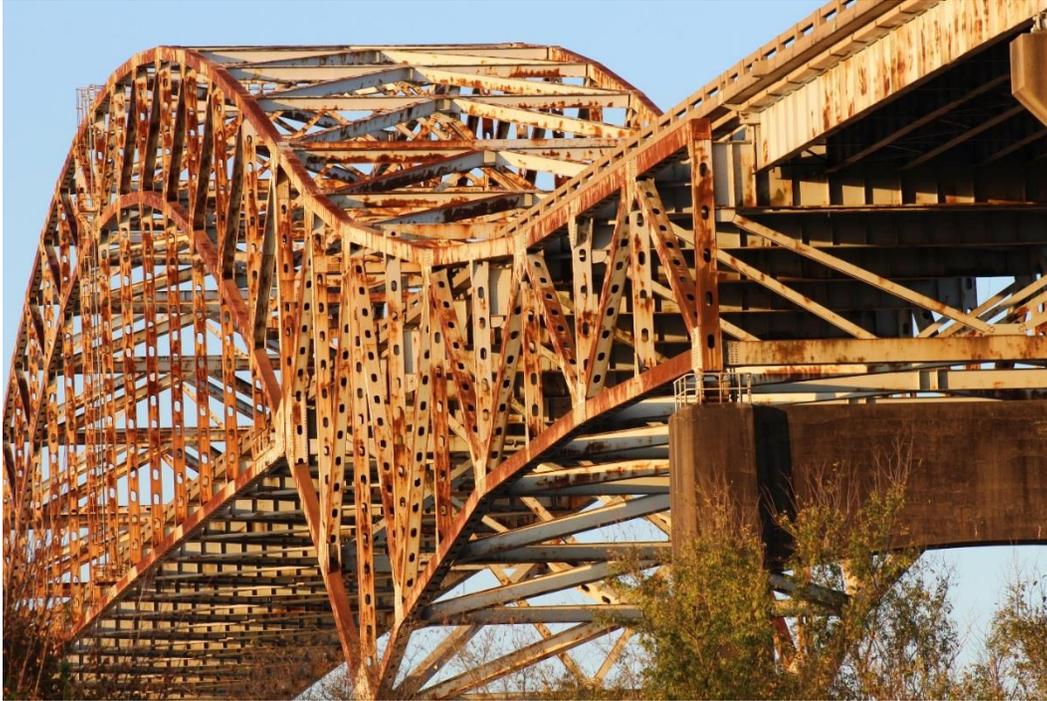
The overall condition of this bridge is satisfactory. The major deficiency is that the paint system on the bridge (steel truss spans and steel plate girder spans) has failed, and areas of exposed metal have moderate surface corrosion throughout the steel truss span and girder spans.

*Condition Photo 1: Truss span paint failure.*

1. Clean and paint all welded steel plate girder spans and the tied arch cantilever steel truss span, including all bearings, in accordance with Specification Section 811 – Painting and Protective Coatings. Such painting should be done per LADOTD standard practice (estimated at 20-year intervals) or as conditions warrant for the life of the painting system.

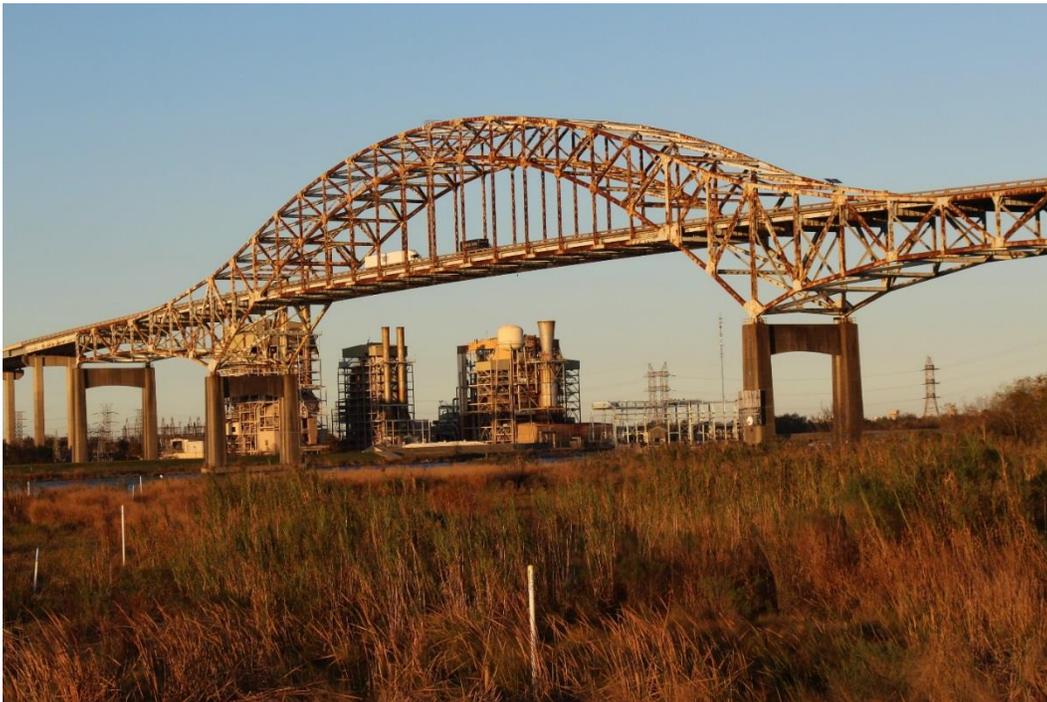
*Condition Photo 2: Truss span paint failure.*

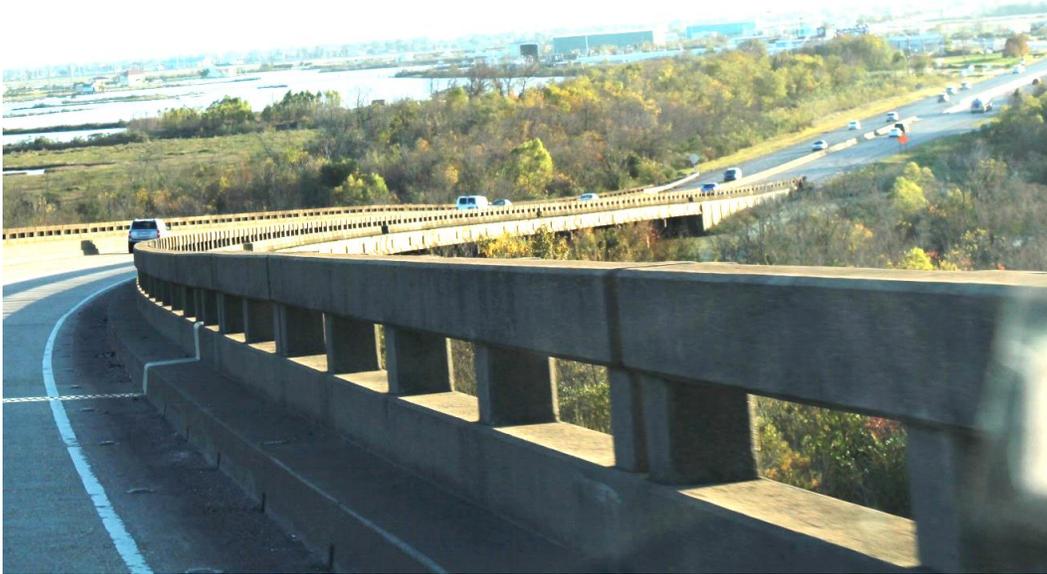
The bridge railings are concrete post and rail type that do not meet current design criteria for height and impact loading, except the newer parapets on the west side of the newer northerly approach spans from the 1989 widening are the standard Jersey-type concrete parapets which meet current design criteria.

*Condition Photo 3: Substandard concrete post and beam bridge railing, typical on entire bridge except at north end, west side, and where newer ramp was added with concrete Jersey-type parapet.*

No design exceptions were noted, nor are any design exceptions recommended. The concrete post and beam bridge railings do not meet current design standards but met design standards at the time of original construction. These bridge railings are not recommended to be updated as part of the proposed rehabilitation activities.

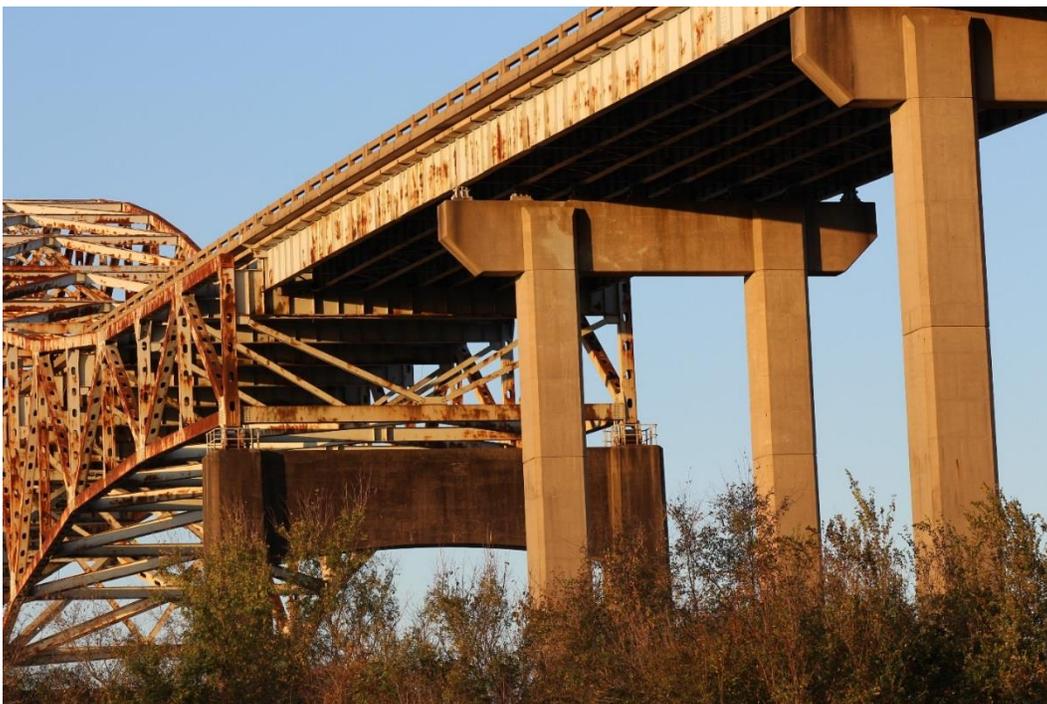
*Condition Photo 4: Steel plate girders paint failure.*

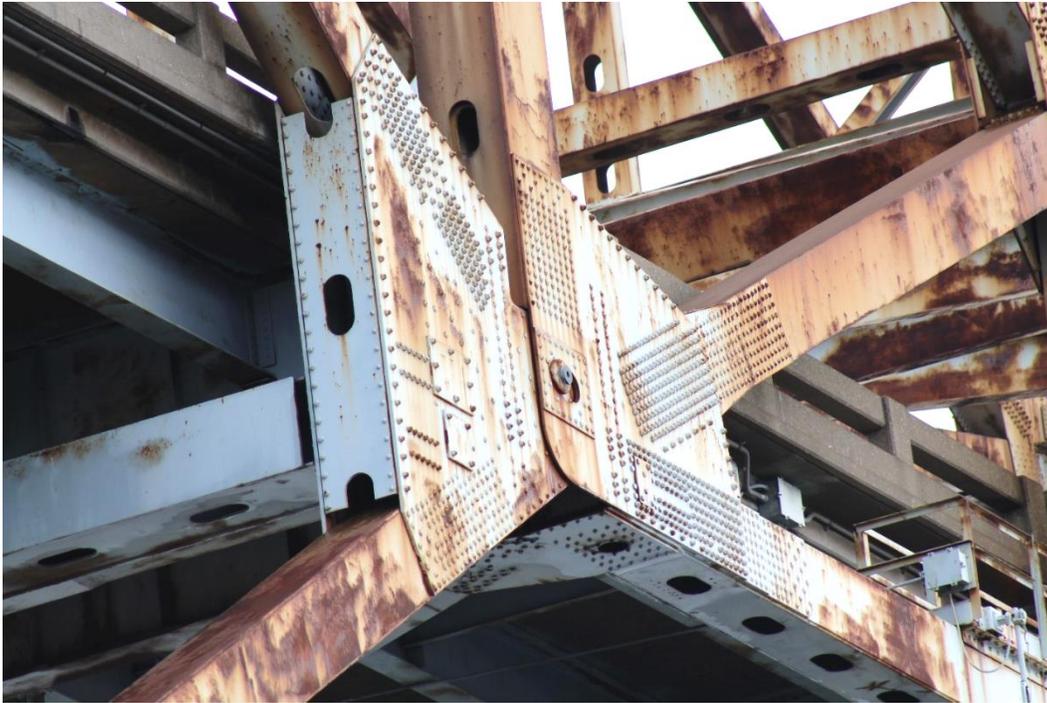
*Condition Photo 5: Condition of hinged pin joint at truss span panel point L9; joint apparently frozen in full contraction position.*

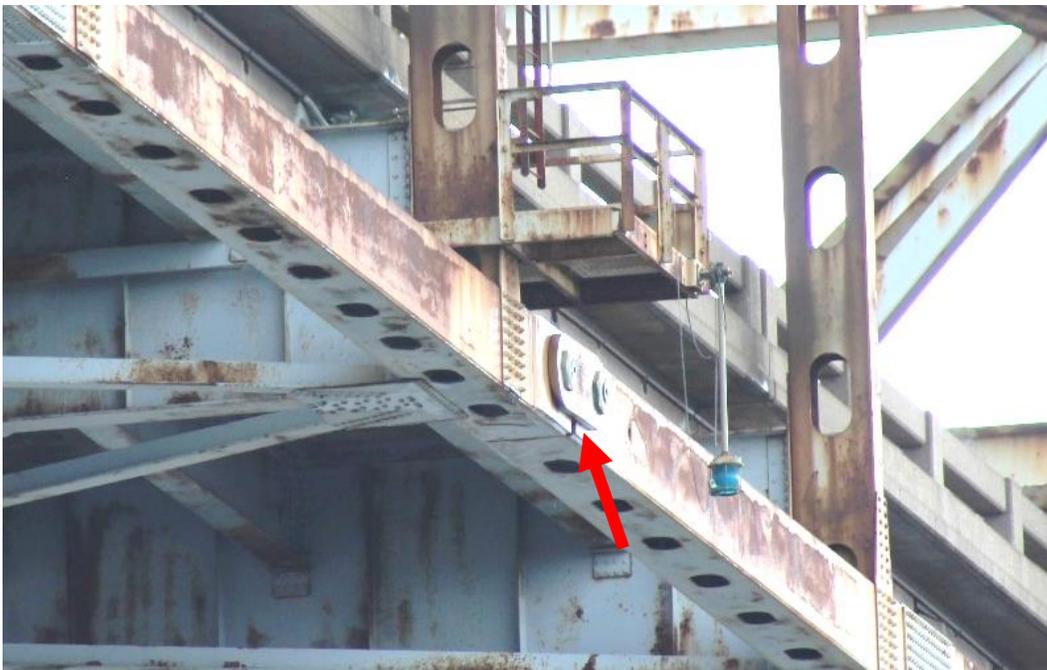
*Condition Photo 6: Condition of hinged pin joint at truss span panel point L16.*

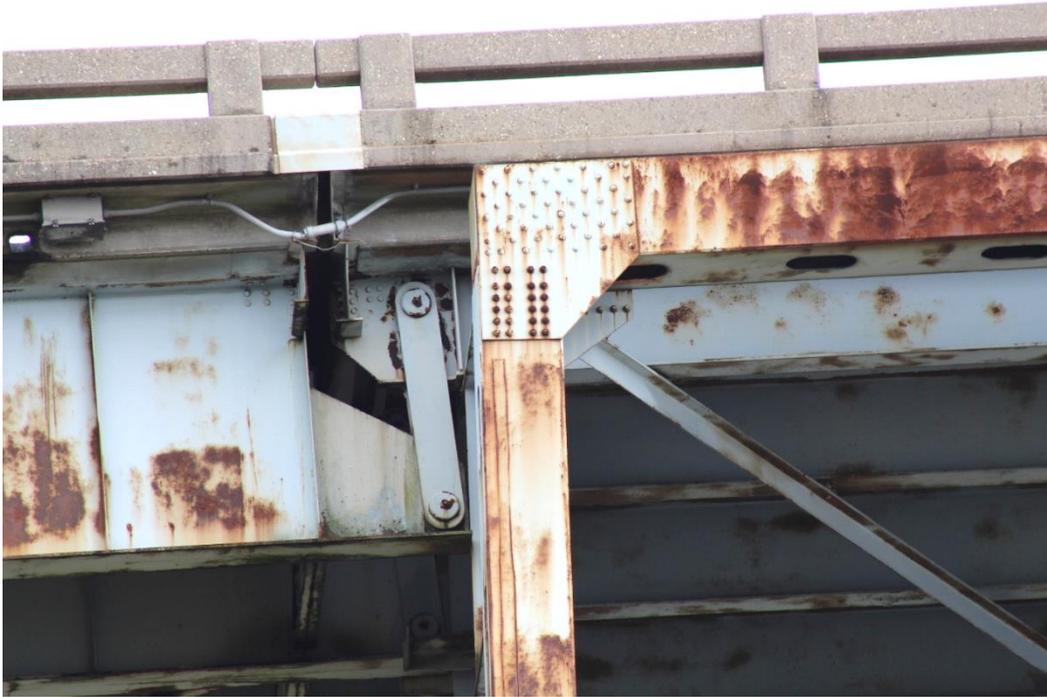
*Condition Photo 7: Condition of hinged hangers of plate girders at connection to truss span, with deck expansion joint above the hinge.*

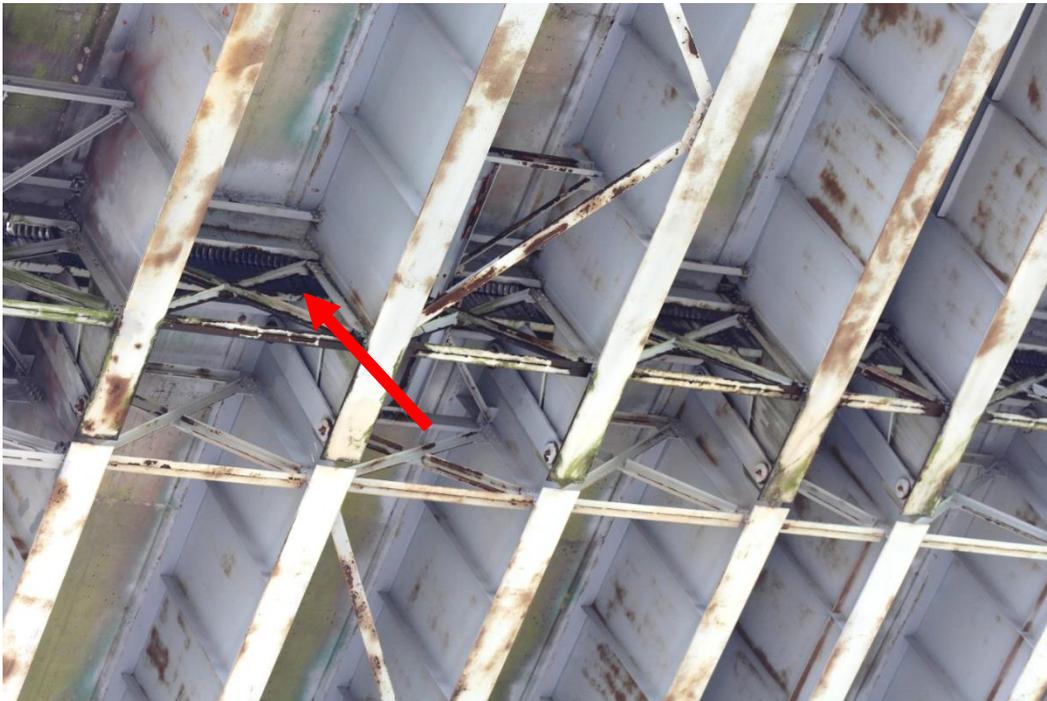
*Condition Photo 8: Condition of steel plate girders hinged expansion joints, and condition of cross frames under the deck joints. Cross frames connection plates (hard to see in photo) also have paint failure, corrosion, and minor section loss, typical at cross frames under expansion joints.*

2. Repair deteriorated secondary structural steel members on the truss span, to match historic appearance, as may be determined during the cleaning and painting operations noted in Item 1 above. These secondary members consist of deteriorated lateral bracing connection gusset plates under expansion joints, and other secondary members.

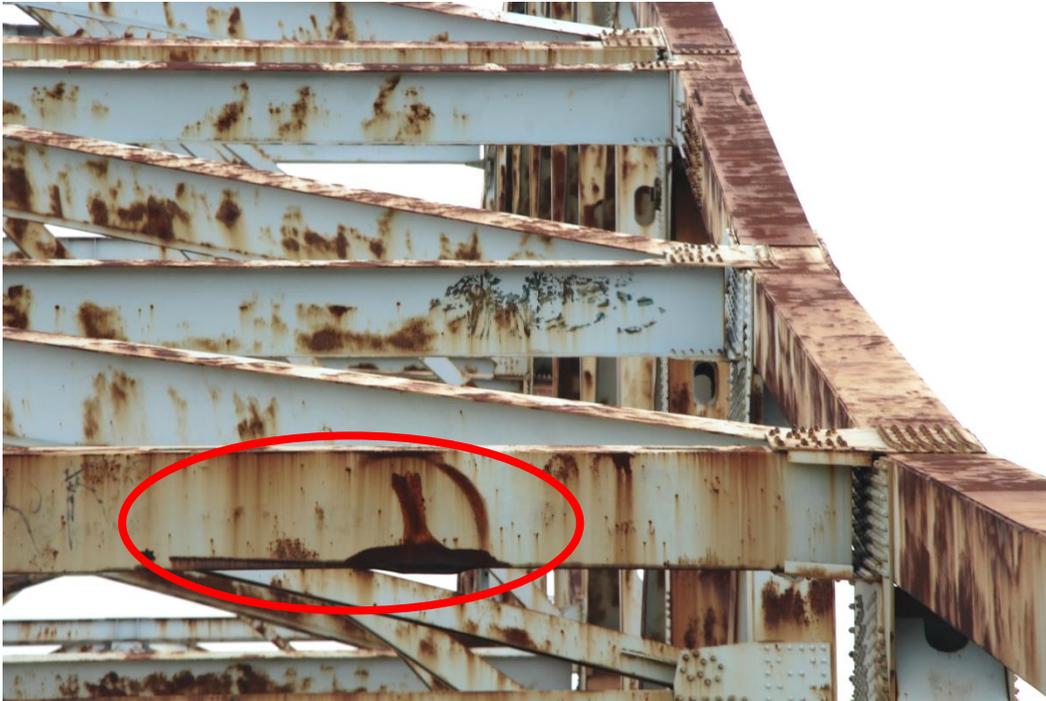
The bridge's north portal bracing over the southbound traffic lanes has minor impact damage but no other collision damage is evident on the truss span.

*Condition Photo 9: Minor impact damage to end of portal member on the north end of bridge, over outside southbound traffic lane (horizontal member in foreground with dark rust and paint failure).*

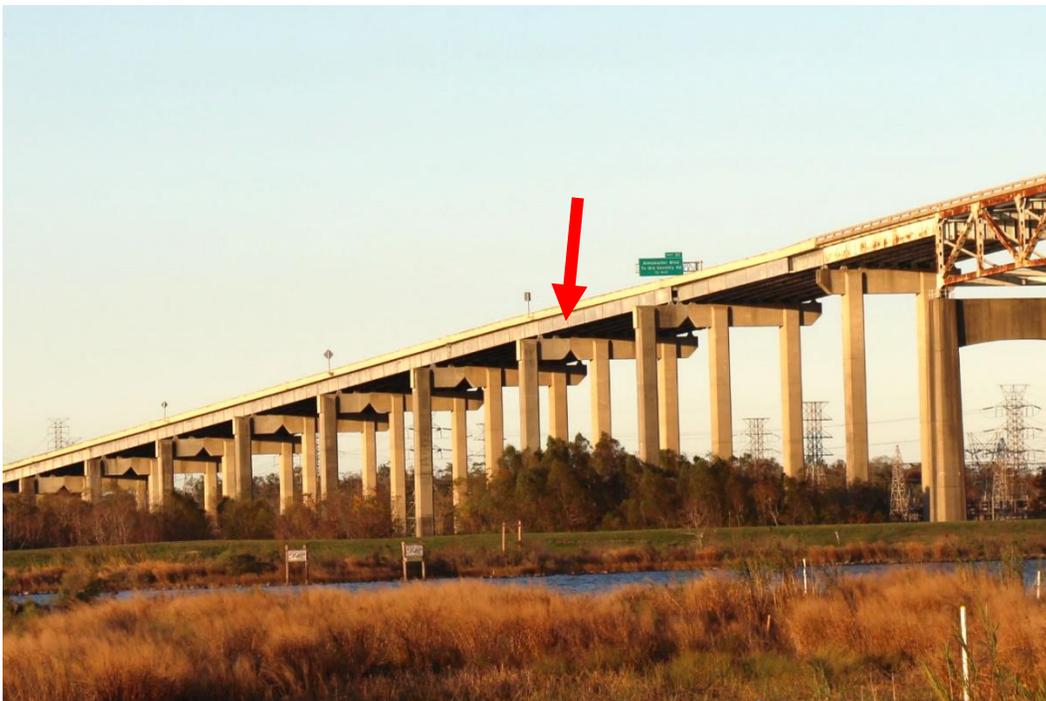
*Condition Photo 10: North approach spans steel plate girders, west side of bridge, showing newer exterior girders and newer parapet from addition of on-ramp from Old Gentilly Road interchange north of the bridge.*

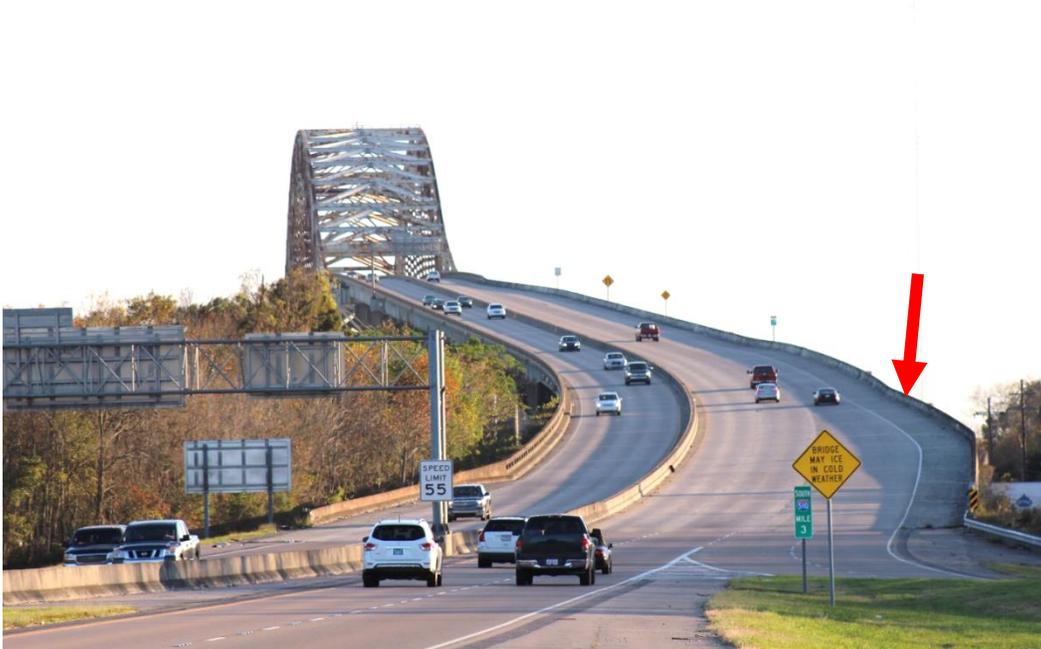
Condition Photo 11: North approach roadway to the bridge, facing southbound direction. Note the on-ramp from Old Gentilly Road Interchange. Note Jersey-style concrete parapet on right side of road.

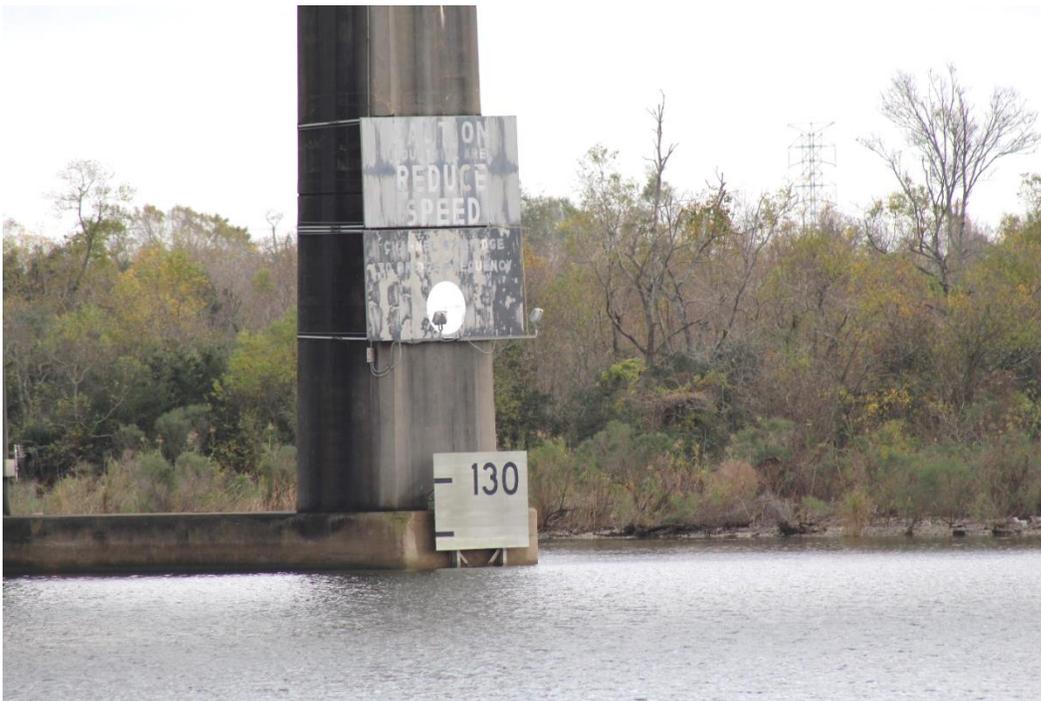
The waterway adequacy appraisal is good. No pier protection is in place or required, nor are waterway control devices such as spur dikes or embankment protection. Waterway banks are in stable condition. Both sides of the waterway are protected with earthen levees that appear to be in good condition. Signage for the waterway, attached to the piers, is adequate, but could use re-painting for easier reading.

Condition Photo 12: Condition of waterway marking signs on pier in waterway, typical for two piers. Signs could be re-painted for easier reading.

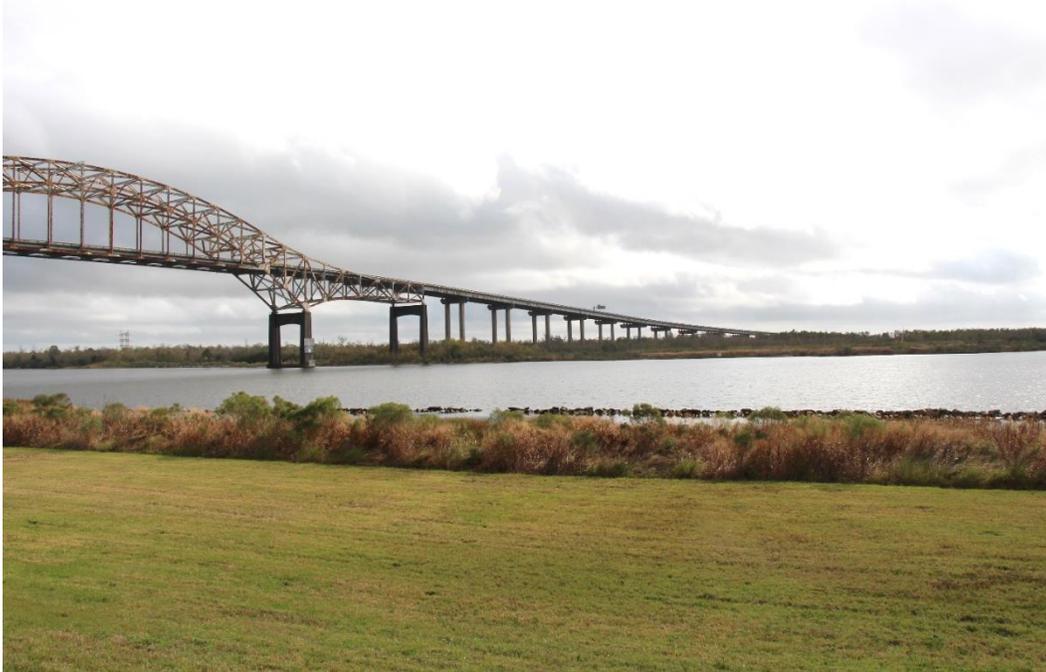
*Condition Photo 13: Condition of waterway banks, each side of waterway; both sides of the waterway are protected with levees.*
