Historic Bridge Management Plan for the Bayou Lafourche-Golden Meadow Bridge

Recall Number: 001030

Structure Number: 02294070100001

March 2017

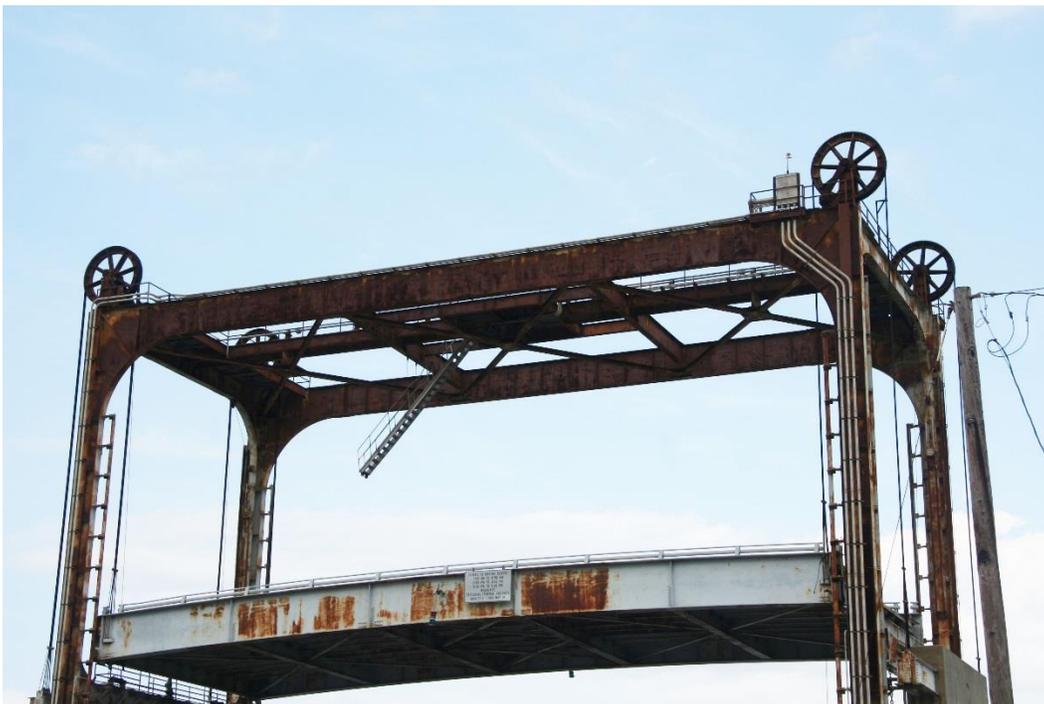
The lift span and towers are generally in satisfactory condition, although the paint system has failed on all structural steel elements of the lift span and tower spans, causing minor corrosion and deterioration on all members. The open metal grid deck is in good condition with light corrosion throughout. The checkered metal plates for the sidewalks are in serious condition, mainly due to the failed paint system with extensive corrosion and section loss. There are several locations where metal plates were welded to the corroded areas of the metal sidewalk plates. The metal railings are in good condition structurally, but the paint system has begun to fail. The operating machinery is functional and generally in good condition. The sheaves, gears, bearings, and exposed machinery are rusty, but functioning properly. The operating electrical system is functional and generally in good condition. The concrete piers are in good condition.

Condition Photo 3: Lift span in open position; note failed paint system on lift span and towers.

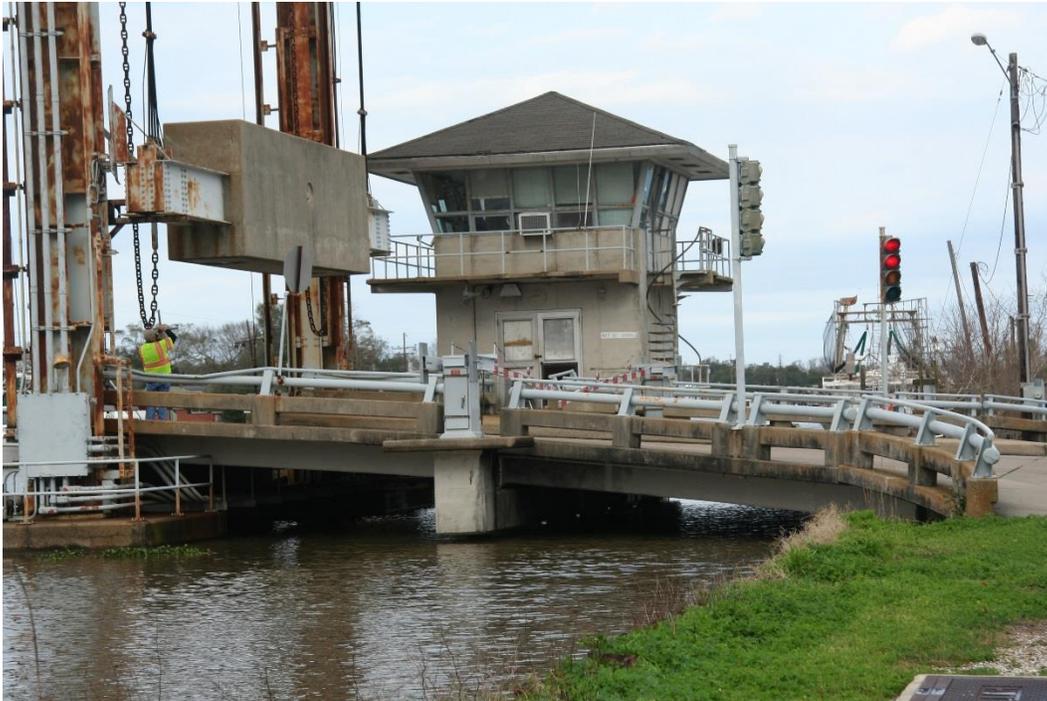
Condition Photo 4: Bridge operator's house and east approach spans at LA 308.

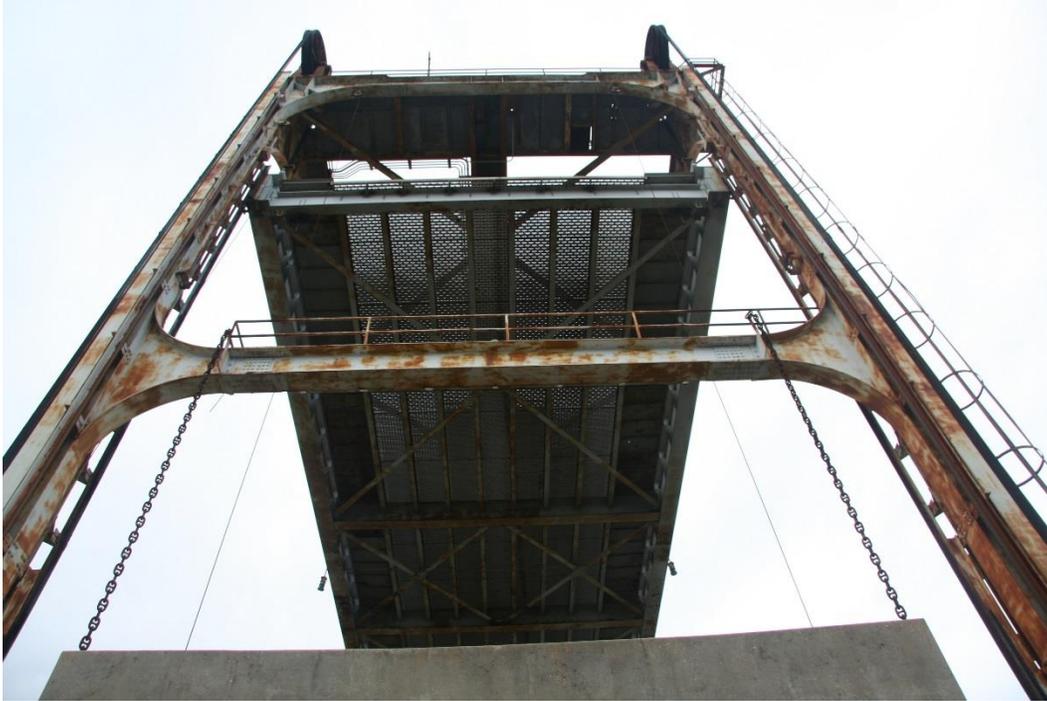
Condition Photo 6: East lift tower with bridge open.

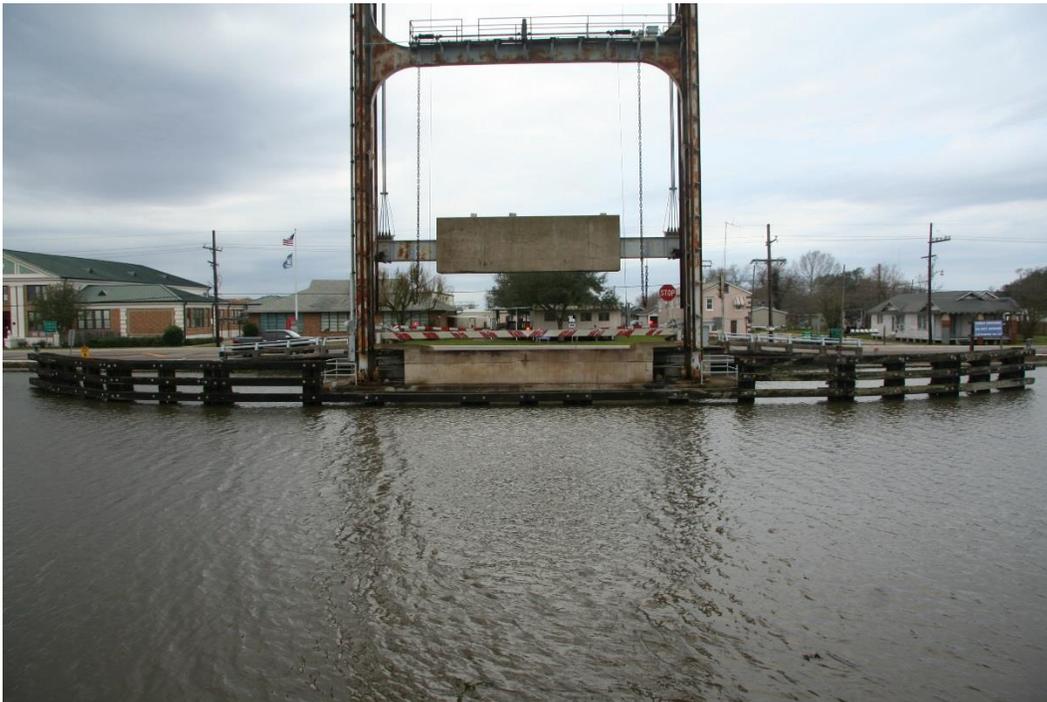
Condition Photo 7: West lift tower pier and timber fender system, looking west.

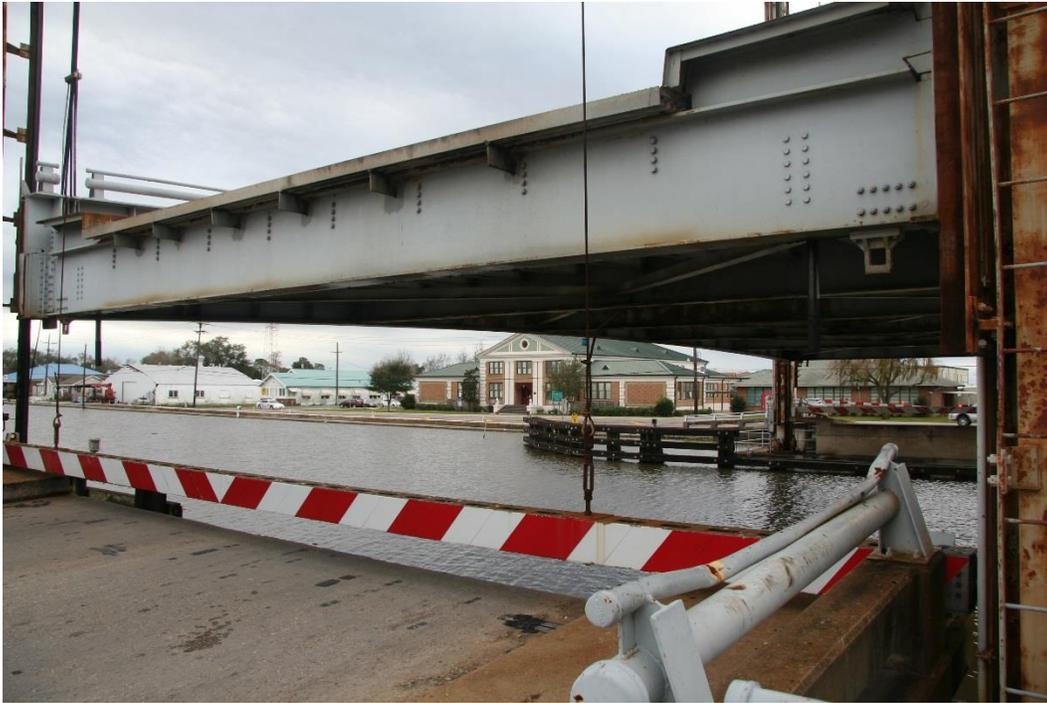
Condition Photo 8: West end of lift span; condition of damaged tubular bridge railing; traffic barrier gate is down.

2. Remove and replace checkered steel plates for the sidewalks on the lift span with new plates. Galvanized checkered steel plates are recommended.
3. Remove and replace damaged steel tubular railing in the four quadrants of the lift span approaches.

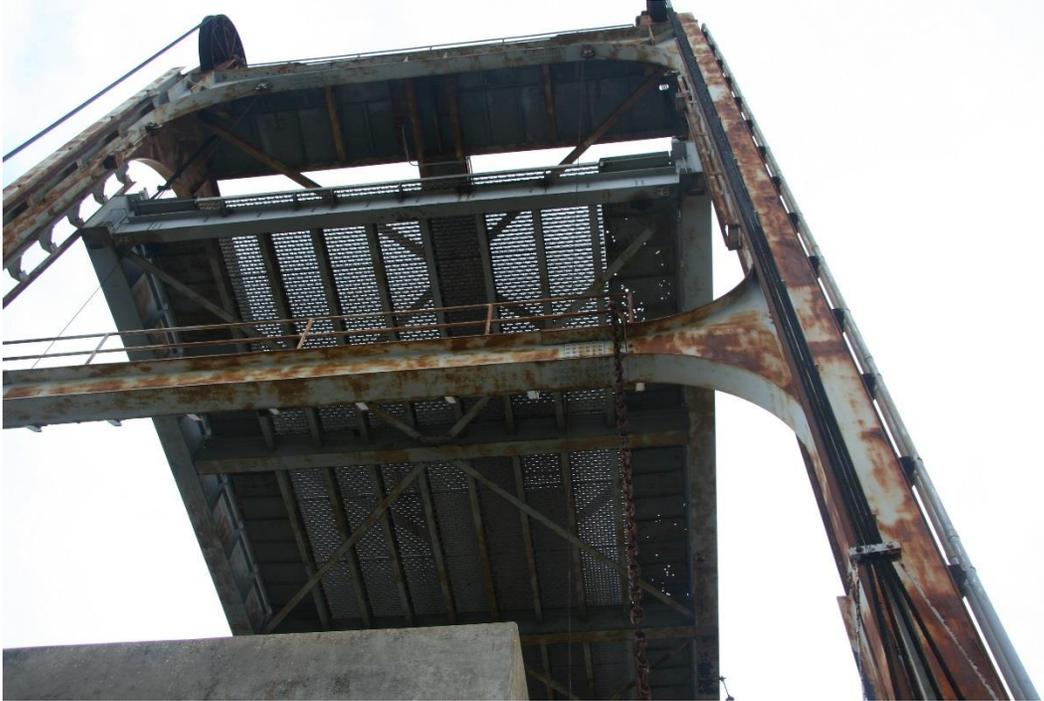
Condition Photo 10: West lift tower with bridge open; note holes in metal sidewalk plates.

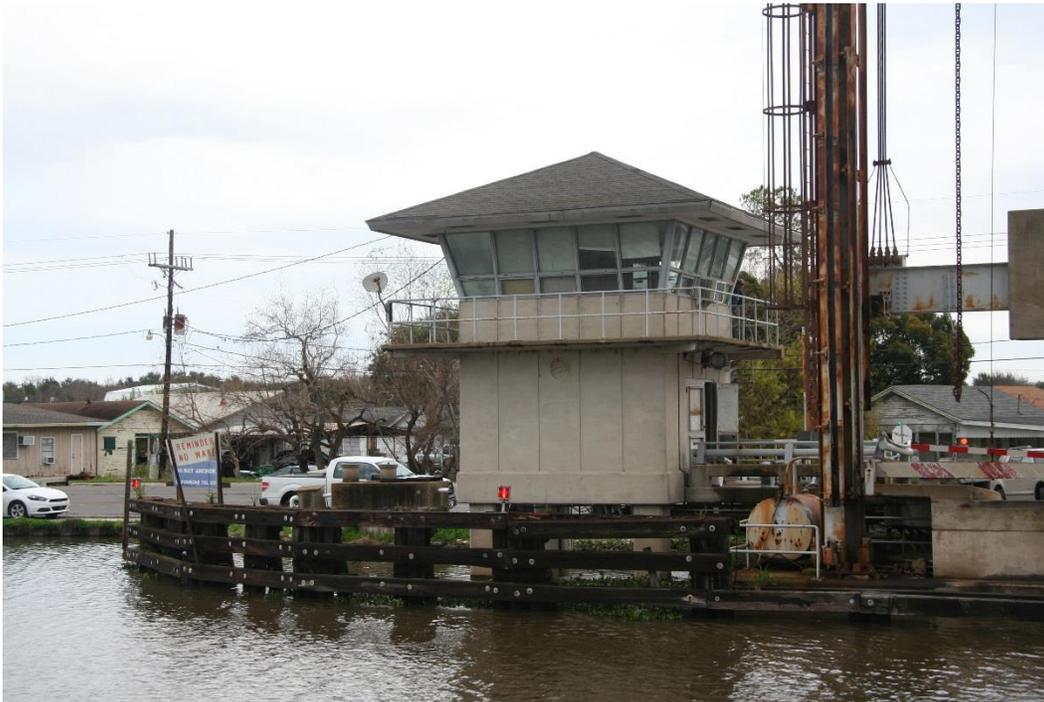
Condition Photo 11: Operator's house and northwest tower and timber fender system.

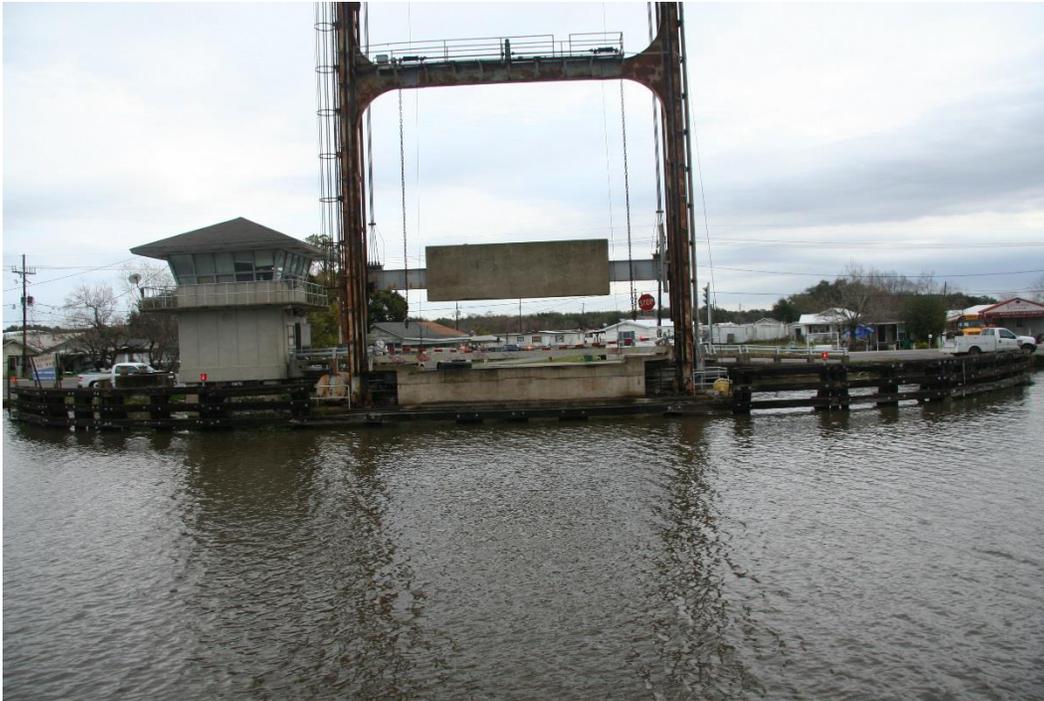
Condition Photo 12: East lift tower and timber fender system, looking east.

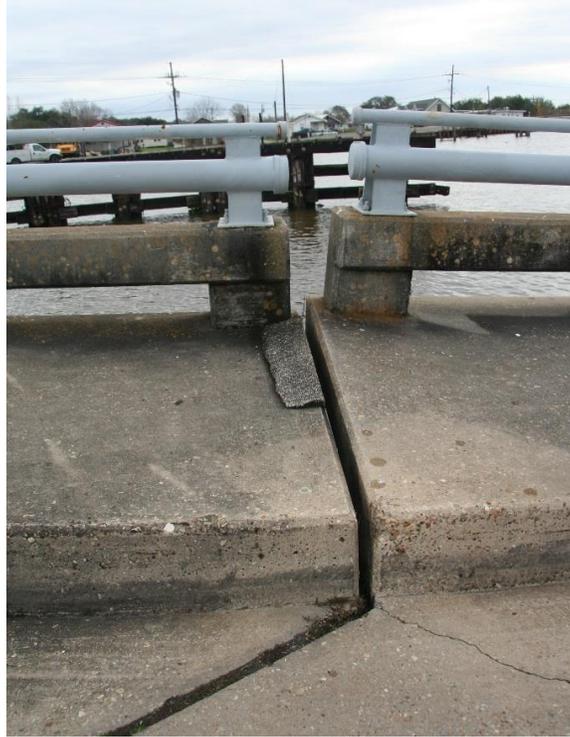
The concrete decks of the approach spans are in good condition, with some longitudinal cracking. The deck joints (expansion joints) have failed and are in poor condition, allowing water and debris to pass through to the elements below the joints. The concrete sidewalks and concrete/metal railings are in generally good condition, except at the ends of the left span in all four quadrants, the metal tube railing is bent and distorted. The concrete substructure units (abutments and piers) are in good condition. The sidewalks on the westerly approach span are misaligned, resulting in a small "step" in the sidewalk surface. The southeast portion of the easterly approach span has a large diagonal crack on the exposed face.

Condition Photo 14: Sidewalk and deck joint in southwest quadrant of west approach span.

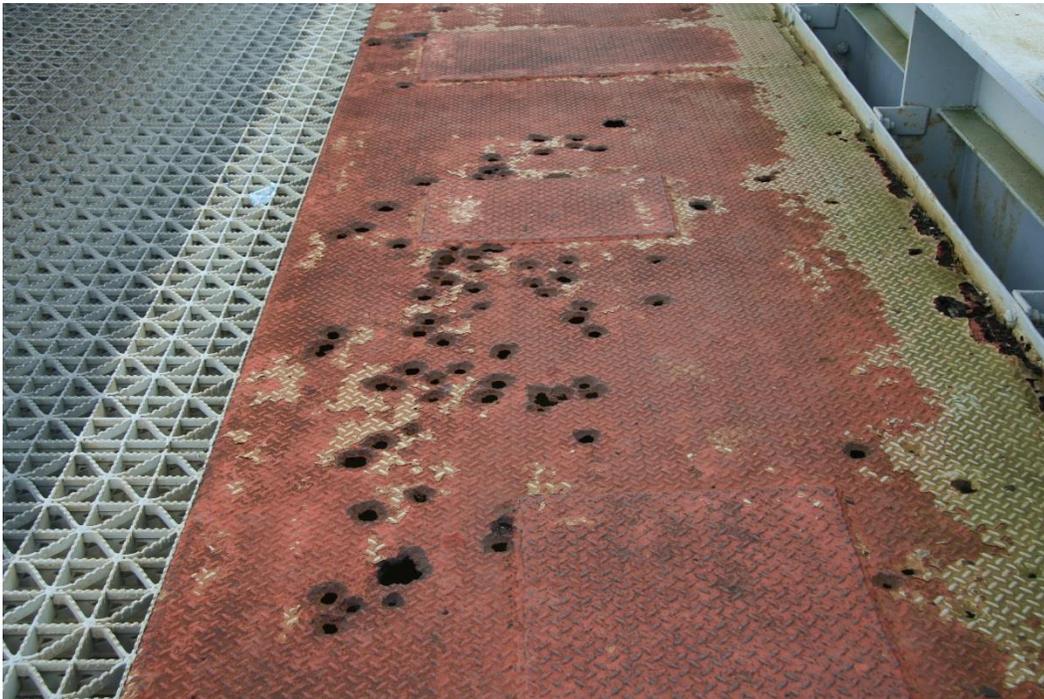
Condition Photo 15: Metal plate walkway condition, south walkway, west end.

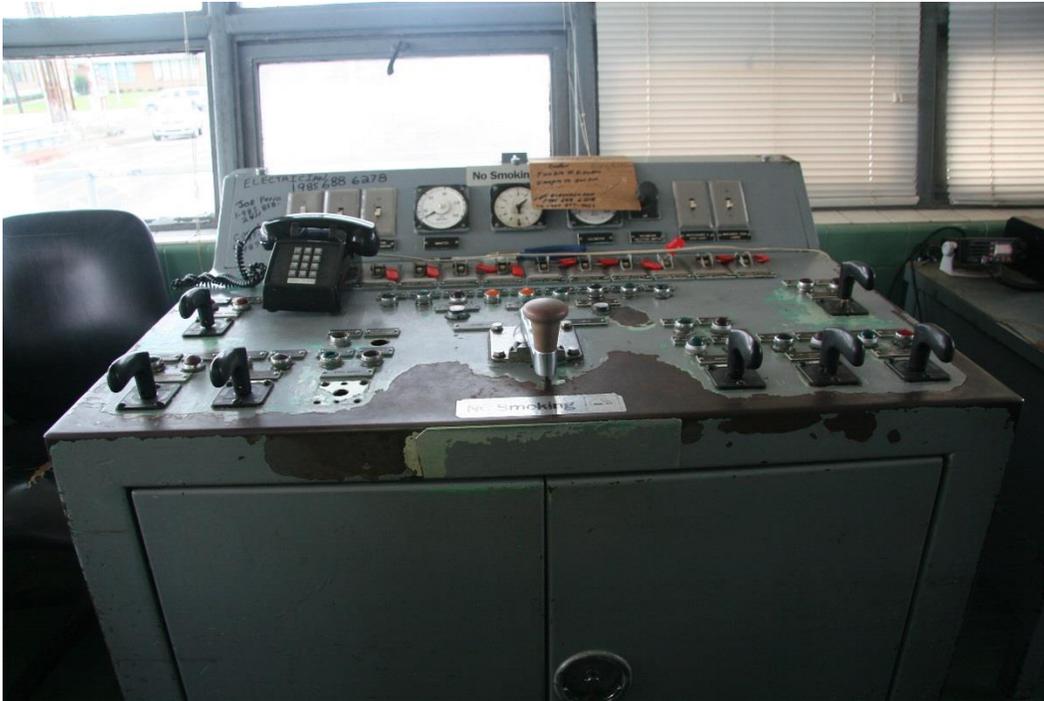
Condition Photo 16: Control panel and inside of bridge operator's house (second floor).

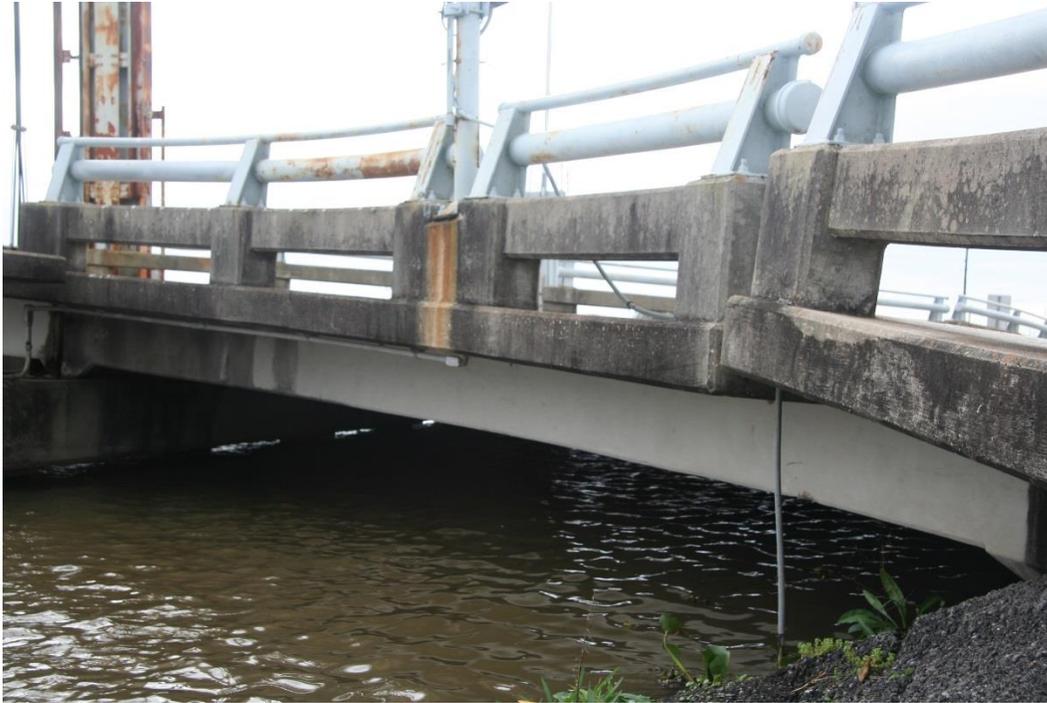
Condition Photo 18: North side of west approach spans; note misalignment in railing.

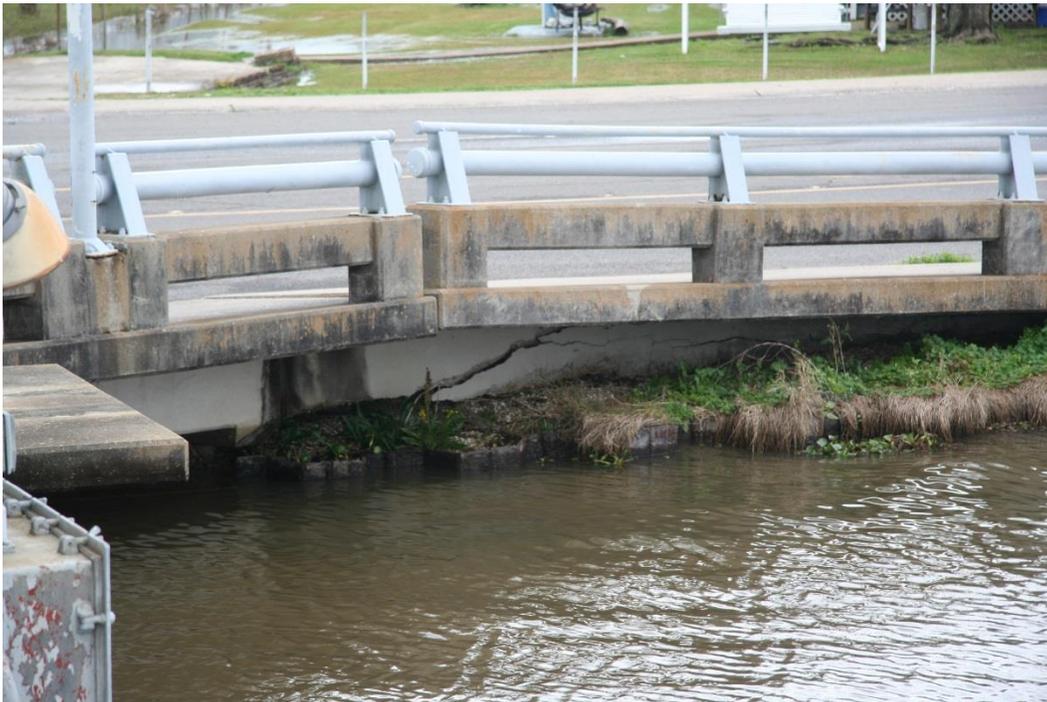
Condition Photo 19: South side of east approach spans; note large diagonal crack.

7. Repair the crack in the southeast approach span by using non-shrink epoxy grout of a color and texture to match the adjacent concrete surfaces.
