Historic Bridge Management Plan for the Belle Terre Boulevard Bridge

Recall Number: 620266

Structure Number: P5230253900571

March 2017

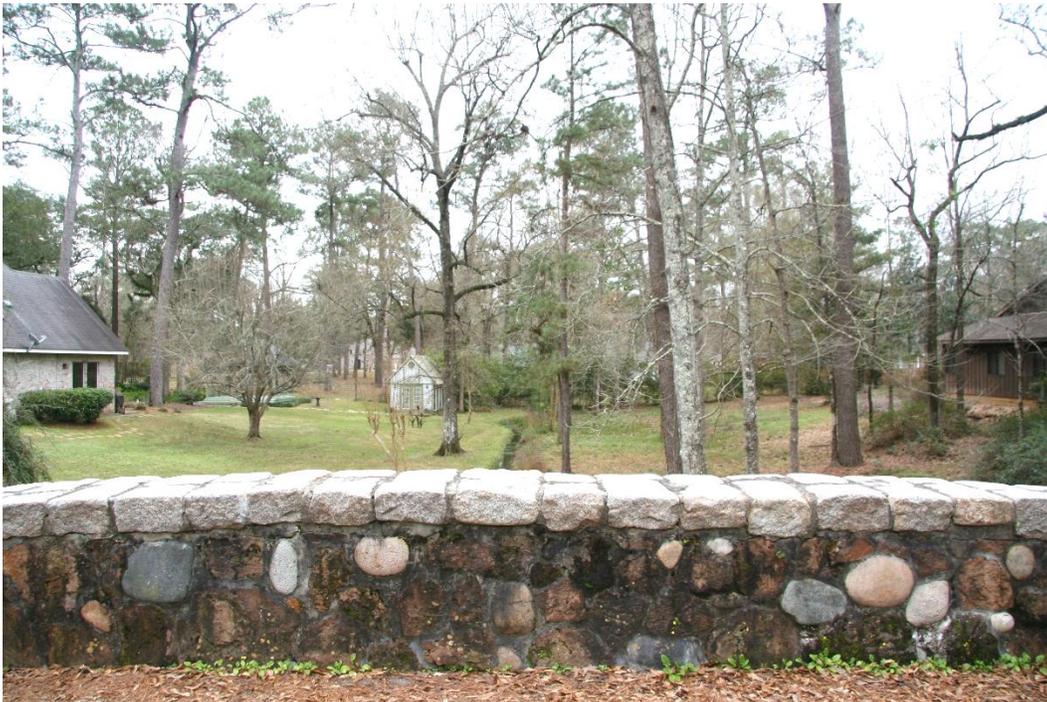
Condition Photo 4: Bridge parapet railing with capstones, looking south (upstream).

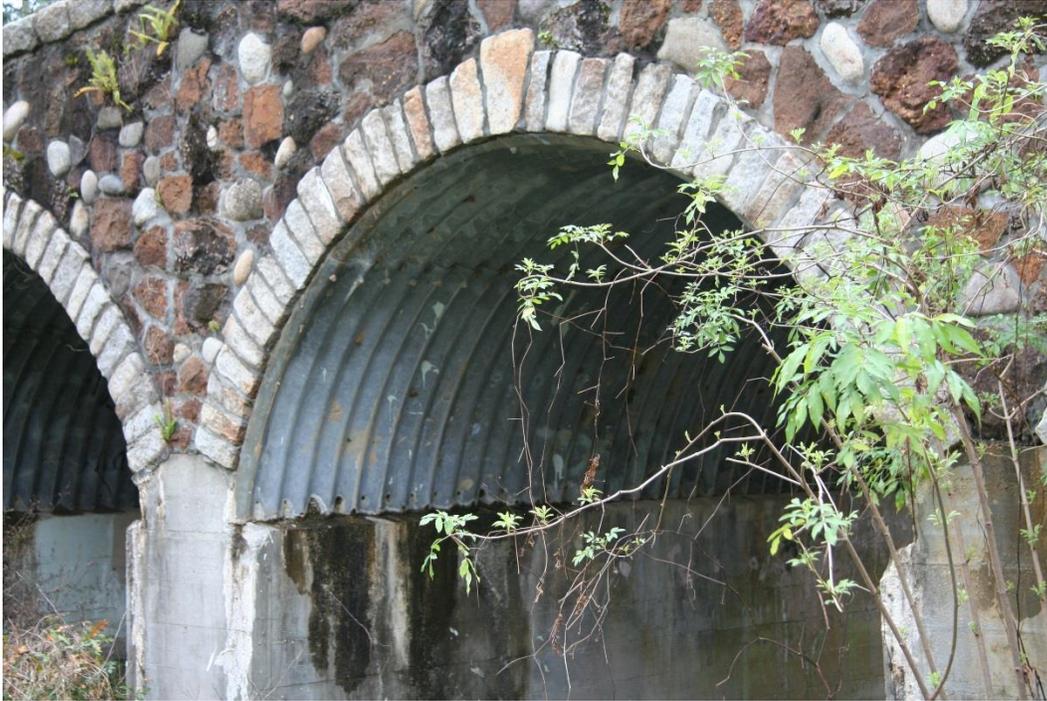
Condition Photo 5: Metal liner plate, stonework, and cast-in-place concrete foundation wall details.

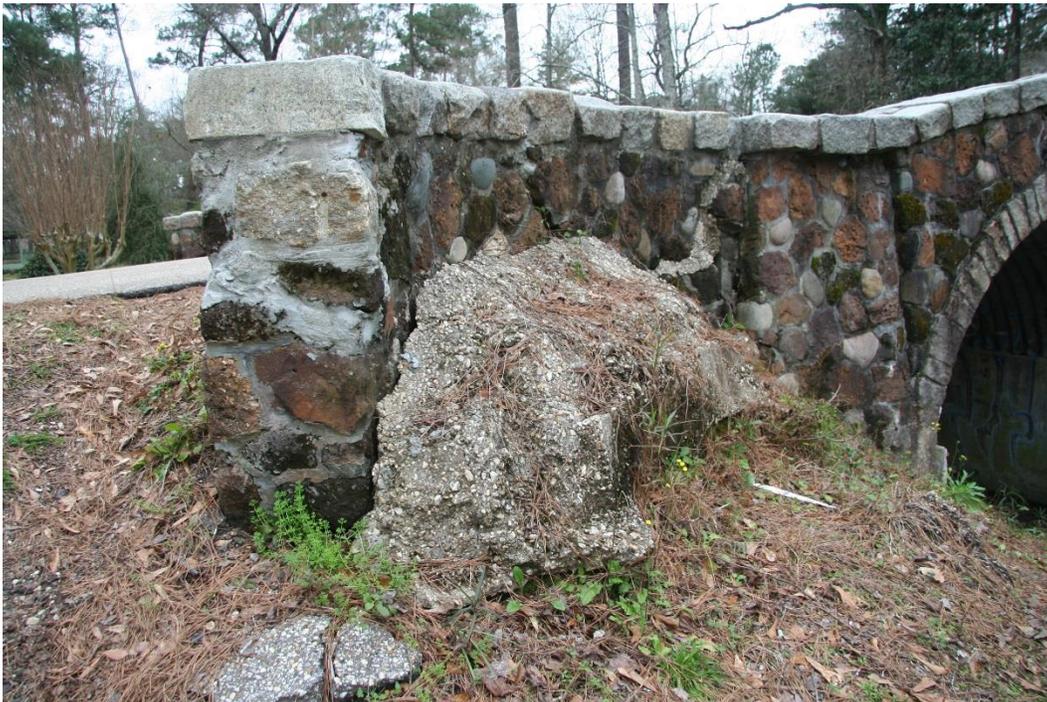
The asphaltic concrete roadway surface across the bridge is in good condition. The metal liner plates are in generally good condition, with very minor corrosion at some of the bolted joints, and at the concrete foundations. The cast-in-place concrete foundations are in fair condition, with minor spalling and efflorescence on each end at the interface with the liner plates. The stones, mortar joints, and capstones are in fair condition, but the southeast and northwest wingwalls and parapet railings and capstones are in poor condition. There are open mortar joints between the fascia stones and capstones in these wingwalls. Mortar joint repairs were previously completed to many areas of this structure. A large chunk of concrete was poured behind the northeast wingwall, possibly to minimize erosion problems.

Condition Photo 6: Northeast wingwall; note mortar joints repairs and large chunk of concrete.

2. Repair deteriorated mortar joints in the wingwalls and capstones of the parapet railing on the wingwalls following a mortar analysis to determine the mortar that will comply with the guidance in National Park Service *Preservation Brief 2: Repointing Mortar Joints in Historic Masonry Buildings*.

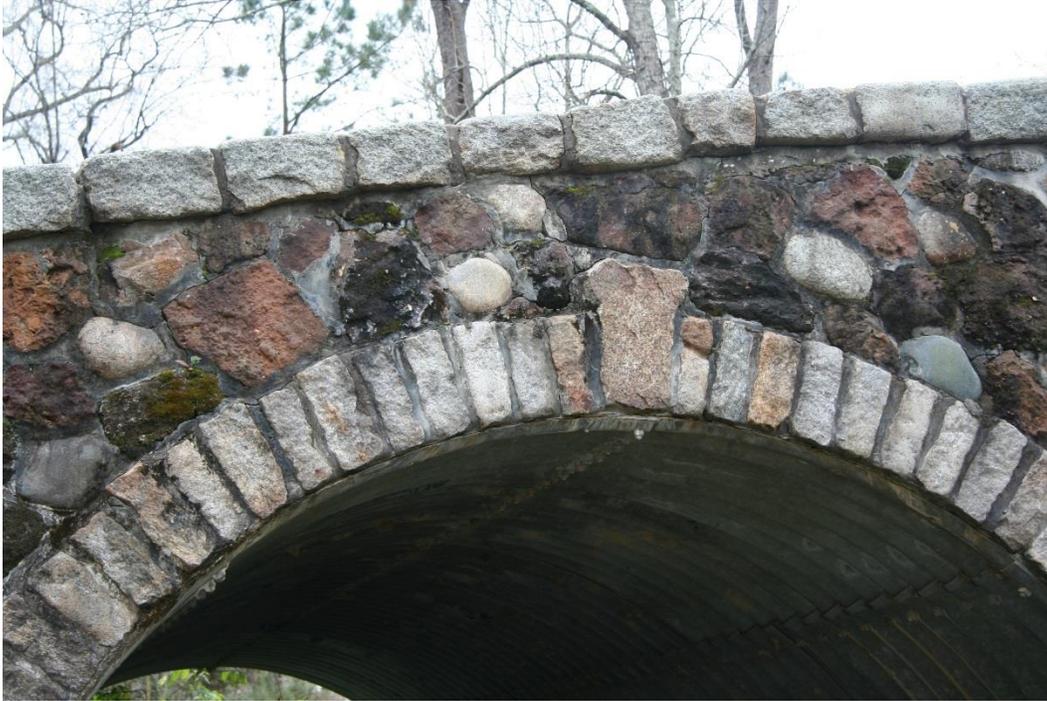
Condition Photo 7: Condition of mortar and stonework.

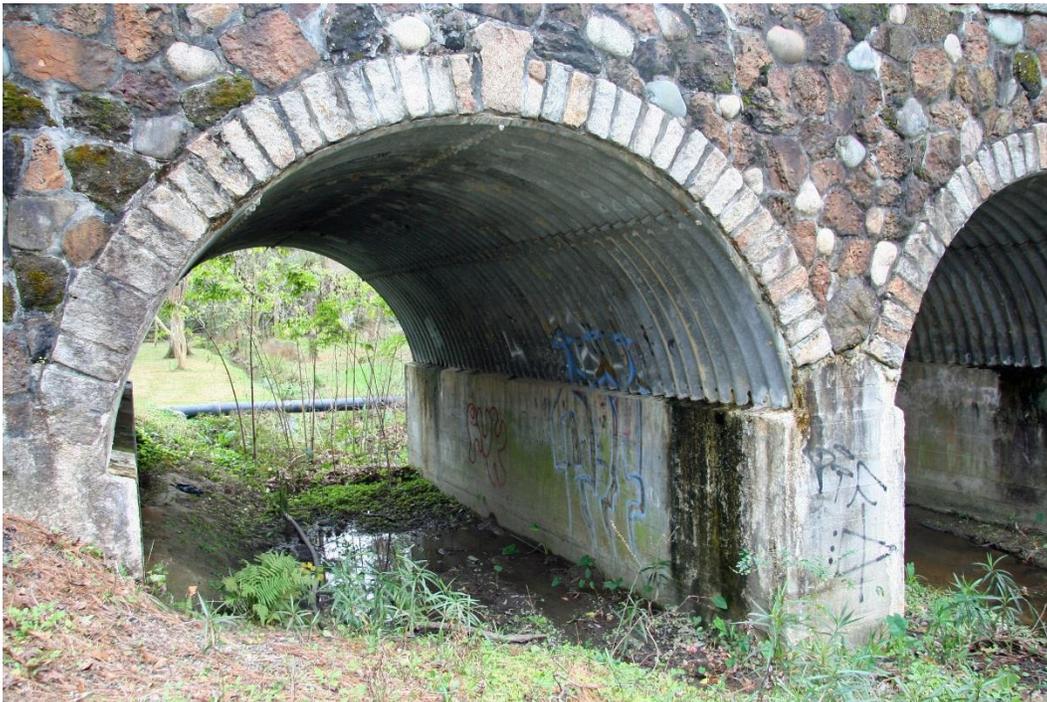
Extensive graffiti was observed in the arch spans of this bridge. The waterway opening in the three arch spans appears to be adequate for storm flows, and there is no visible scouring of the concrete foundations.

Condition Photo 8: Condition of easterly arch span; note graffiti on arch metal liner plates and cast-in-place concrete foundation walls.

1. Non-destructive graffiti removal, using low-pressure water blast cleaning (no solvents) following testing on a small area.

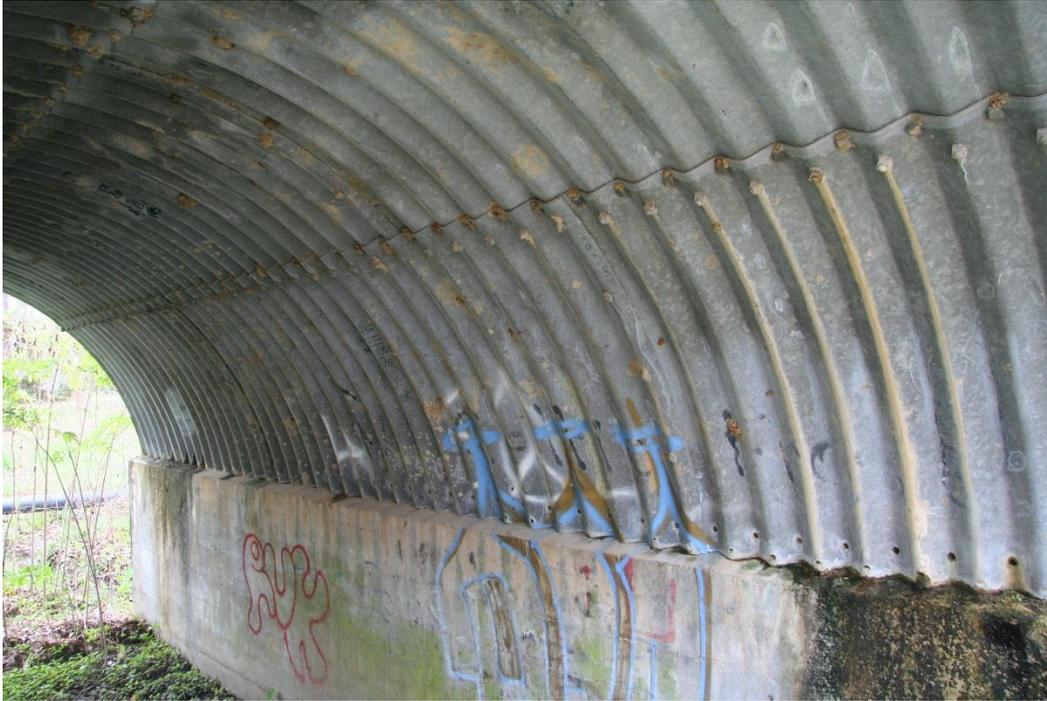
Condition Photo 9: Condition of metal liner plate detail.

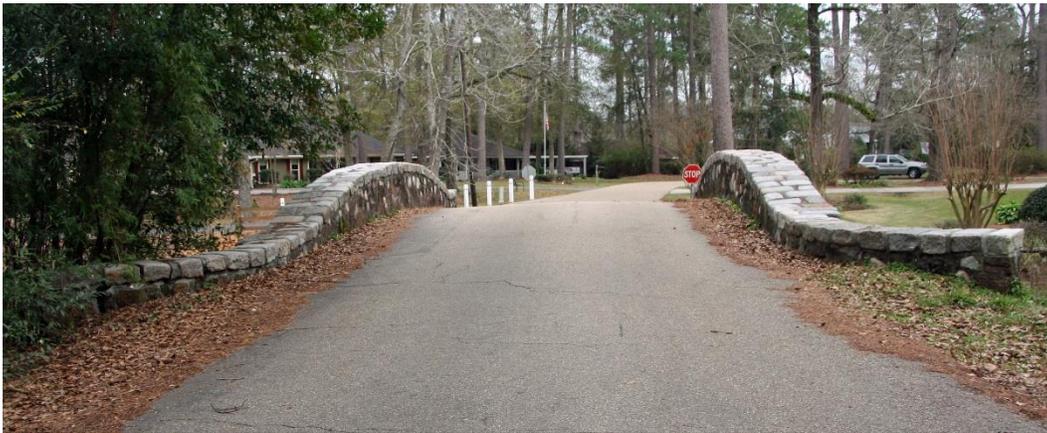
Condition Photo 10: Looking east across the bridge; note debris along parapet railings.

1. Clean debris and vegetation from the bridge deck semi-annually, or as conditions warrant, after leaves and pine needles fall from the trees (suggested in spring and fall). The cost for this maintenance activity is not included in the cost estimate as it is routinely done.

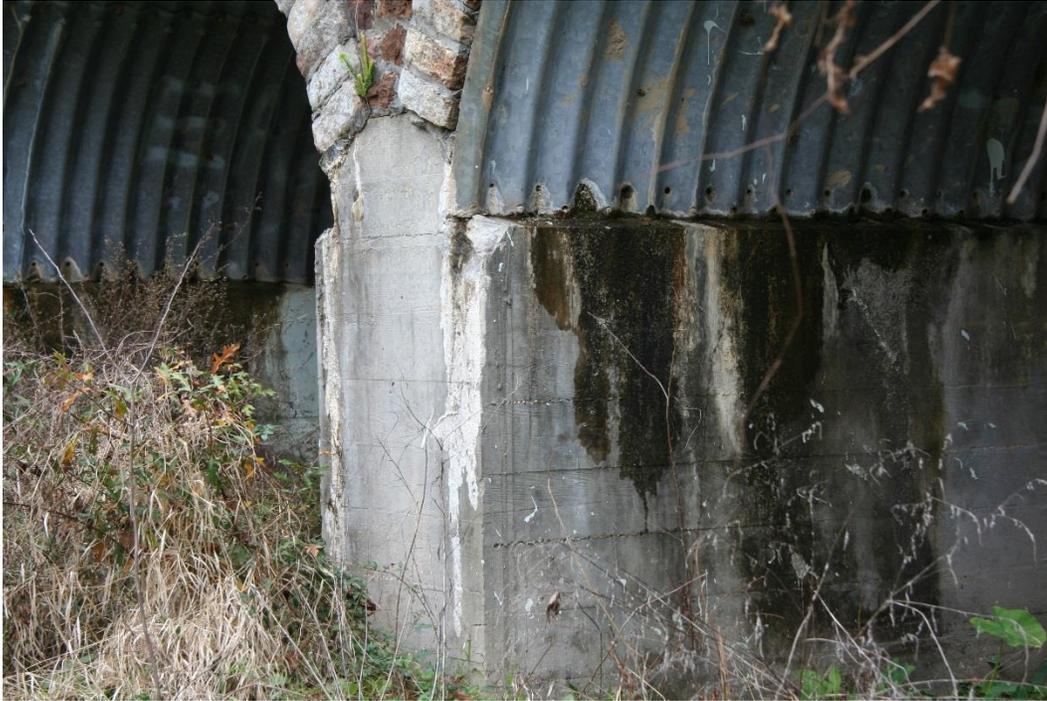
Condition Photo 11: Condition of cast-in-place concrete foundation walls and metal liner plate detail.

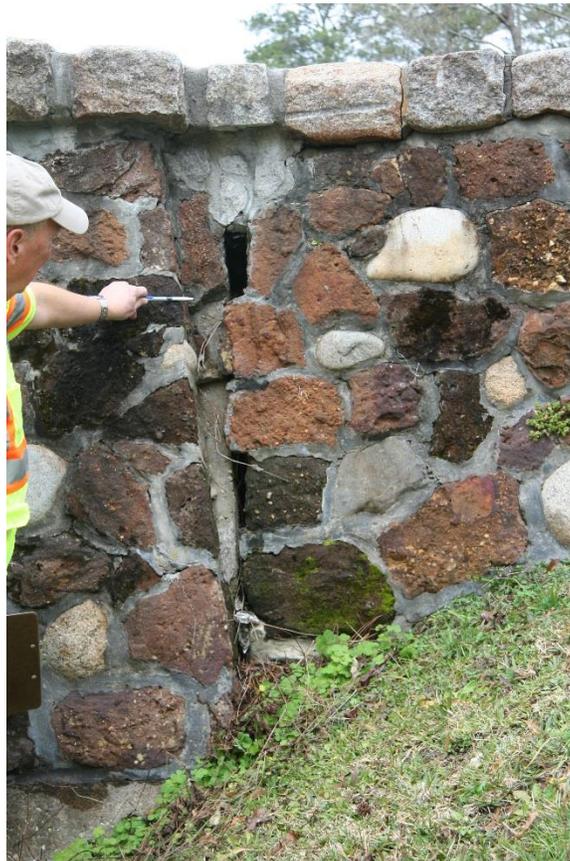
The bridge exhibits missing and open mortar joints between the fascia stones and capstones on the southeast and northwest wingwalls. Elsewhere, mortar joint repairs were previously completed to many areas of the structure and a large chunk of concrete was poured behind the northeast wingwall. Despite the condition of the mortar joints, the bridge retains good integrity. The Belle Terre Boulevard Bridge is eligible for listing in the National Register under *Criterion C: Engineering*. Its significance is demonstrated by its distinctive multi-plate arch design as an important example of a distinctive culvert type in Louisiana. The bridge also possesses high artistic value under *Criterion C: Architecture* due to its ornamental mortared stonework and curved parapet railings reflecting the Rustic style.

Condition Photo 12: Condition of southeast wingwall stones and mortar joints.

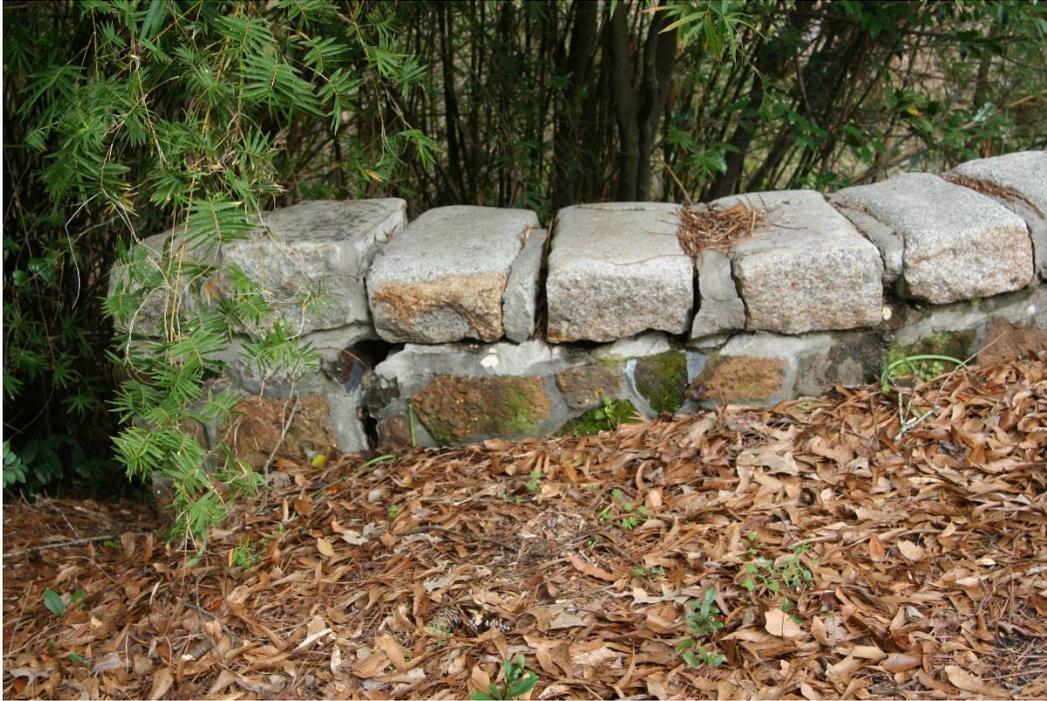
Condition Photo 13: Condition of mortar joints on northwest wingwall and capstones.
