Historic Bridge Management Plan for the Bayou Teche Bridge at Daspit Road

Recall Number: 005900

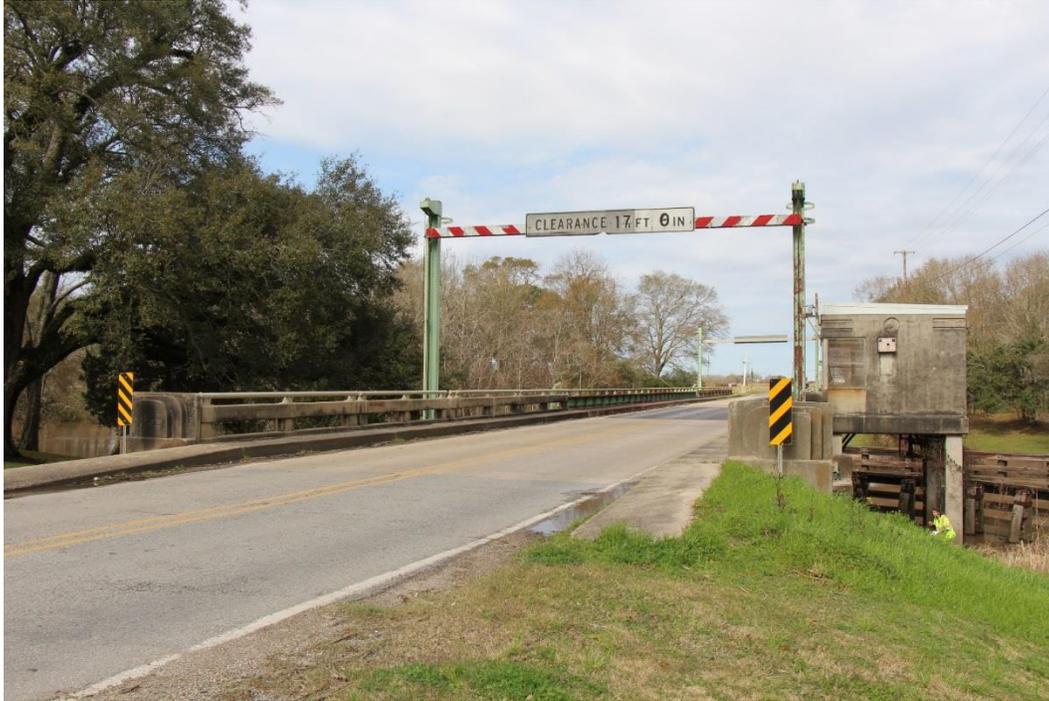
Condition Photo 1: South approach roadway looking north at the bridge. Note traffic barrier gate and towers, and operator's house.

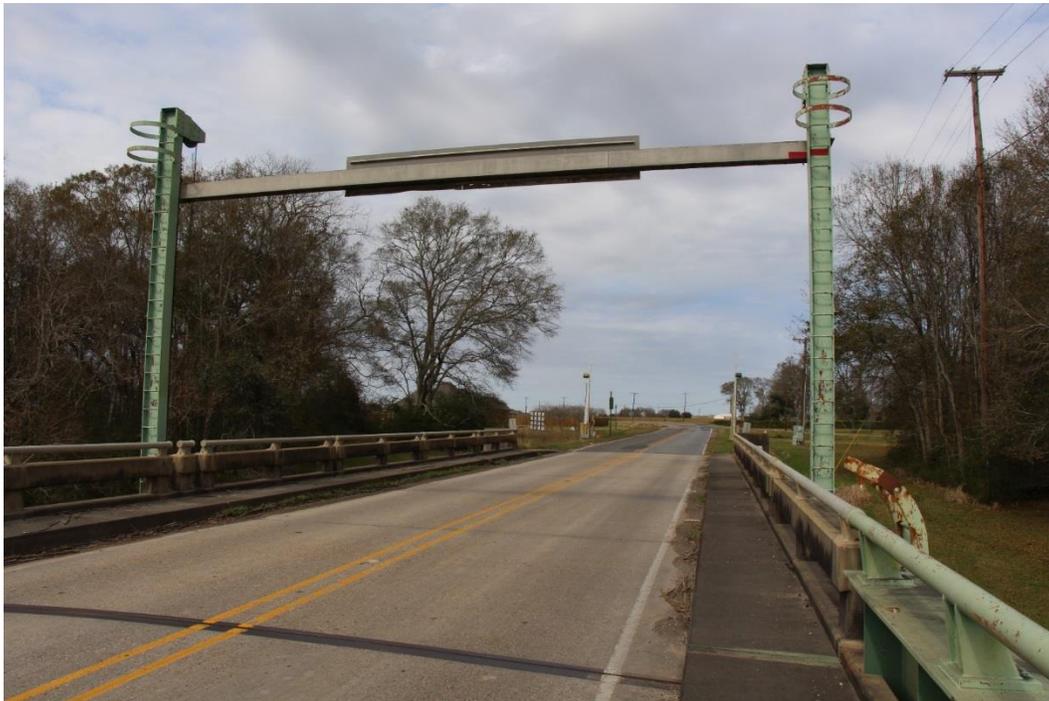
Condition Photo 2: Northerly concrete approach spans and traffic barrier gate, looking north toward north end of bridge.

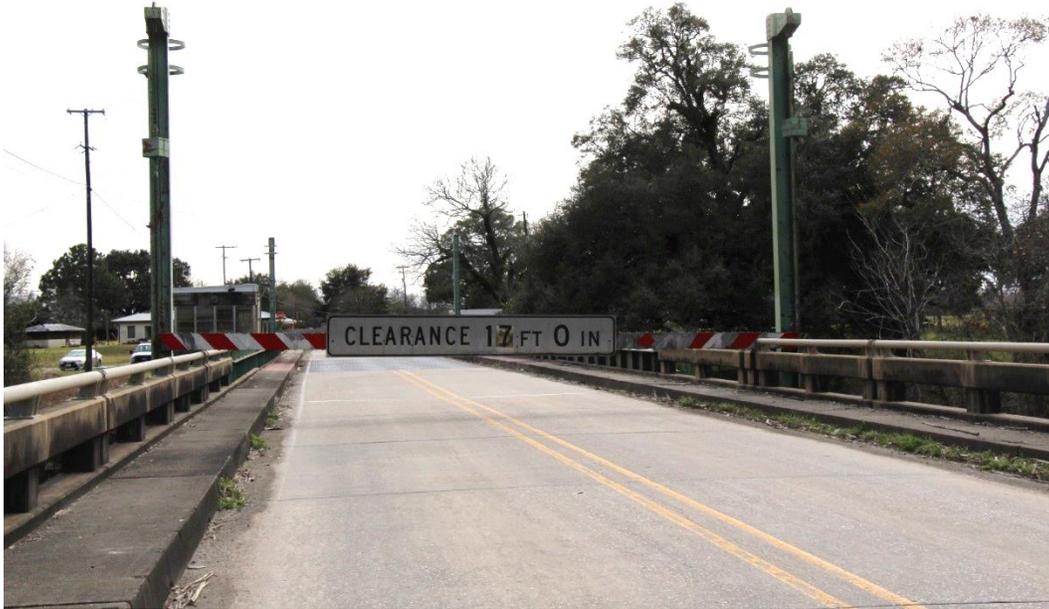
Condition Photo 3: North traffic barrier gate with towers and vertical clearance sign, looking south.

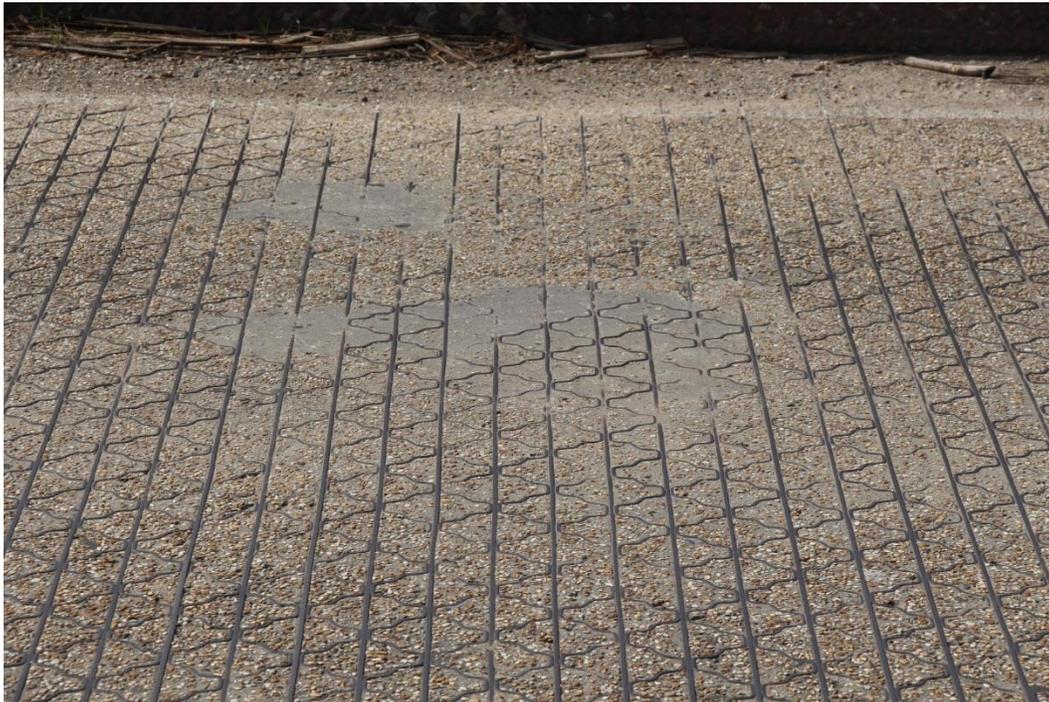
Condition Photo 4: Concrete-filled metal grid deck wear and patched areas on swing span.

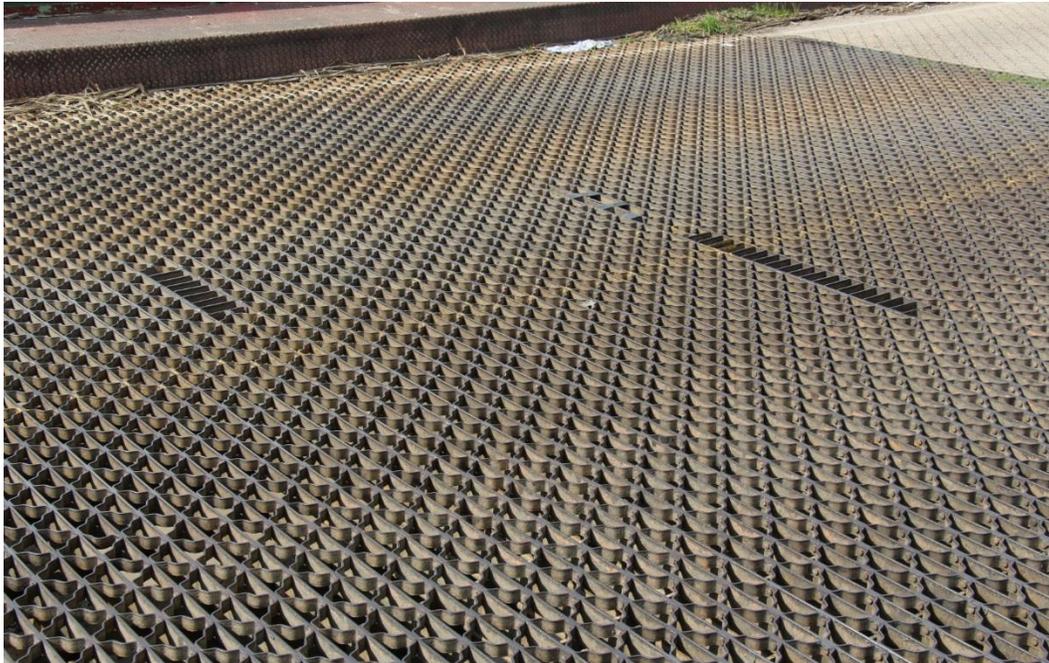
Condition Photo 5: Open metal grid deck condition showing repairs on swing span.

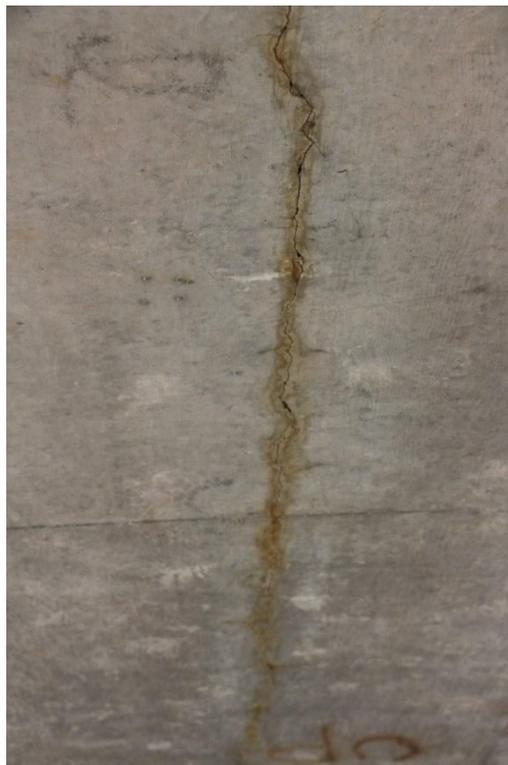
Condition Photo 6: Typical concrete slab approach span cracking and efflorescence on the underside of the slab.

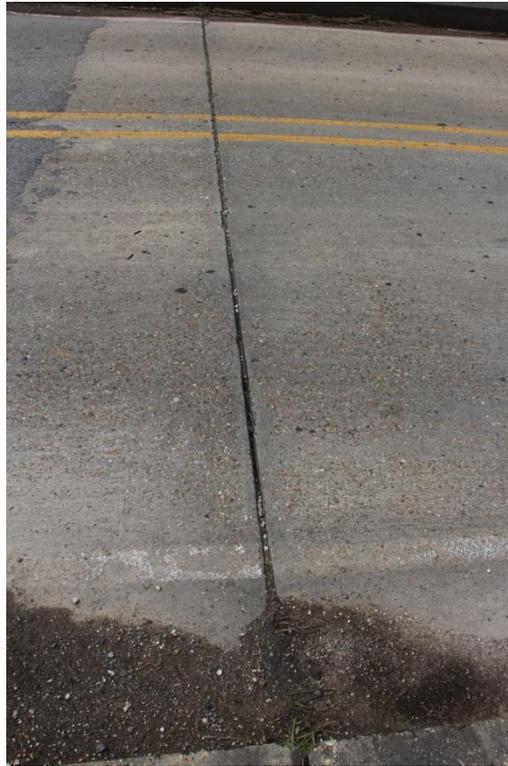
Condition Photo 7: Deck expansion joint and shoulder full of debris, typical for approach spans.

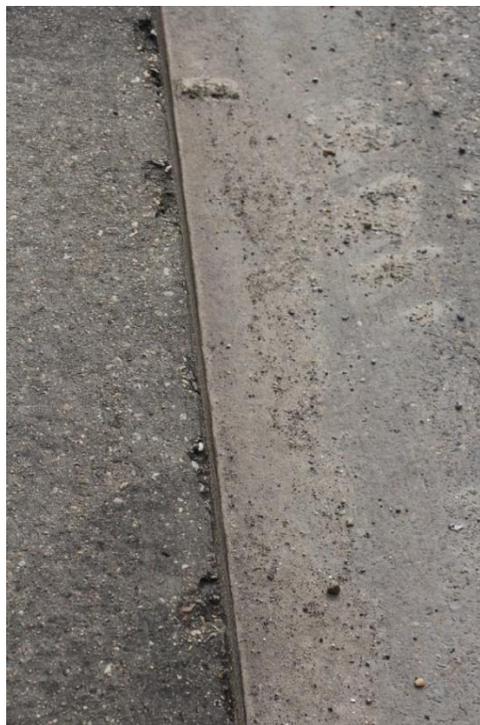
Condition Photo 8: Spalling of the concrete joint in approach span concrete deck at concrete approach slab at end of bridge.

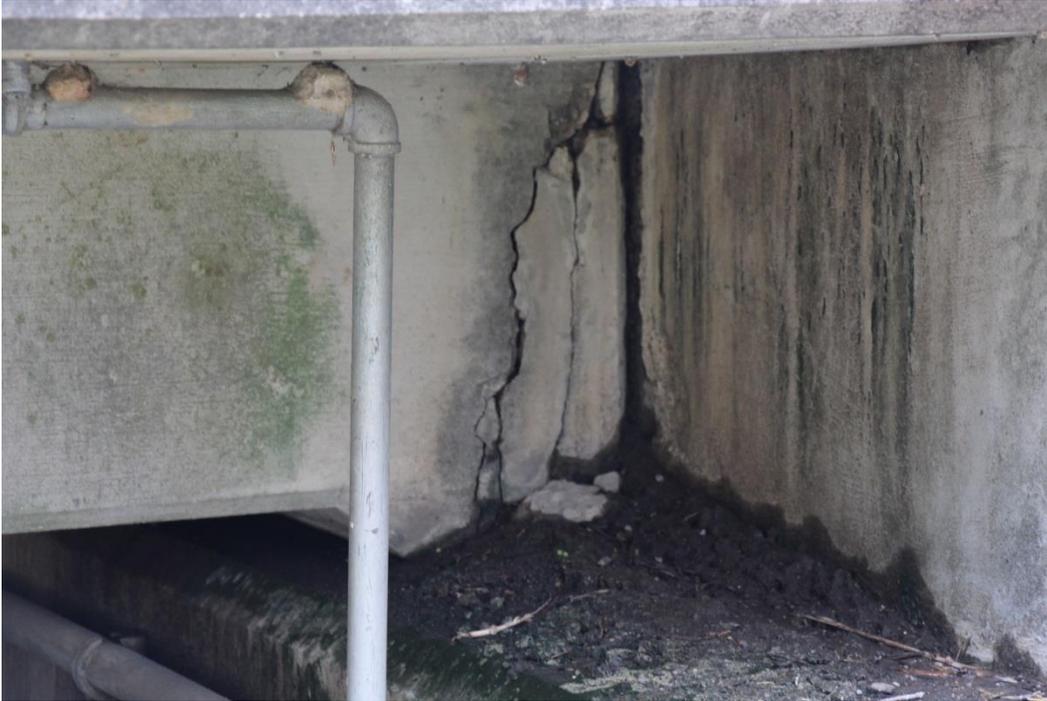
Condition Photo 9: Crack in haunch of concrete deck slab at the end bent 1.

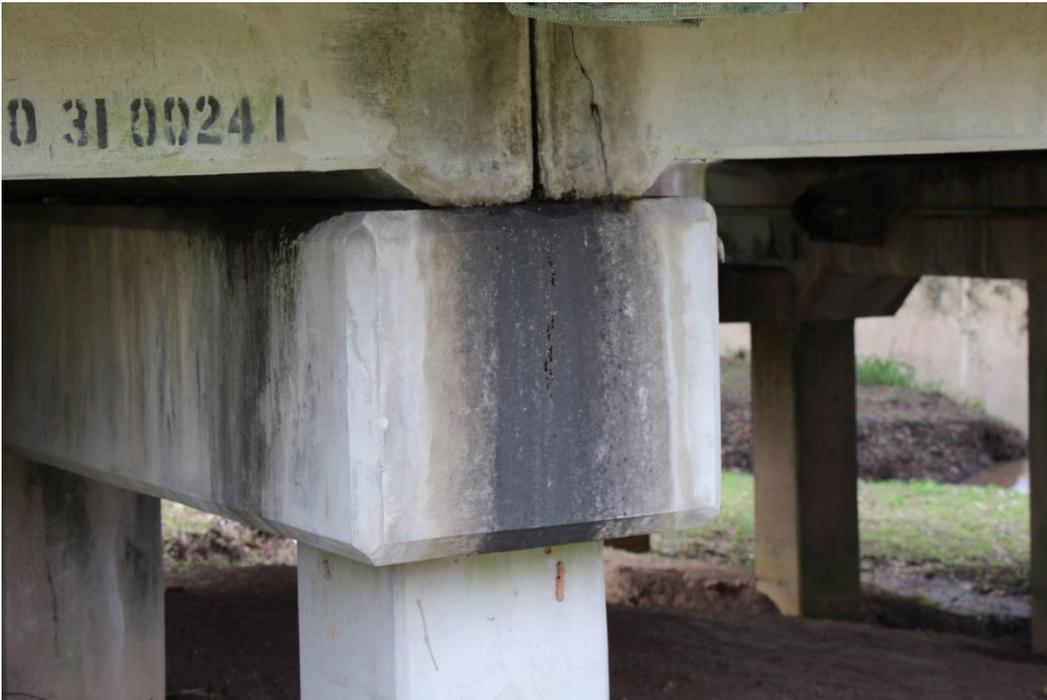
Condition Photo 10: End of concrete bent cap water staining and crack in concrete deck slab haunch.

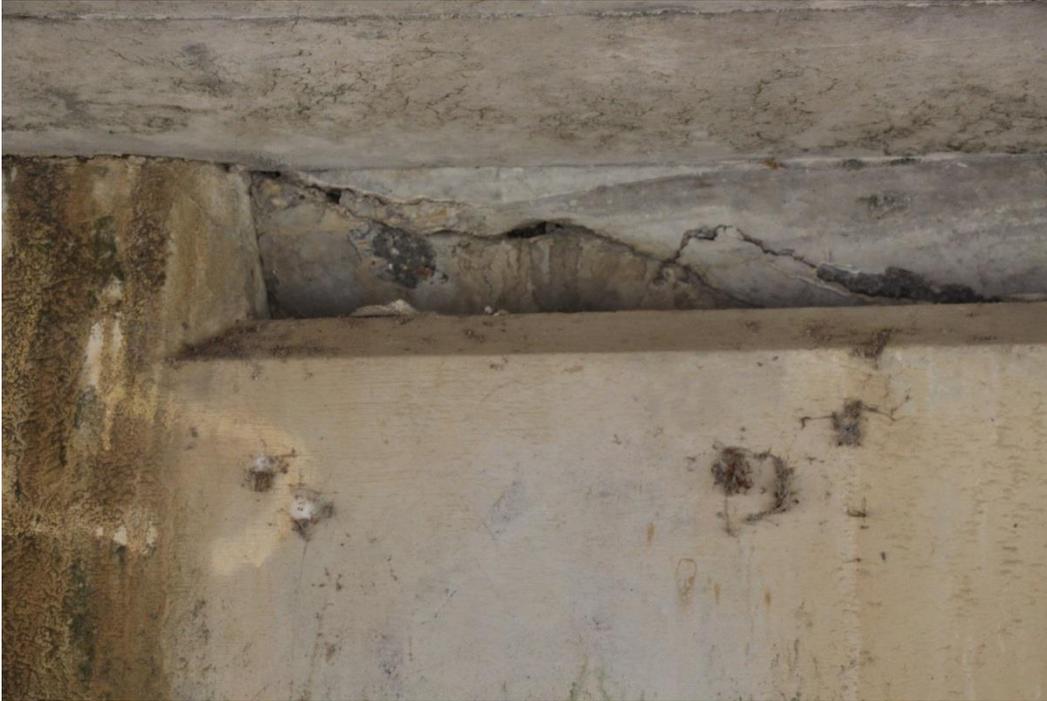
Condition Photo 11: Spall at the concrete deck slab where the deck and haunch meet at bent 4.

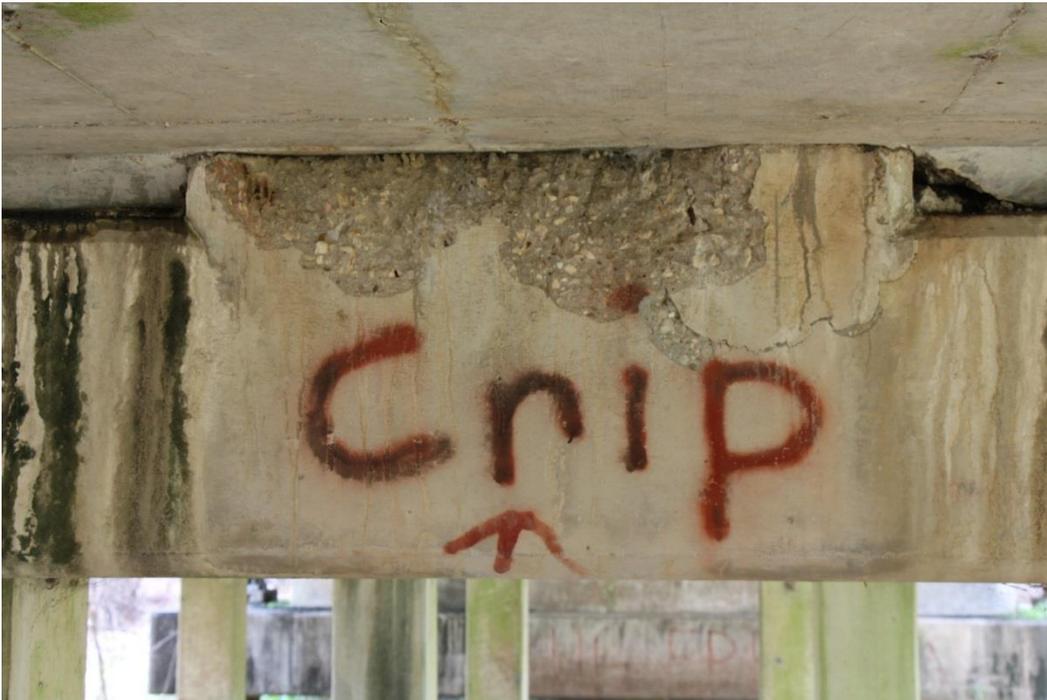
Condition Photo 12: Bent 10, spalled concrete bent cap where the deck and haunch meet at the bent cap; also note graffiti on bent cap.

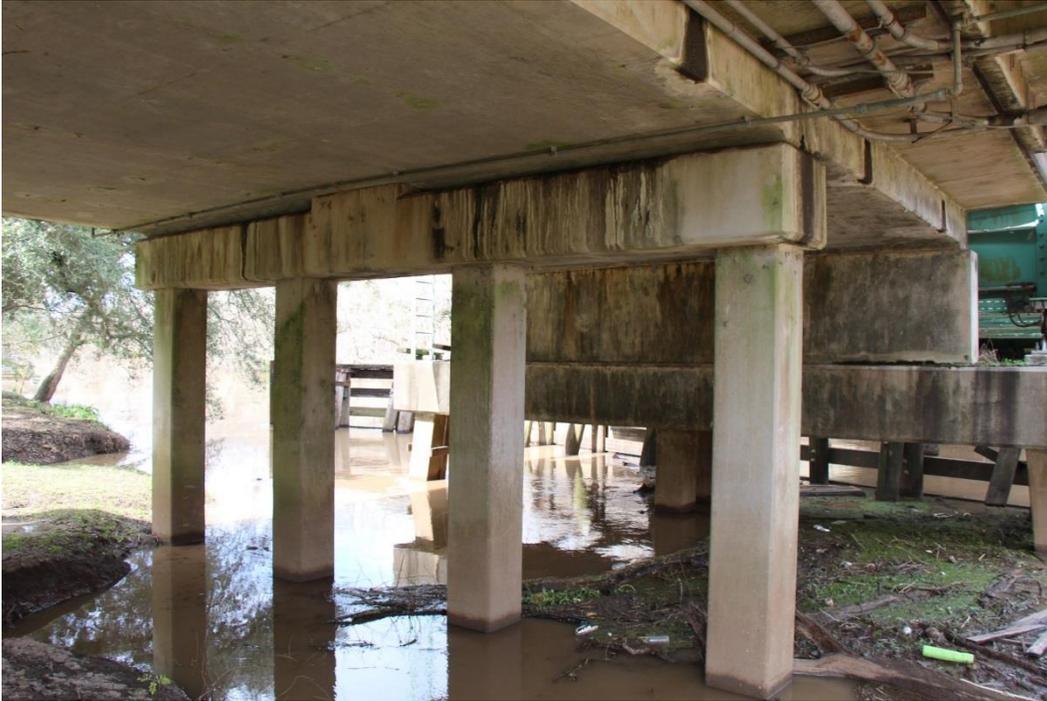
Condition Photo 13: Concrete bent cap and columns exhibiting water staining, typical condition.

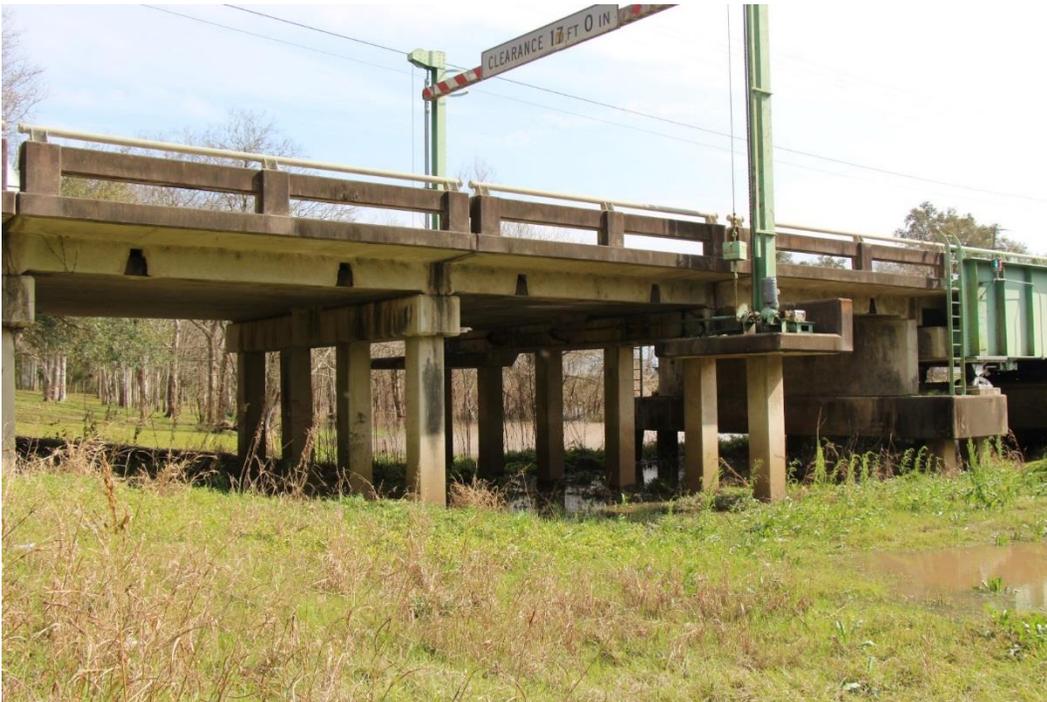
Condition Photo 14: Water staining on concrete slab and bents on the approach spans, typical condition.

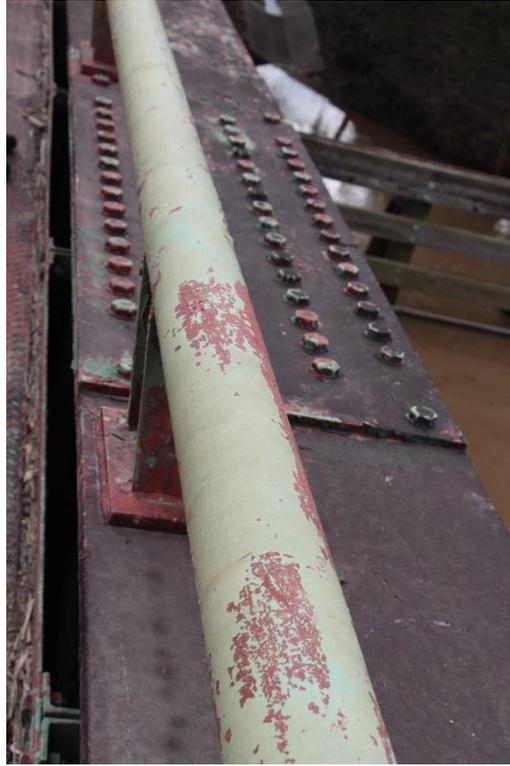
Condition Photo 15: Main span longitudinal steel girder and steel railing paint failure.

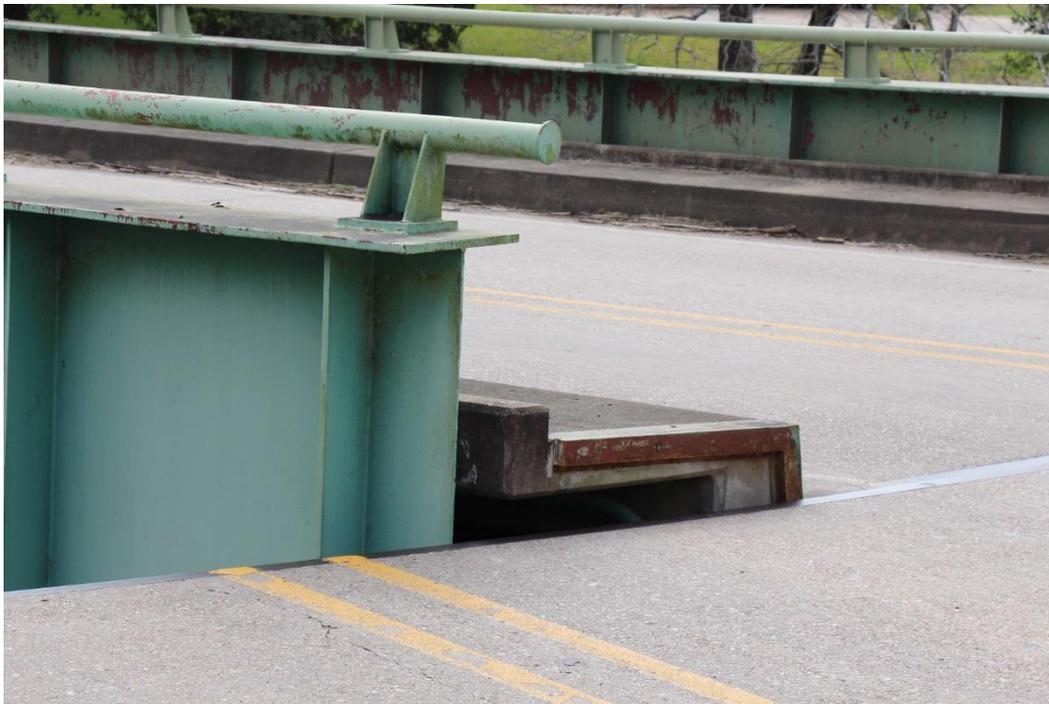
Condition Photo 16: Paint failure on the girders, railings, and sidewalks of the swing span.

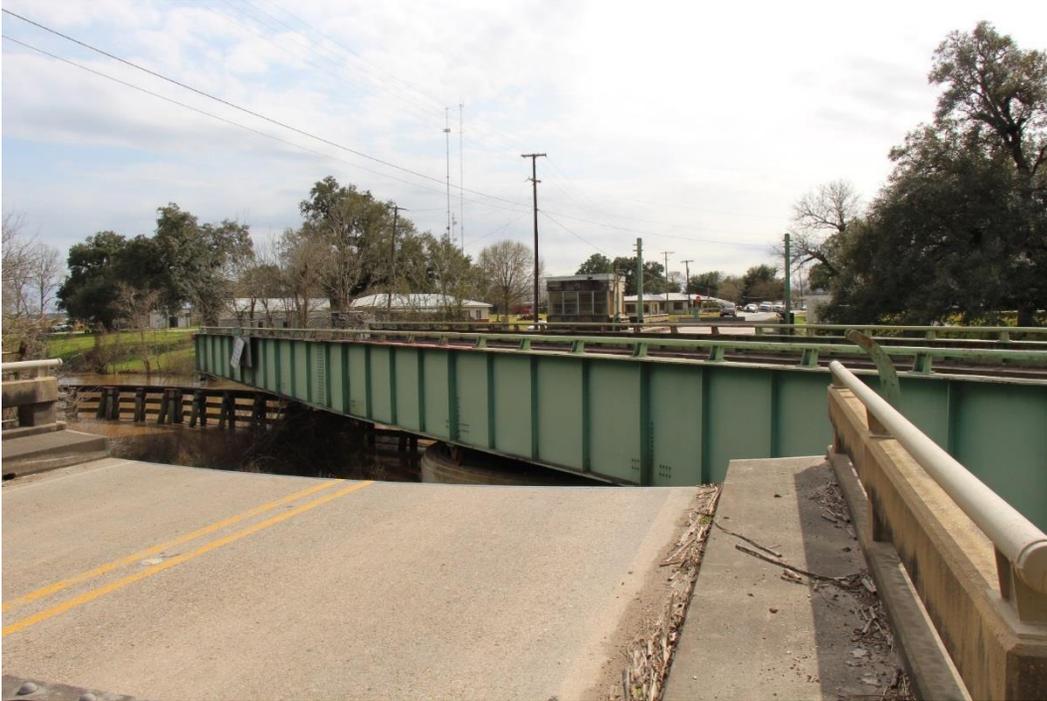
Condition Photo 17: The opening of the steel plate girder swing span. Also note the debris along the approach span shoulder and the sidewalk and the paint system failure.

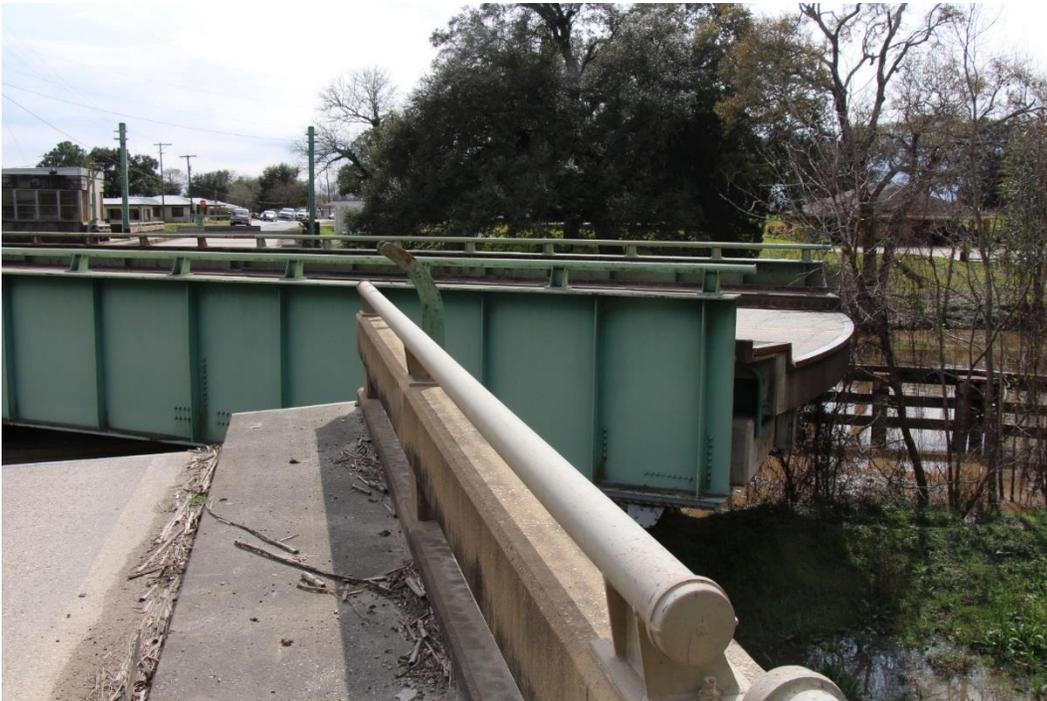
Condition Photo 18: Steel plate girder swing span hitting vegetation located west of the bridge. Also note the debris along the approach span shoulder and the sidewalk and the paint system failure.

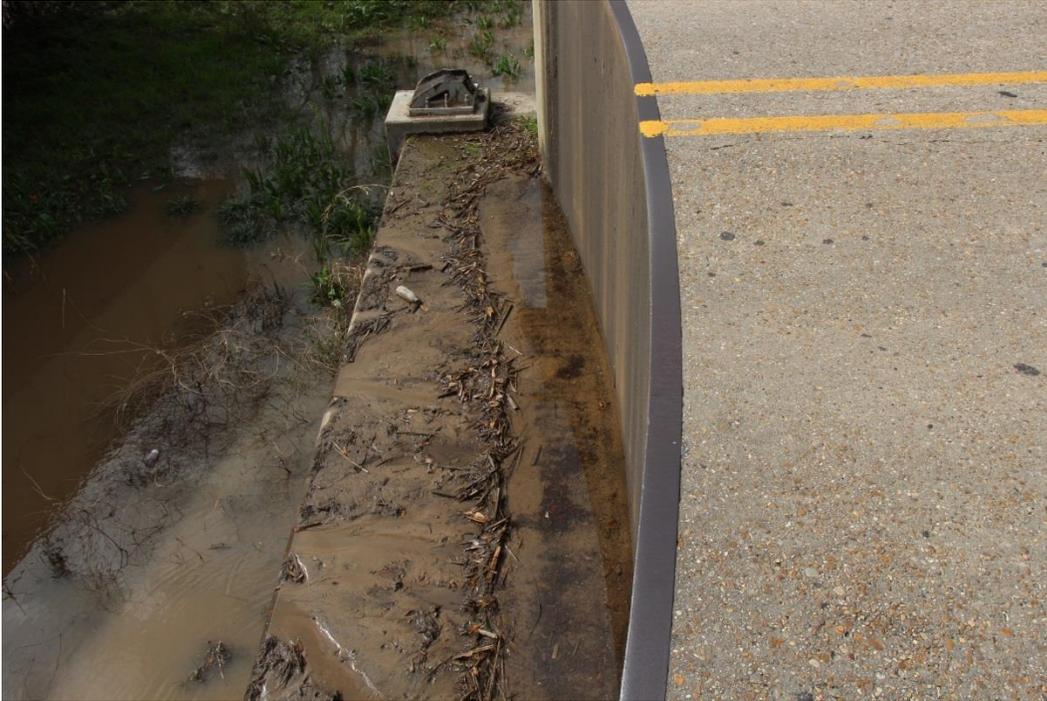
Condition Photo 19: Drift, water, and debris build-up at pier 3 for the swing span bearing seat.

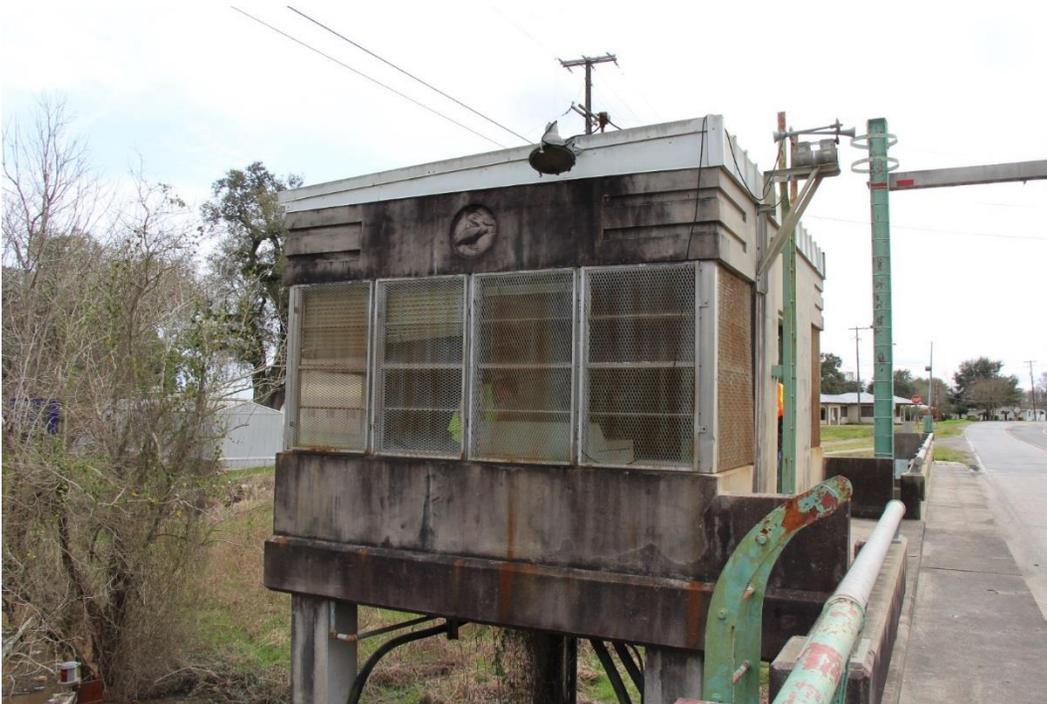
Condition Photo 20: Operator's house, north walls, windows, and metal protective screening over windows, looking south.

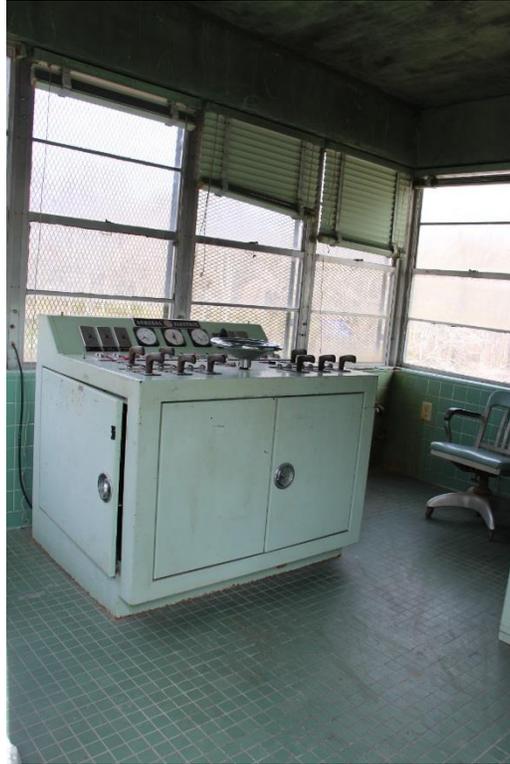
Condition Photo 21: Control console and tile floor in the operator's house.

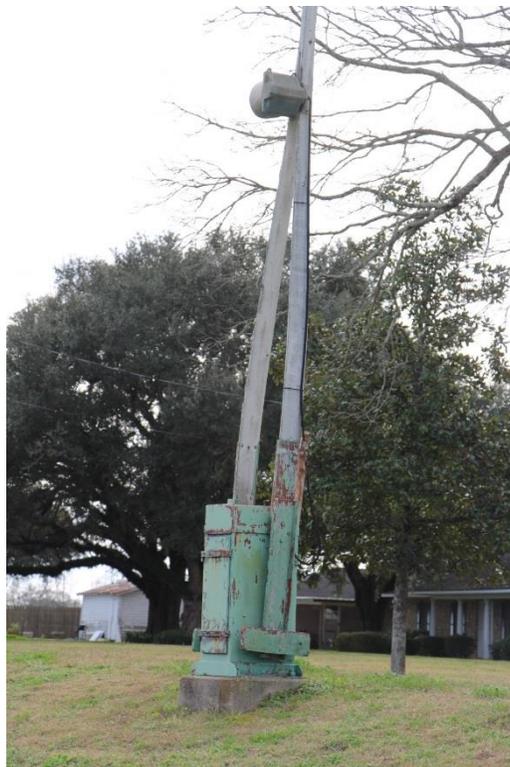
Condition Photo 22: Traffic gate exhibiting minor paint failure.

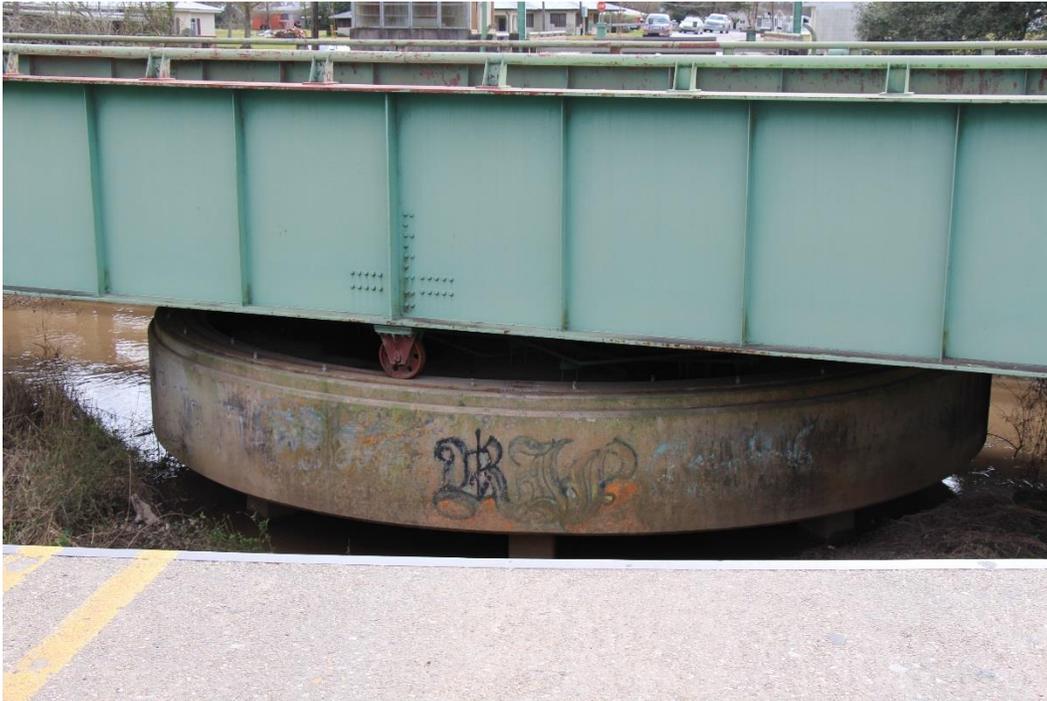
Condition Photo 23: Center pivot bearing and roller assembly; note the graffiti.

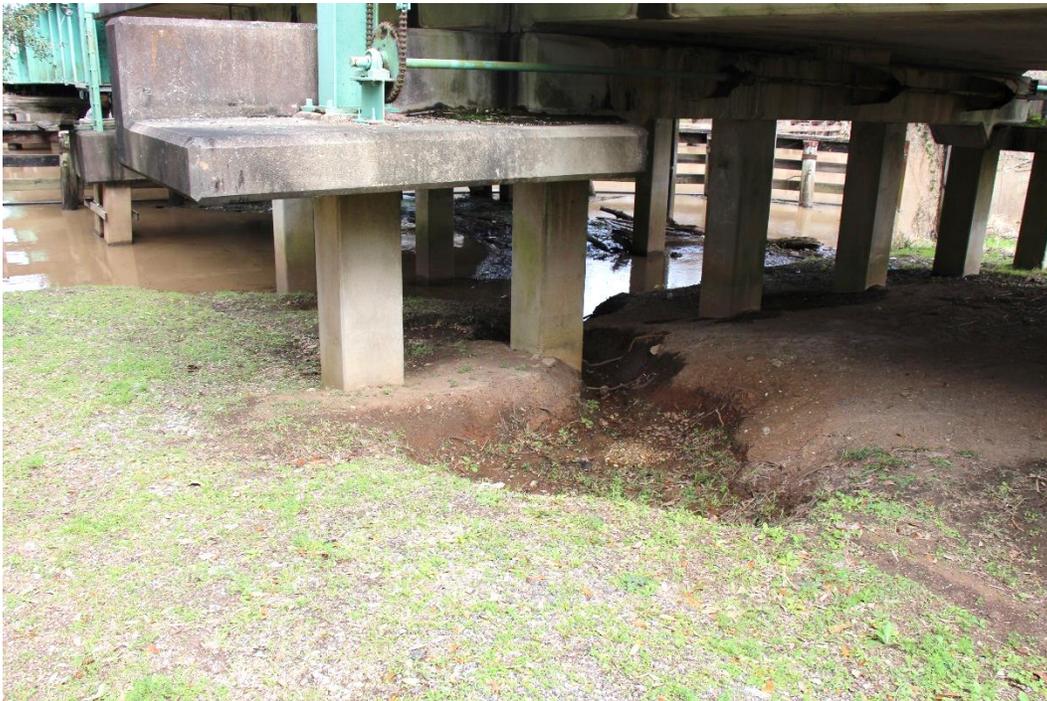
Condition Photo 24: Bent columns exhibiting scour at the columns of bent 3.
