# Historic Bridge Management Plan for the Mermentau River – Grand Chenier Bridge

Recall Number: 033700

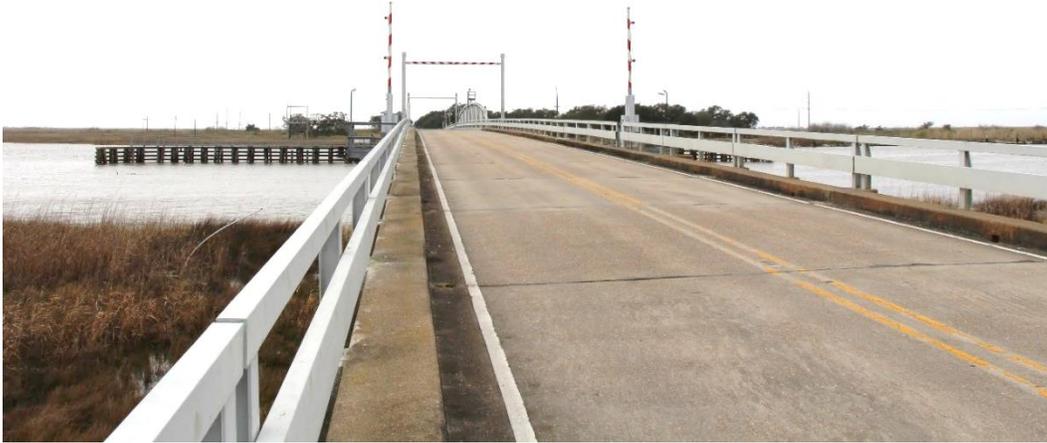
*Condition Photo 1: Looking east toward swing span from the west approach spans.*

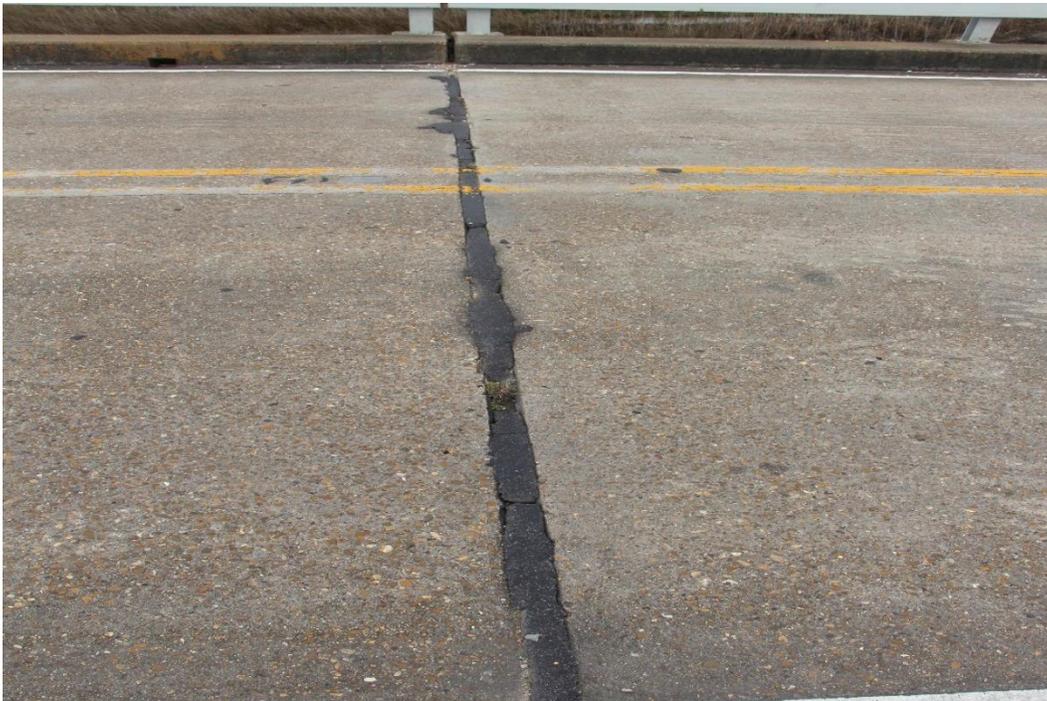
*Condition Photo 2: Typical pour seal joint deterioration and vegetation growth in approach spans concrete decks.*

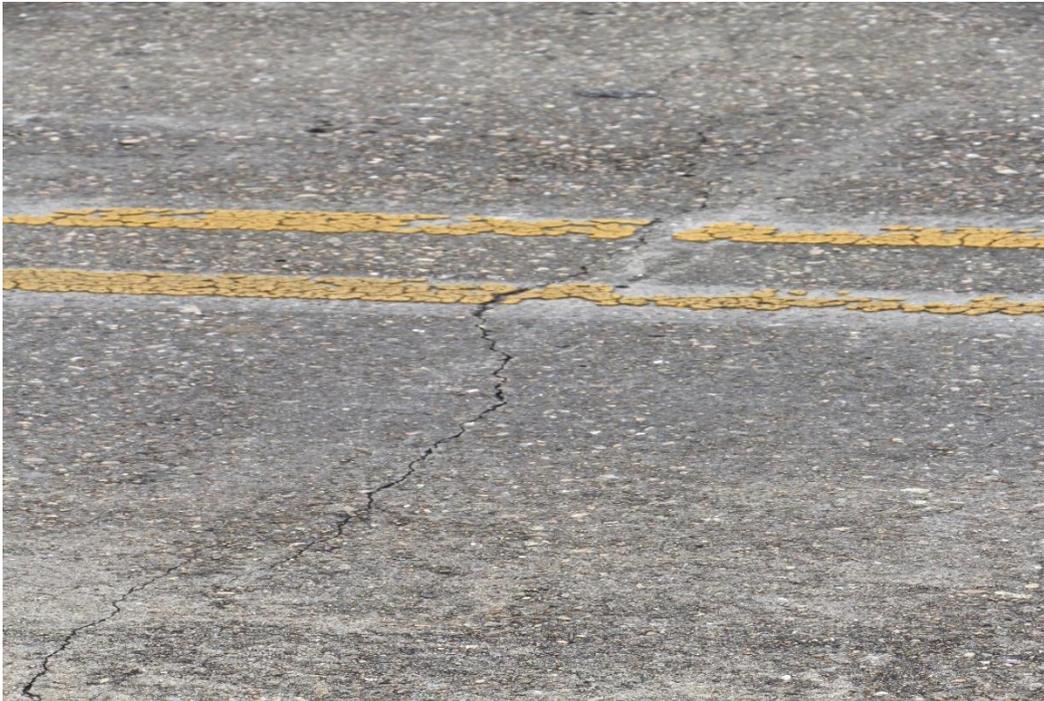
*Condition Photo 3: Typical cracking in top of concrete approach spans, longitudinal cracking, and painted lane line striping faded.*

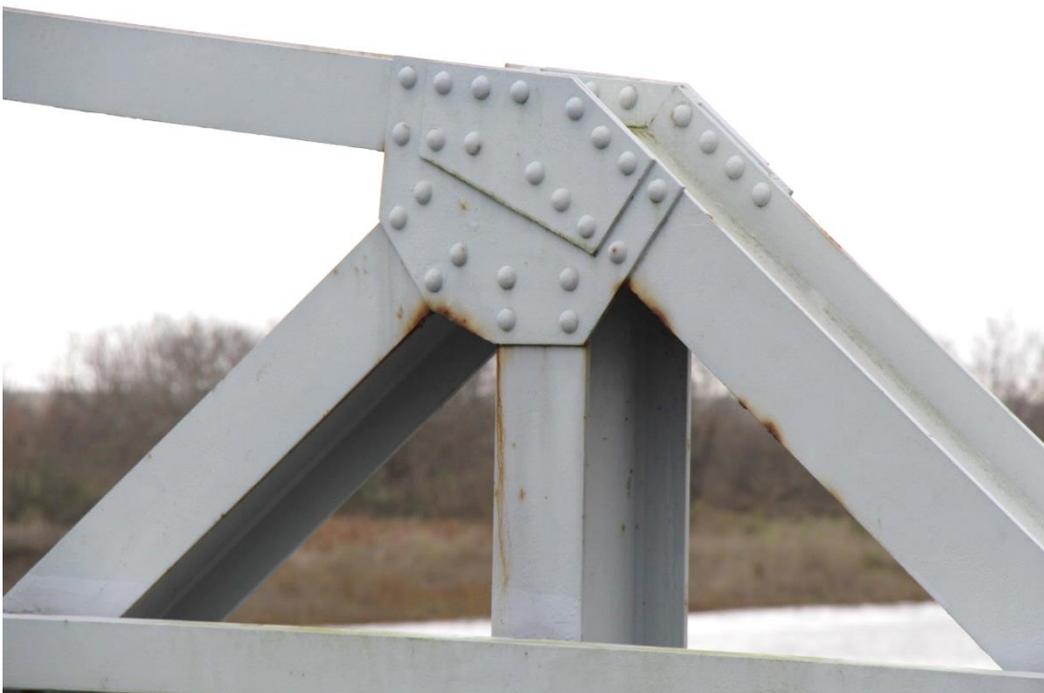
*Condition Photo 4: Paint system failure and rust at pony truss connections; upper chord connection joint shown, other connection joints similar condition.*

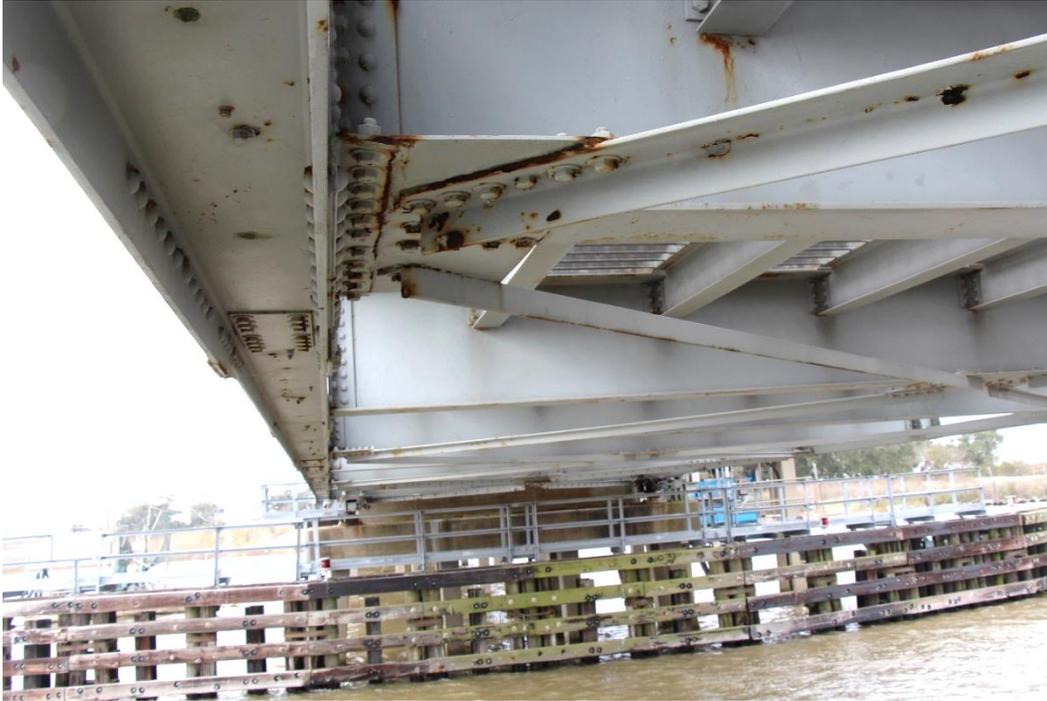
*Condition Photo 5: Underside of truss span and floor system, showing paint system failure and rust at truss member connections.*

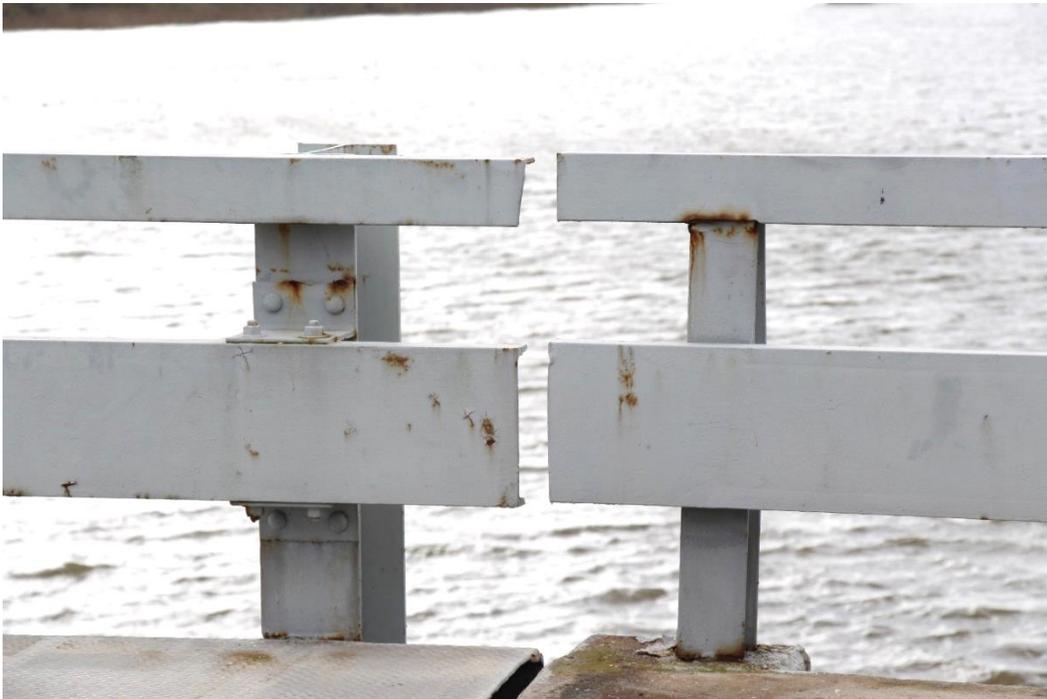
*Condition Photo 6: Bridge railing rust and paint system failure, typical throughout the bridge. Photo at joint between approach span and swing truss span.*

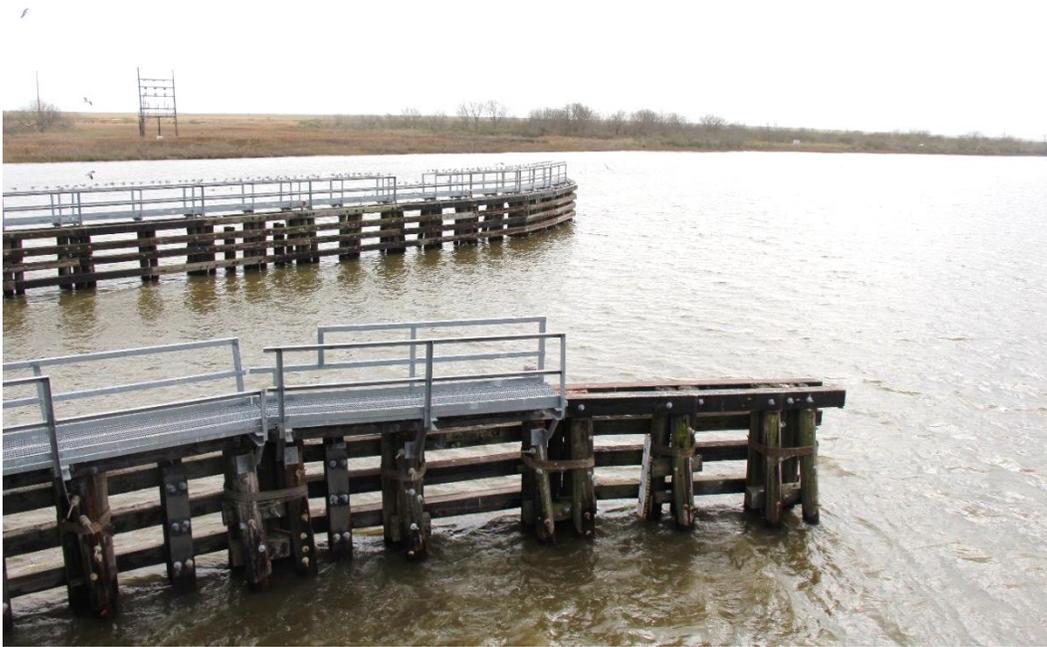
*Condition Photo 7: South timber fender system with catwalks.*

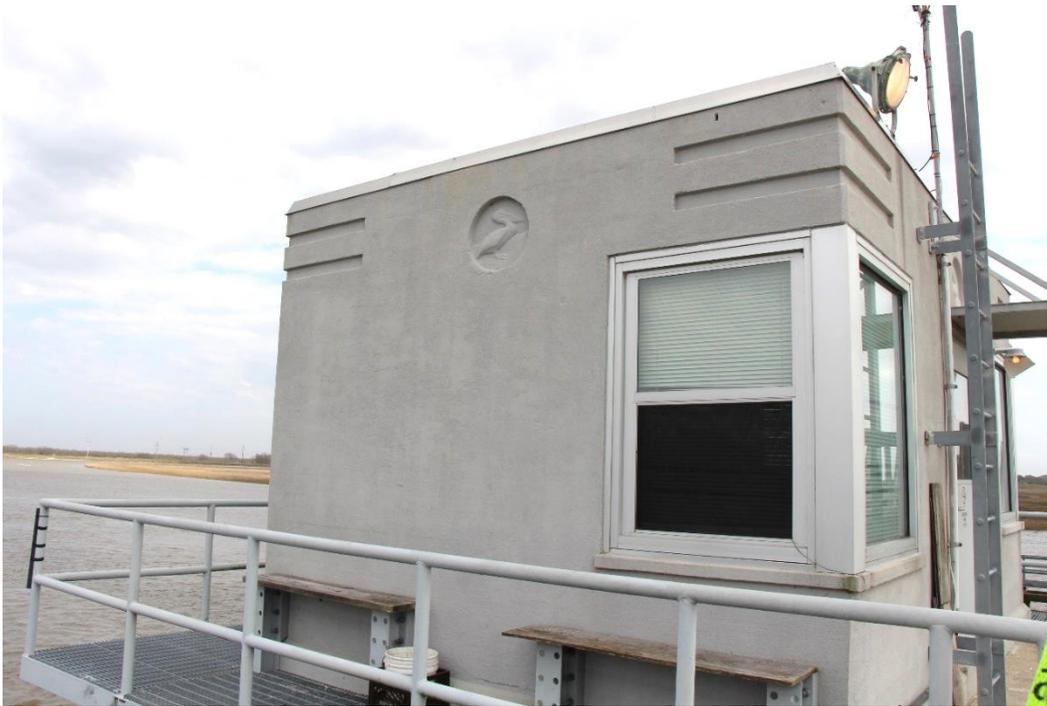
*Condition Photo 8: Operator's house exterior, rehabilitated in 2011.*

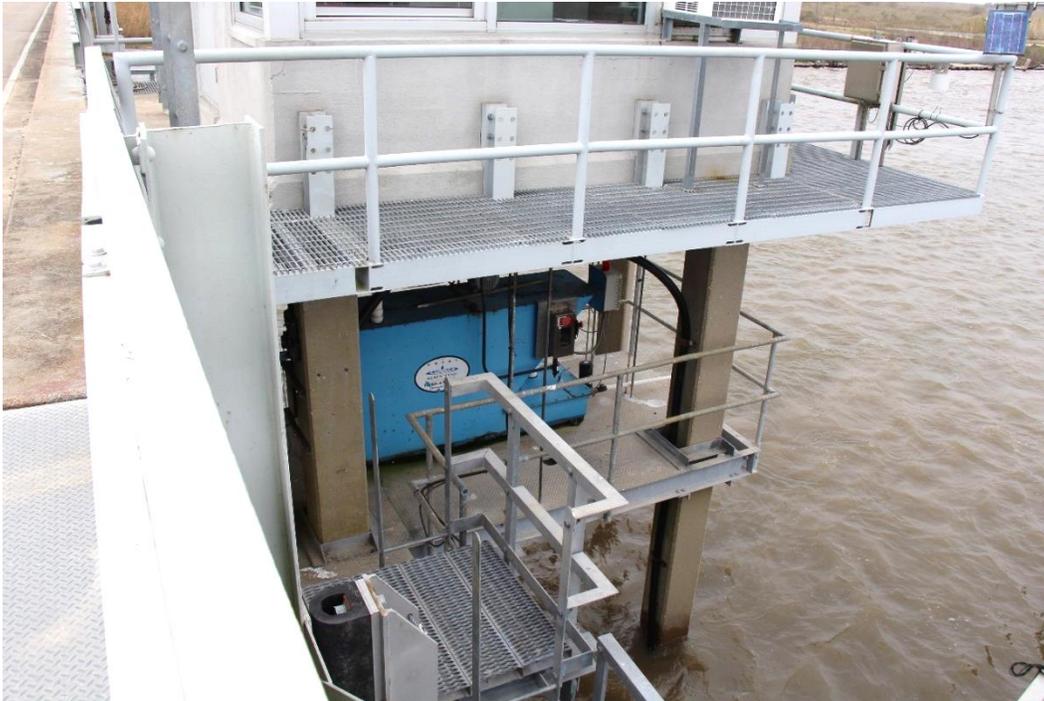
*Condition Photo 9: Air compressor and sewage system under the operator's house.*

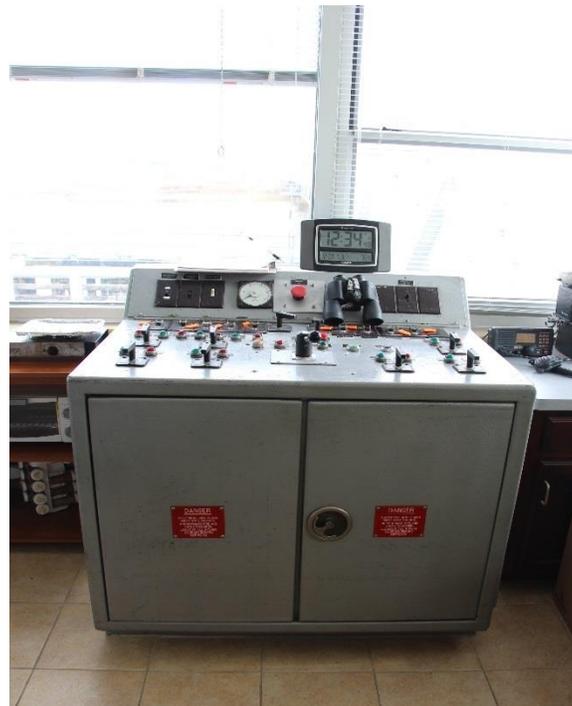
*Condition Photo 10: Control panel in the operator's house.*

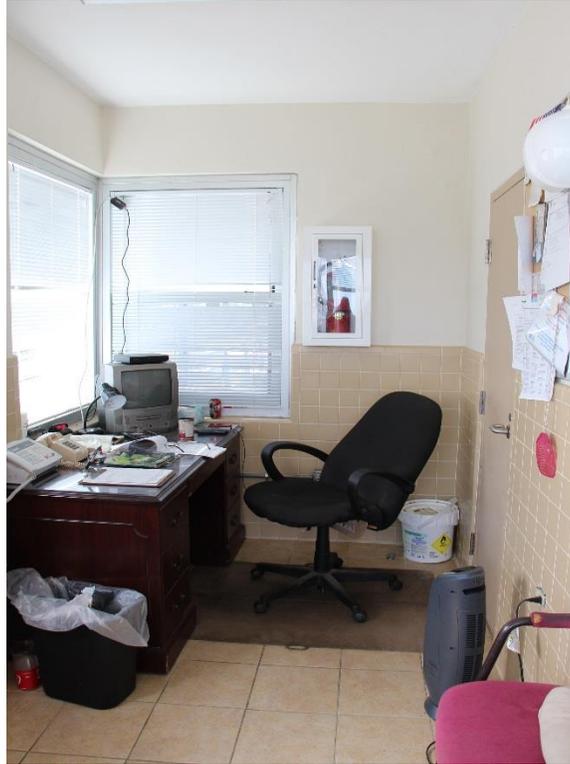
*Condition Photo 11: Tile, paint, and windows in the operator's house from 2011 rehabilitation.*

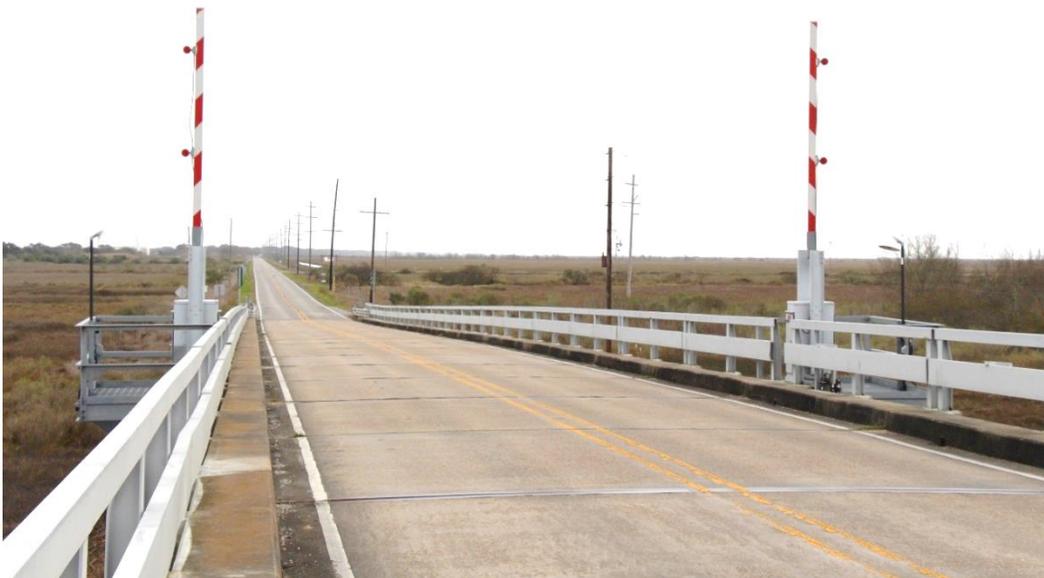
*Condition Photo 12: East approach spans looking east.*

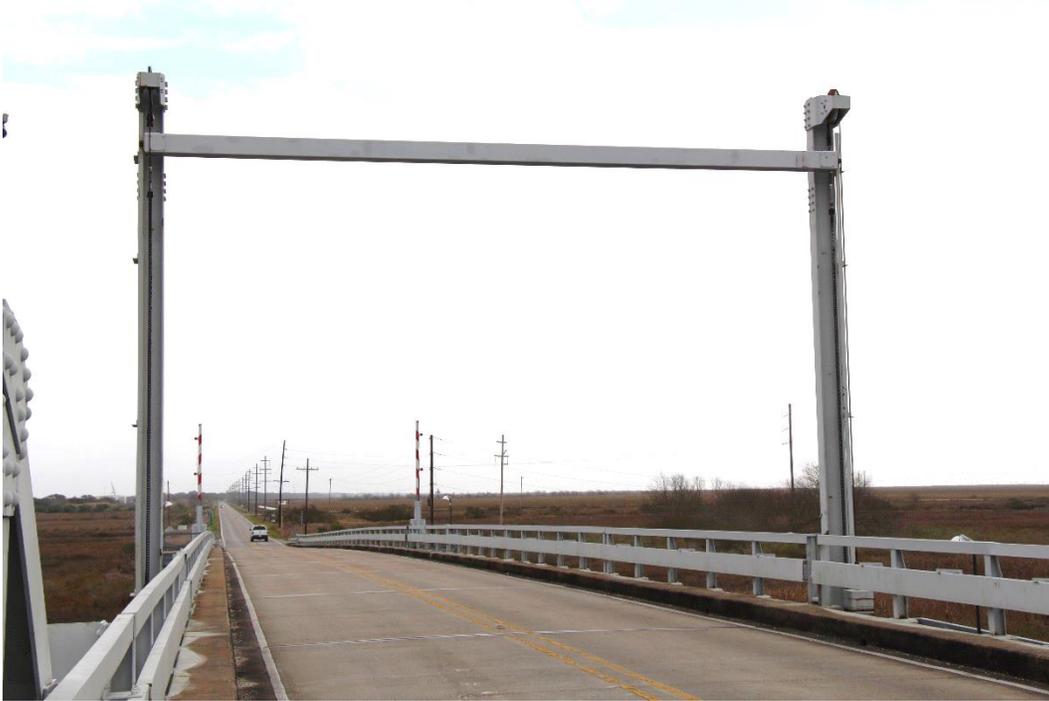
*Condition Photo 13: East approach spans with tower, traffic barrier gate, and signals.*

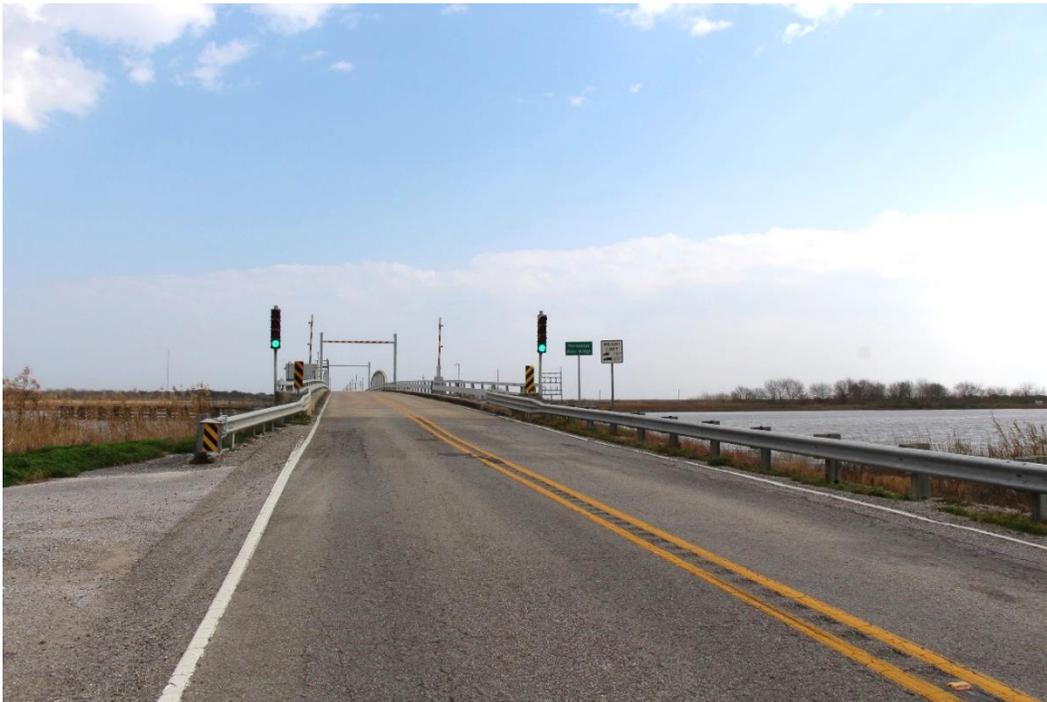
*Condition Photo 14: West approach spans and west approach roadway with traffic signals and guardrail, looking east.*

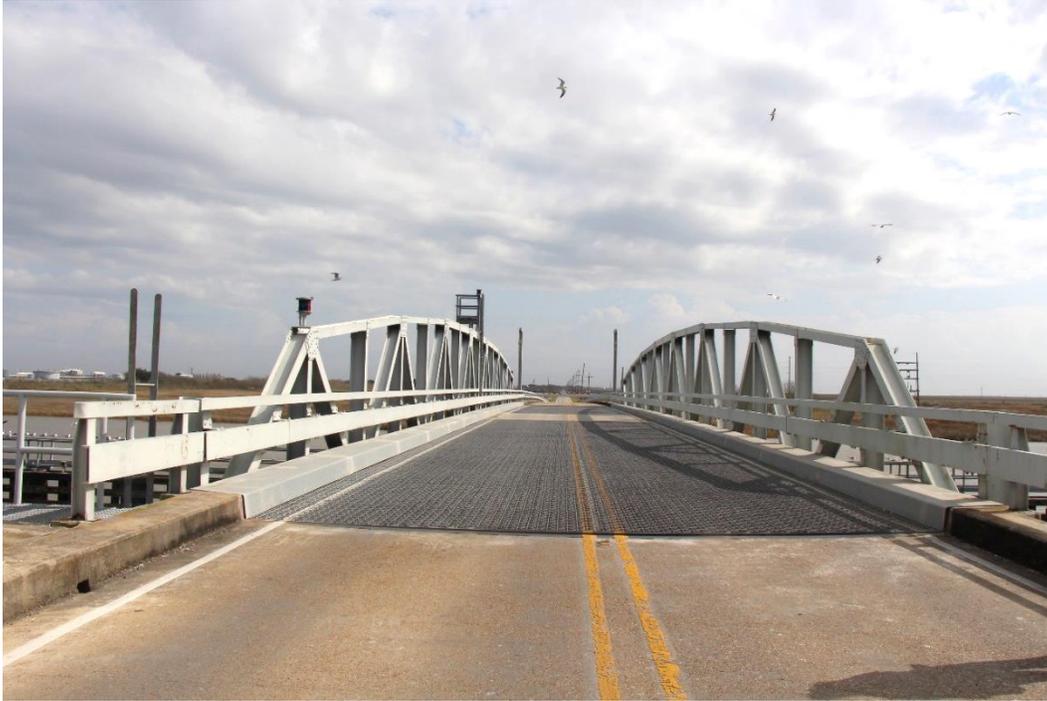
*Condition Photo 15: Swing pony truss looking east.*

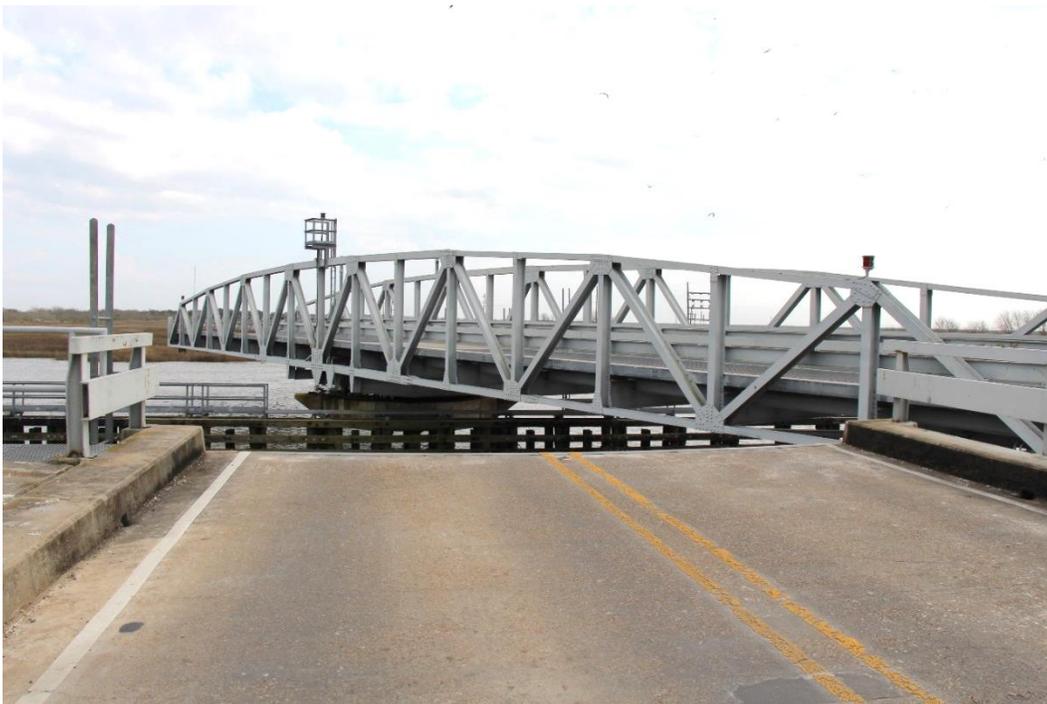
*Condition Photo 16: Swing pony truss opening.*

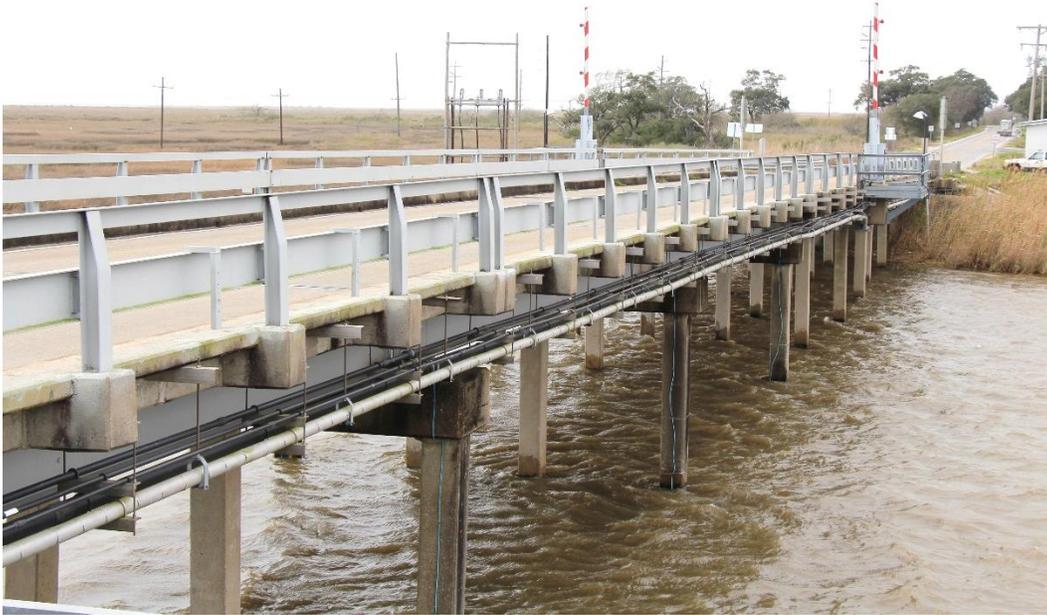
*Condition Photo 17: Discoloration of the approach west span bents.*

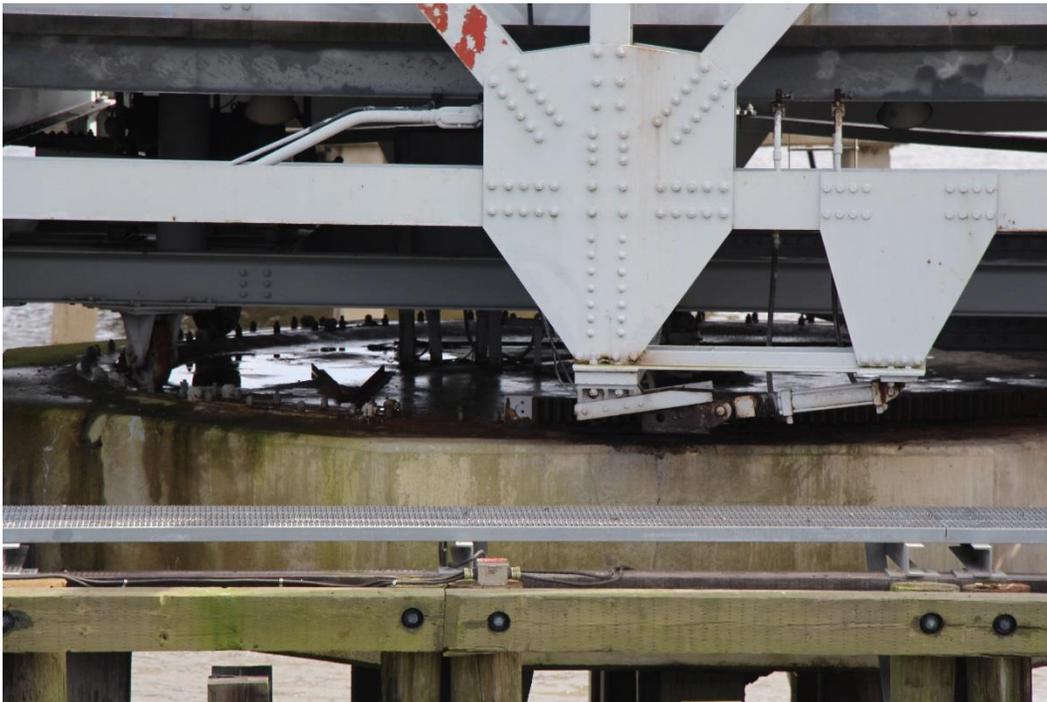
*Condition Photo 18: Center concrete pivot pier with operating machinery, center pivot bearing, and pivot rail and rollers.*

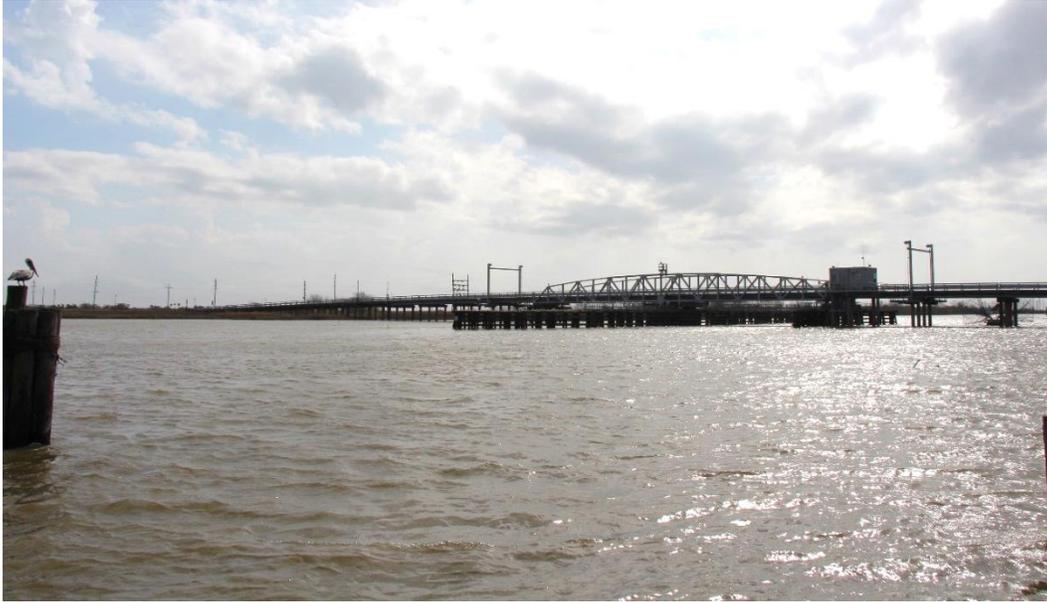
*Condition Photo 19: Overall view of bridge looking south.*

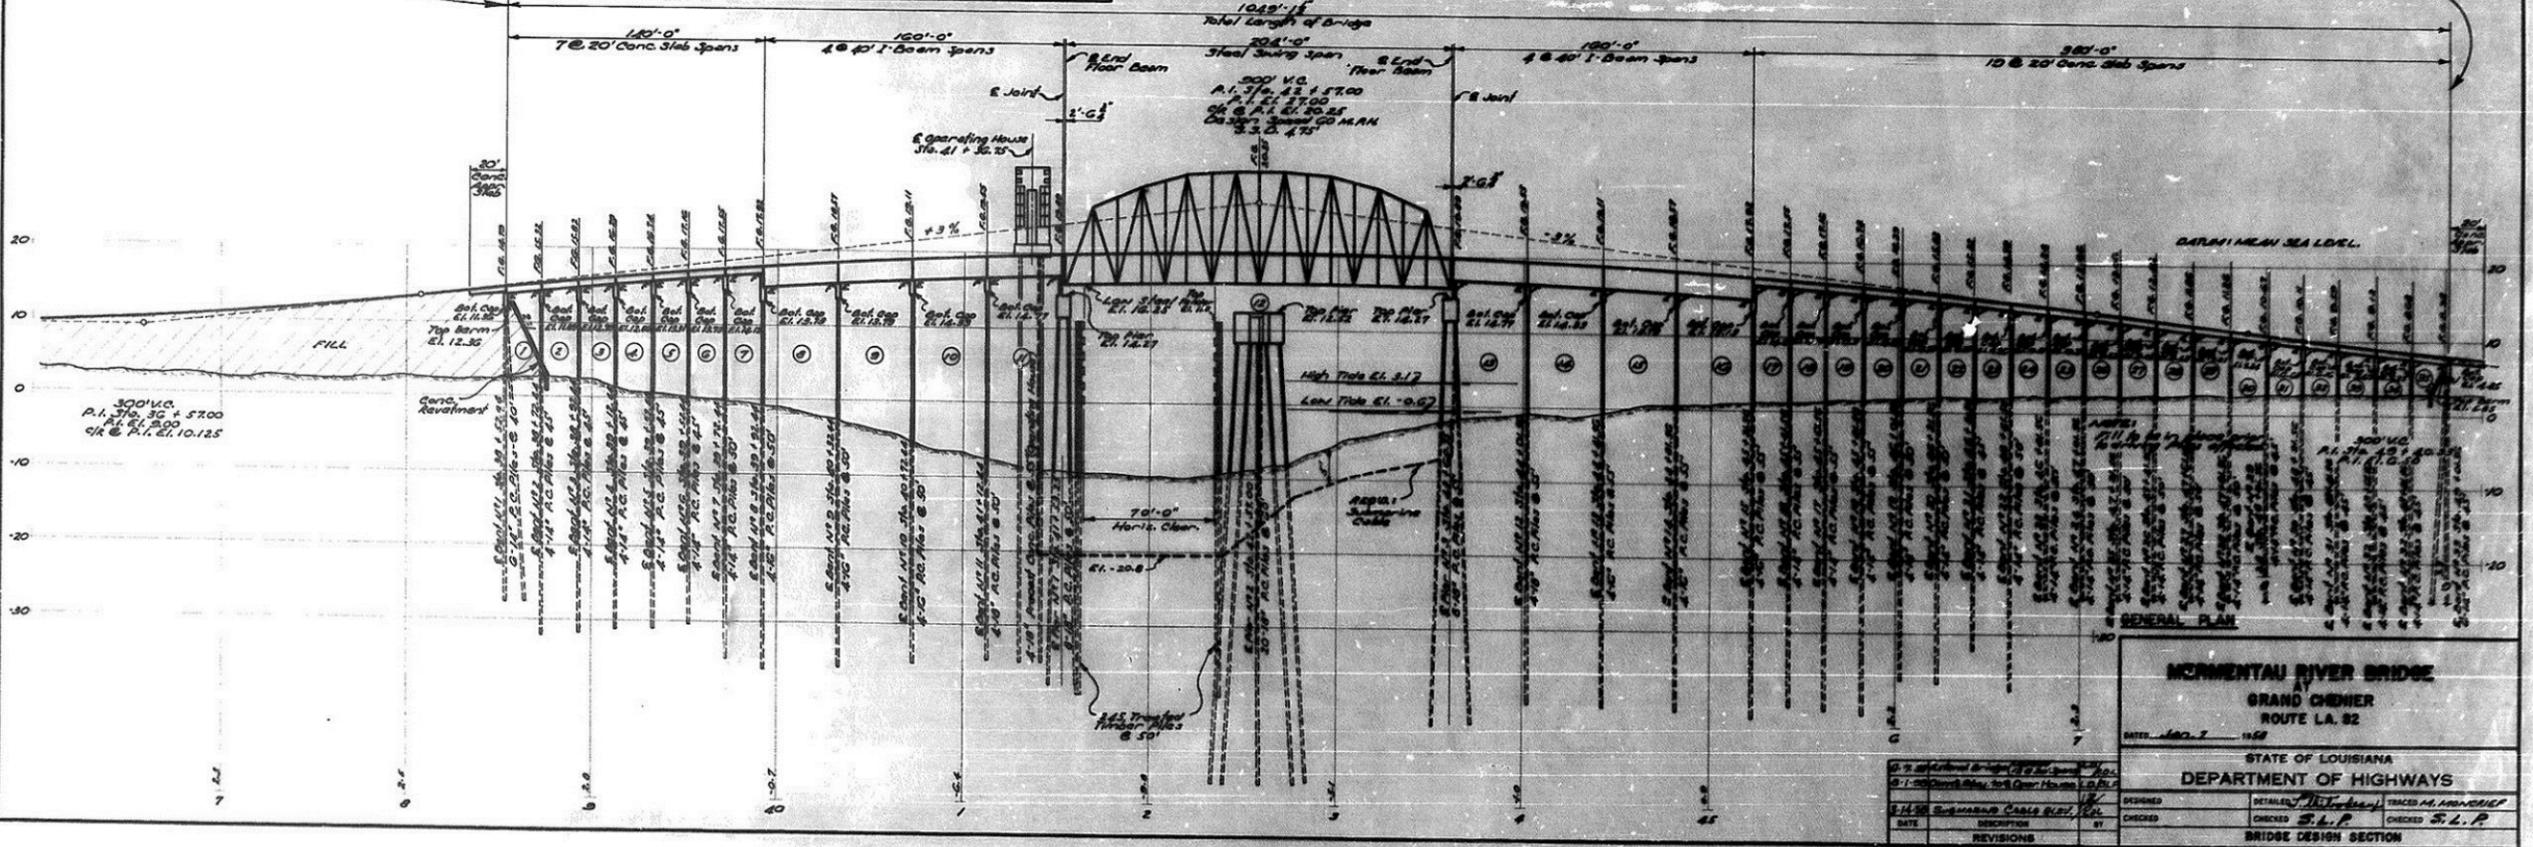
**MERMENTAU RIVER BRIDGE**  
GRAND CHENIER  
ROUTE LA 32

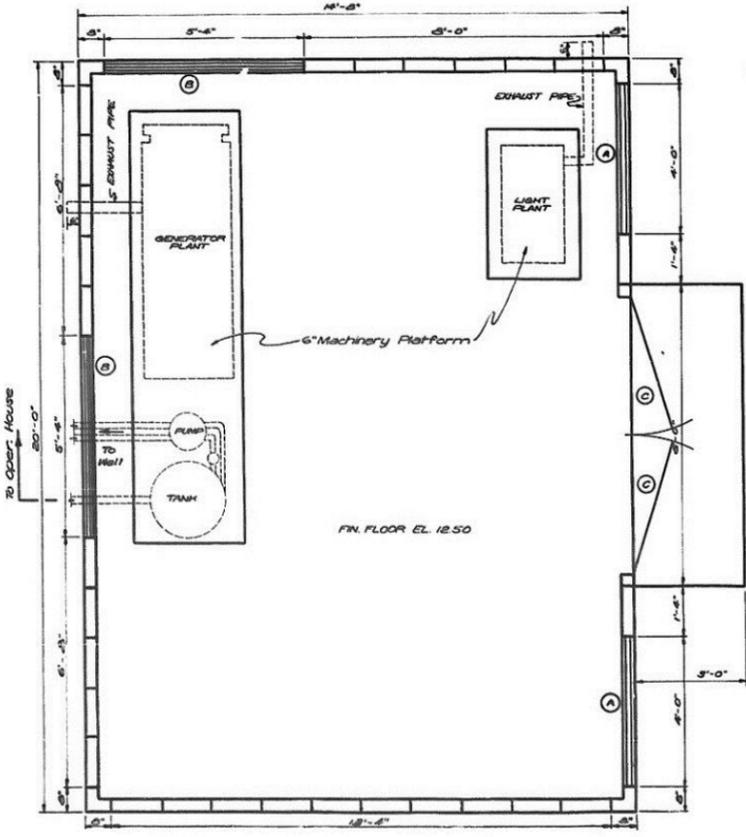
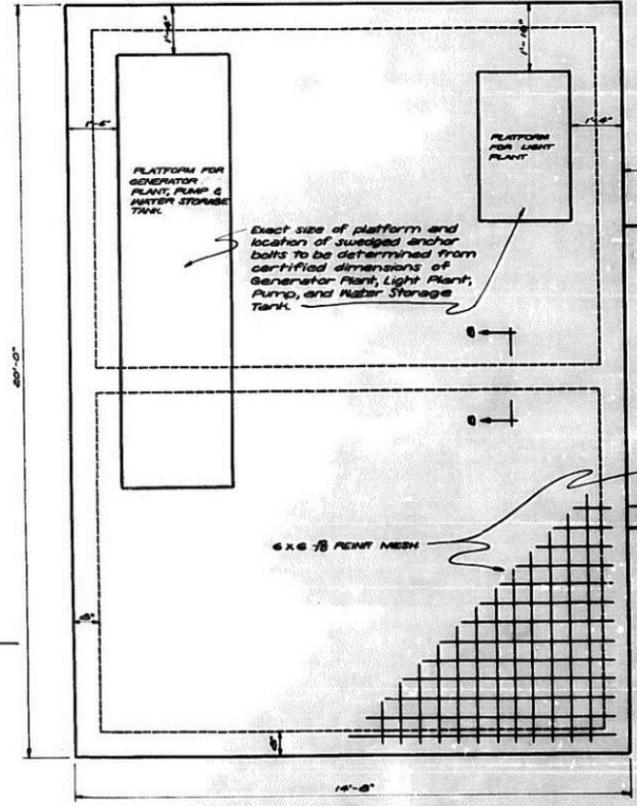
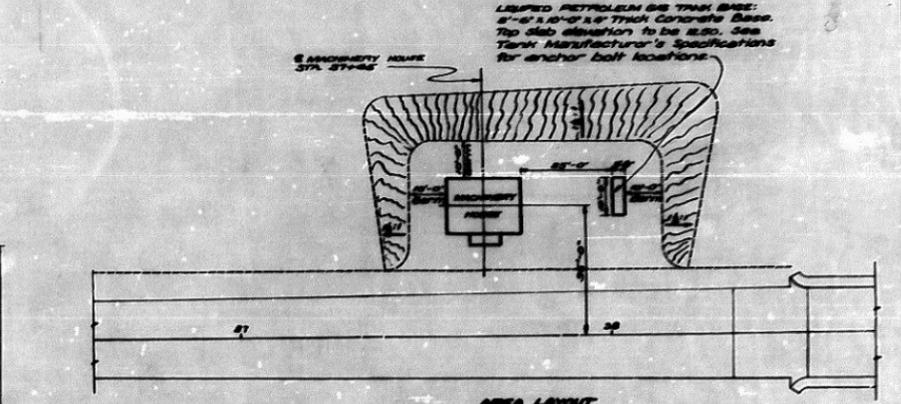
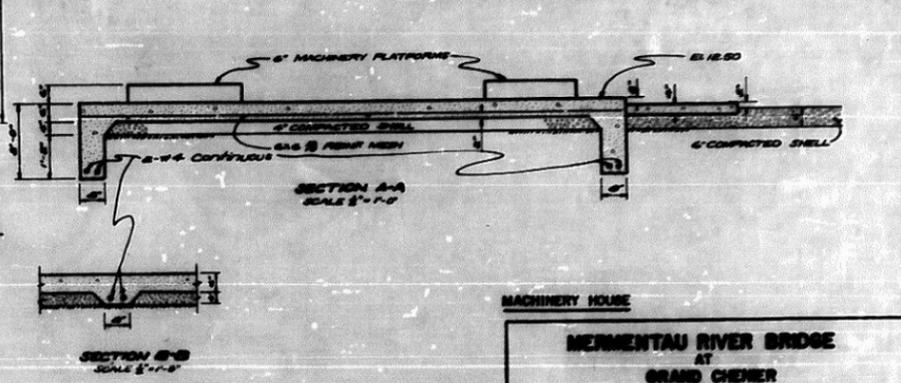
All material required to complete house including compacted shell surfacing, concrete slab base for gas tank, and liquified petroleum gas tank complete with fittings and connections as described to be paid for as "Machinery House" item 5-B-2, except for other items which are to be paid for as noted.
