Re: Asbestos Survey Report

H.013842 - Causeway Boulevard - Earhart Expressway

1714 S. Causeway Boulevard Metairie, Louisiana 70001 Terracon Project No. ET227174

ASBESTOS SURVEY REPORT H.013842 – Causeway Boulevard – Earhart Expressway 1714 S. Causeway Boulevard

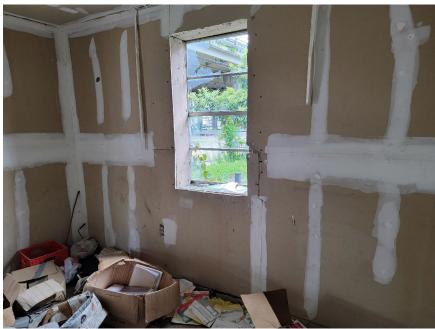
<u>Photograph No. 1</u>
HA-01: White Drywall with Joint Compound and Tape

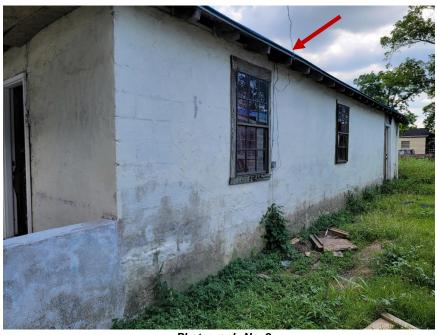
Photograph No. 2

HA-02: Black/Brown Roof Shingles with Black Tar Paper

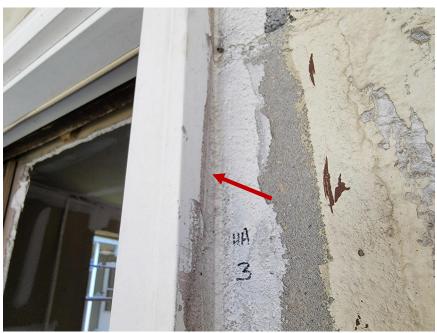
Photograph No. 3

HA-03: Gray/White Door Frame Caulk
