Asbestos Inspection Report

Residential Structure

9632 Lockhart Road

Terracon Project No.EH237063

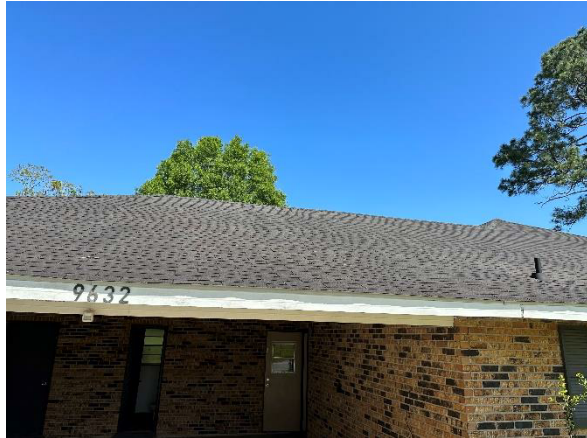
Photo #1: HA-1: Black roofing shingles (from House)

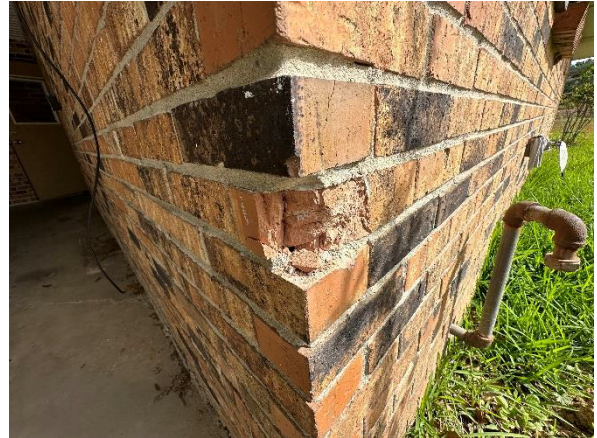
Photo #2: HA-2: Grey exterior brick mortar

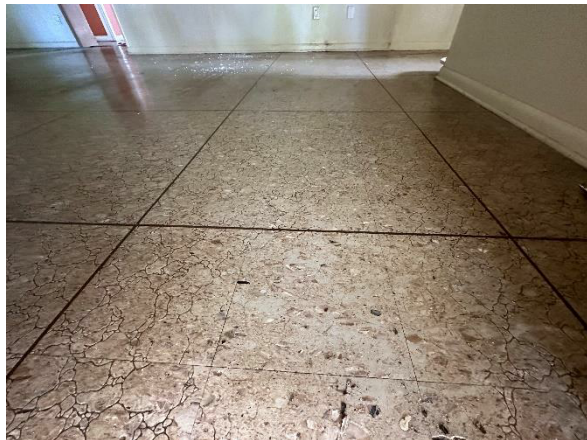
- HA-03: Pebble pattern sheet flooring
- HA-06: White popcorn ceiling

According to USEPA NESHAP regulations, friable ACM is considered RACM and is required to be removed prior to disturbance or demolition.

Photo #3: HA-3: Pebbled pattern sheet flooring

Therefore, Terracon recommends these materials should be removed and disposed by a Louisiana-licensed asbestos abatement contractor prior disturbance. This would require that all sections of the AAC-2 (a) Form must be completed and submitted to LDEQ prior to renovation or demolition activities and Asbestos Disposal Verification Form(s) (ADVF) requested in accordance with the requirements of as indicated in LAC 33:III.5151 Subclause F.1.a. An ADVF is required for each load of RACM disposed. Upon proper notification, the LDEQ will issue the requested ADVF(s) to provide approval to begin demolition activities and to ensure that the ACM is removed and disposed of properly. A current AAC-2(a) form must be on site during all RACM removal activities.

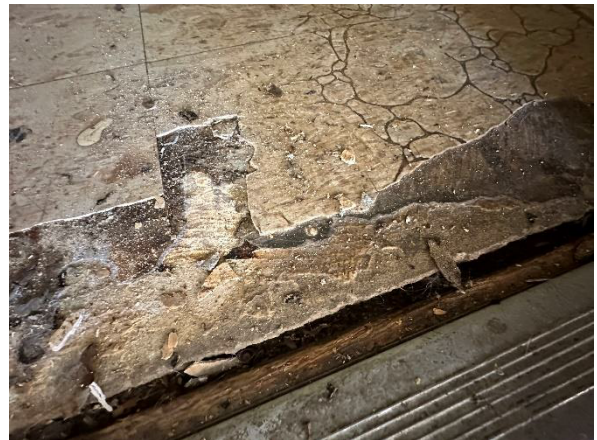
- HA-04: Black floor tile and associated mastic (under HA-03, tile size undetermined)

According to LDEQ and USEPA NESHAP regulations, asbestos-containing resilient floor coverings that are removed by using dry ice, heat, wet methods, and chemicals where the tiles or sheeting are removed intact (with only minor tears or minor breakage) are not considered regulated asbestos-containing materials (RACM). Additionally, asbestos containing mastic used to attach resilient flooring to the floor surface that are removed by chemical or other means that results in the asbestos fibers in Asbestos-Containing Waste Material (ACWM) being bound within a macro substrate and cannot reasonably become airborne unless further forces are applied are also not considered RACM. However, asbestos containing resilient sheet flooring and associated mastic that is scraped, sanded, abraded, bead blasted, cut, ground, crumbled, pulverized, or reduced to a powder by any means, including hand and mechanical equipment is considered a RACM.

Photo #4: HA-4: Black floor tile with associated mastic (Under HA-3)

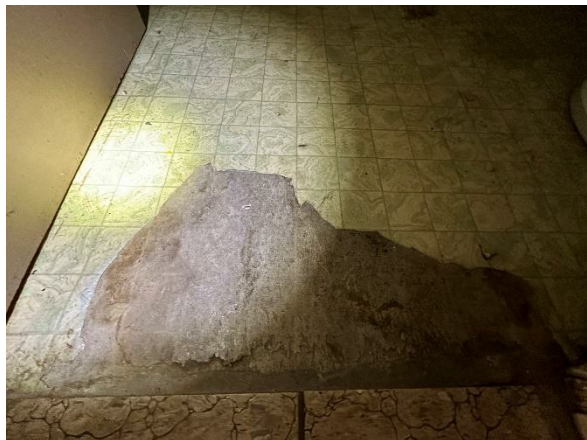
Photo #5: HA-5: Marbled square shaped floor covering with adhesive

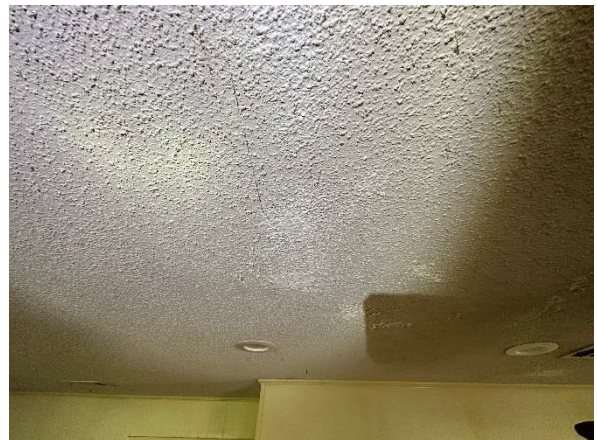
Photo #6: HA-6: White popcorn ceiling

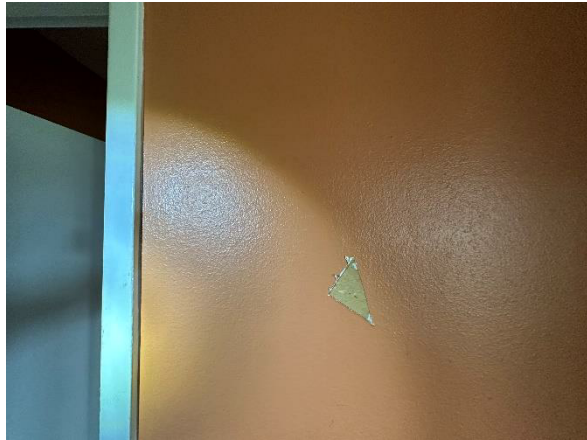
- HA-07: Wallboard texture
- HA-08: Wallboard system and texture (Texture is positive only, could not separate)
- HA-14: Exterior white window caulk

According to LDEQ and USEPA NESHAP regulations, Category II nonfriable ACM is any material, excluding Category I nonfriable ACM, that when dry, cannot be crumbled, pulverized, or reduced to powder by hand pressure. Category II nonfriable ACM that has a high probability of becoming or has become crumbled, pulverized, or reduced to powder by the forces expected to act on the material during demolition operations are considered RACM and are required to be abated prior to disturbance or demolition.

Photo #7: HA-7: Wallboard texture (only)

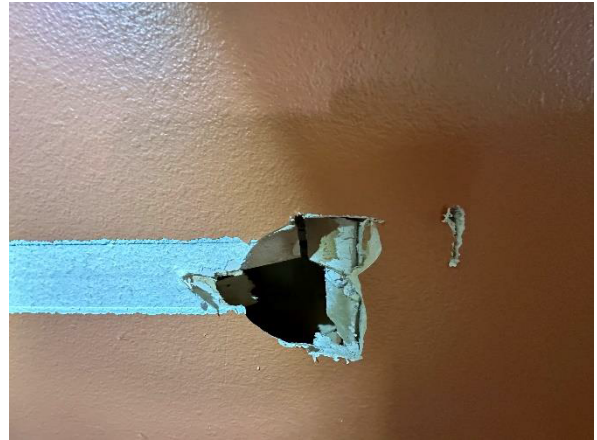
Photo #8: HA-8: Wallboard system with texture (could not separate texture)

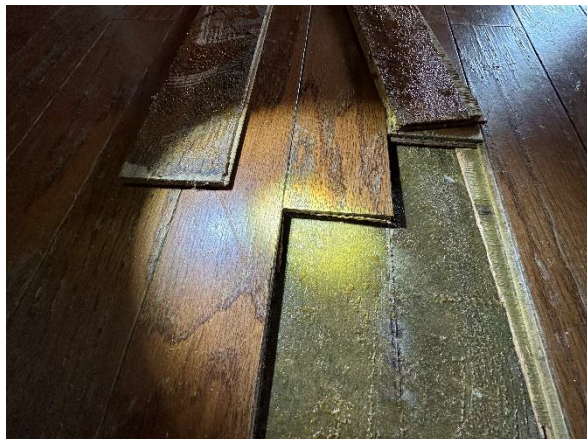
Photo #9: HA-9: Mastic associated with 3"x36" wood flooring

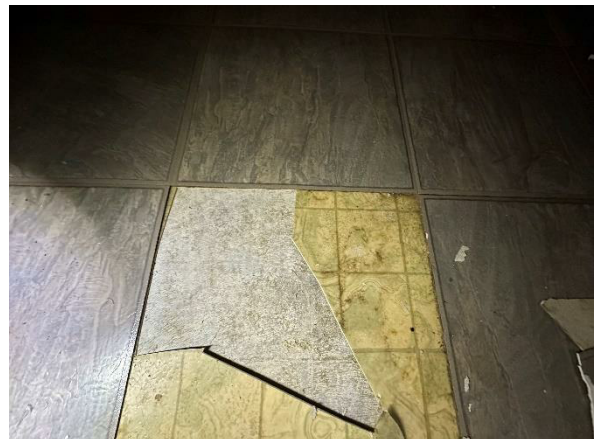
Photo #10: HA-10: 12"x12" Grey floor tile with associated mastic

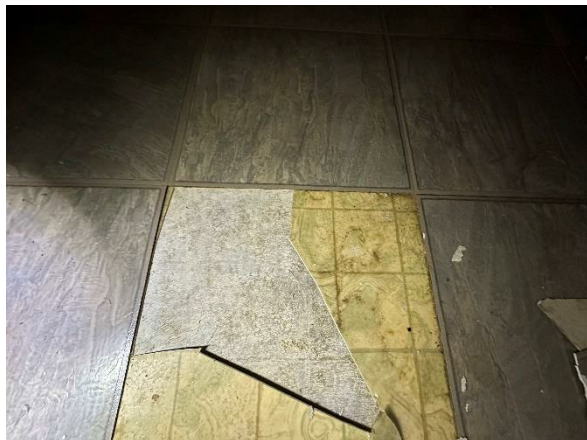
Photo #11: HA-11: Yellow sheet flooring with adhesive (Under HA-10)

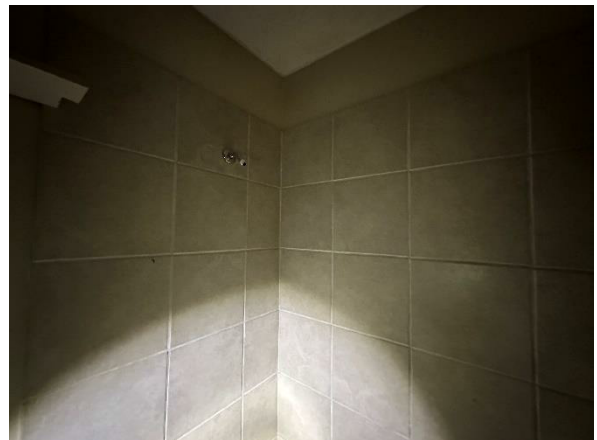
Photo #12: HA-12: 12"x12" Beige ceramic shower tile with grout and thinset

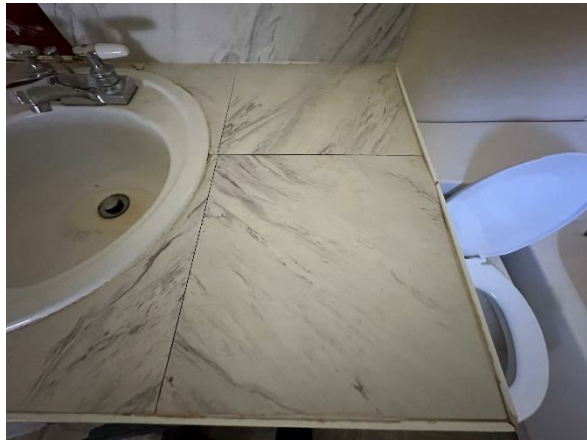
Photo #13: HA-13: 12"x12" White and grey floor tile with associated mastic (used on countertop)

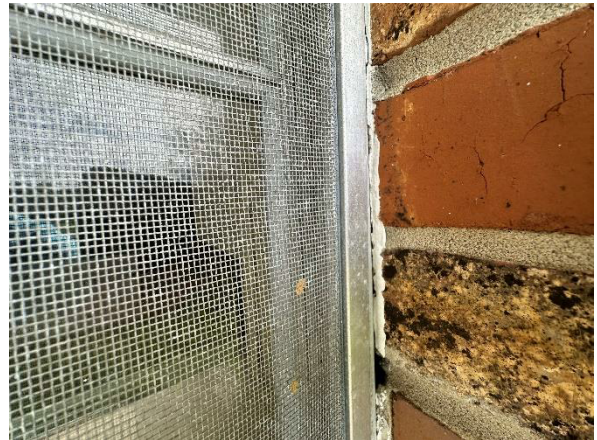
Photo #14: HA-14: White window caulk

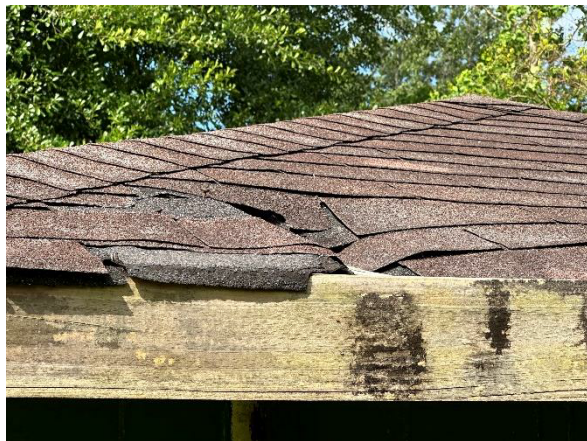
Photo #15: HA-15: Black roofing shingles and felt paper associated with detached shed

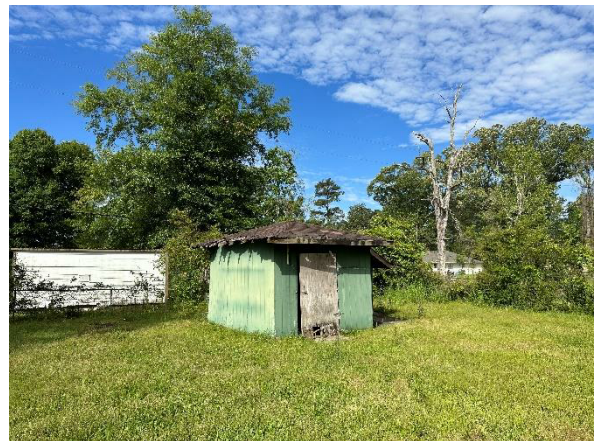
Photo #16: View of shed

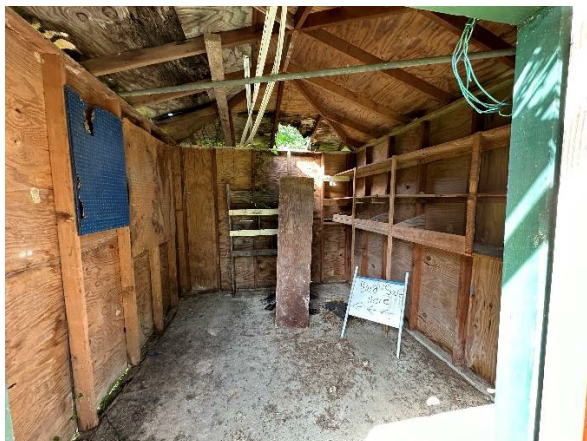
Photo #17: View of shed interior

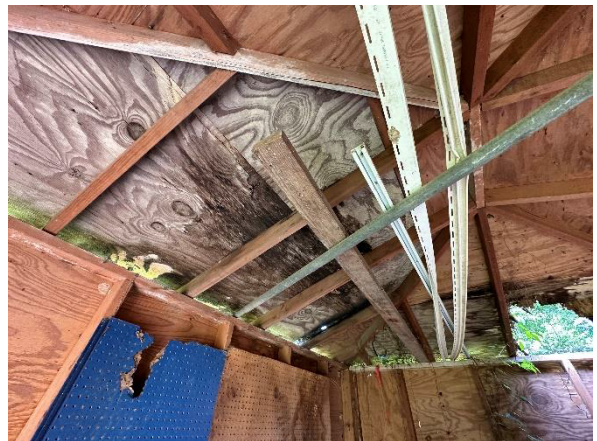
Photo #18: View of shed roof from the interior
