ASBESTOS SAMPLING REPORT

Lafayette Connector

400 Mudd Ave., 425 Sampson St., & 212 First St.
Lafayette, LA

SEMS Project #553-0032

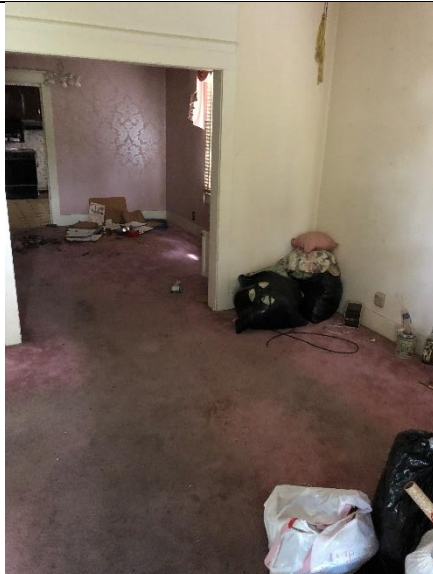
212 First St – Foyer

Sample ID	Material Description	Location	Result
SA-21-287-003	Ceiling tile	Bathroom	None Detected
SA-21-287-004	Sheetrock and compound	Kitchen – North	None Detected
SA-21-287-005	Sheetrock and compound	Kitchen – North	None Detected
SA-21-287-006	Sheetrock and compound	Kitchen – North	None Detected
SA-21-287-007	Linoleum and brown mastic	Living room – South	None Detected
SA-21-287-008	Linoleum and brown mastic	Living room – West	None Detected
SA-21-287-009	Linoleum and brown mastic	Living room – East	None Detected
SA-21-287-010	Linoleum and yellow mastic	Addition closet	None Detected
SA-21-287-011	Linoleum and yellow mastic	Addition closet	None Detected
SA-21-287-012	Linoleum and yellow mastic	Addition closet	None Detected
FS-21-287-001	Ceiling tile	Living room	None Detected
FS-21-287-002	Ceiling tile	Sitting room	None Detected
FS-21-287-003	Ceiling tile	Front Bedroom	None Detected
FS-21-287-004	Sheetrock, compound, tape	Foyer – NW	3% Chrysotile

From the results above, the sheetrock compound and two different linoleum floors are positive for asbestos at 212 First Street. None of the samples collected at 400 Mudd Avenue or 425 Sampson Street are positive for asbestos.

- **Texture Material and Joint Compound (Walls & Ceilings)**

The texture material and joint compound are Category I non-friable asbestos-containing materials. This material will have to be removed by a licensed abatement contractor prior to demolition.

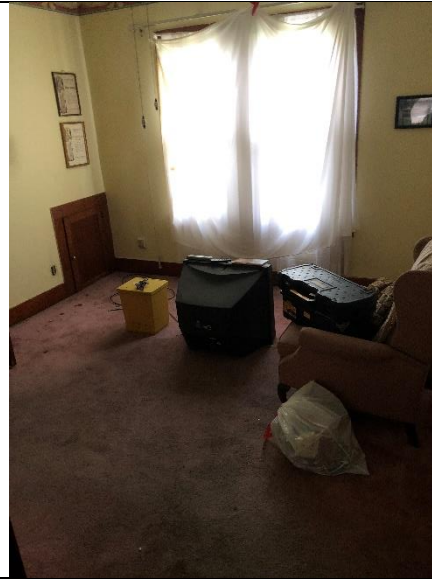
212 First St – Sitting room

FS-21-287-005	Sheetrock, compound, tape	Sitting room – SE	3% Chrysotile
FS-21-287-006	Sheetrock, compound, tape	Front Bedroom – NW	3% Chrysotile
FS-21-287-007	Linoleum and yellow mastic	Kitchen – North	None Detected
FS-21-287-008	Linoleum and yellow mastic	Kitchen – NE	None Detected
FS-21-287-009	Linoleum and yellow mastic	Kitchen – East	None Detected
FS-21-287-010	Linoleum and tan mastic	Master Bathroom – North	23% Chrysotile
FS-21-287-011	Linoleum and tan mastic	Master Bathroom – North	23% Chrysotile
FS-21-287-012	Linoleum and tan mastic	Master Bathroom – South	23% Chrysotile
FS-21-287-013	Linoleum and tan mastic	Hall Bath – North	23% Chrysotile

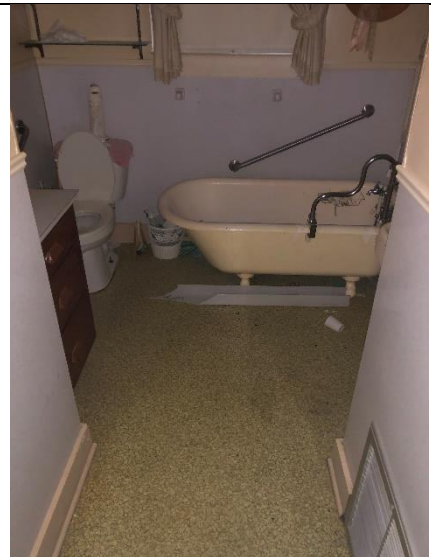
212 First St – Hall Bath

Sample ID	Material Description	Location	Result
FS-21-287-014	Linoleum and tan mastic	Hall Bath – North	23% Chrysotile
FS-21-287-015	Linoleum and tan mastic	Hall Bath – South	23% Chrysotile
FS-21-287-016	Fibrous insulation	Attic above Living room	None Detected
FS-21-287-017	Fibrous insulation	Attic above Living room	None Detected
FS-21-287-018	Fibrous insulation	Attic above Living room	None Detected

- **Floor Tile & Mastic**

The floor tile and mastic are Category I non-friable asbestos-containing materials. The floor tile and mastic would need to be removed by a licensed abatement contractor prior to demolition.

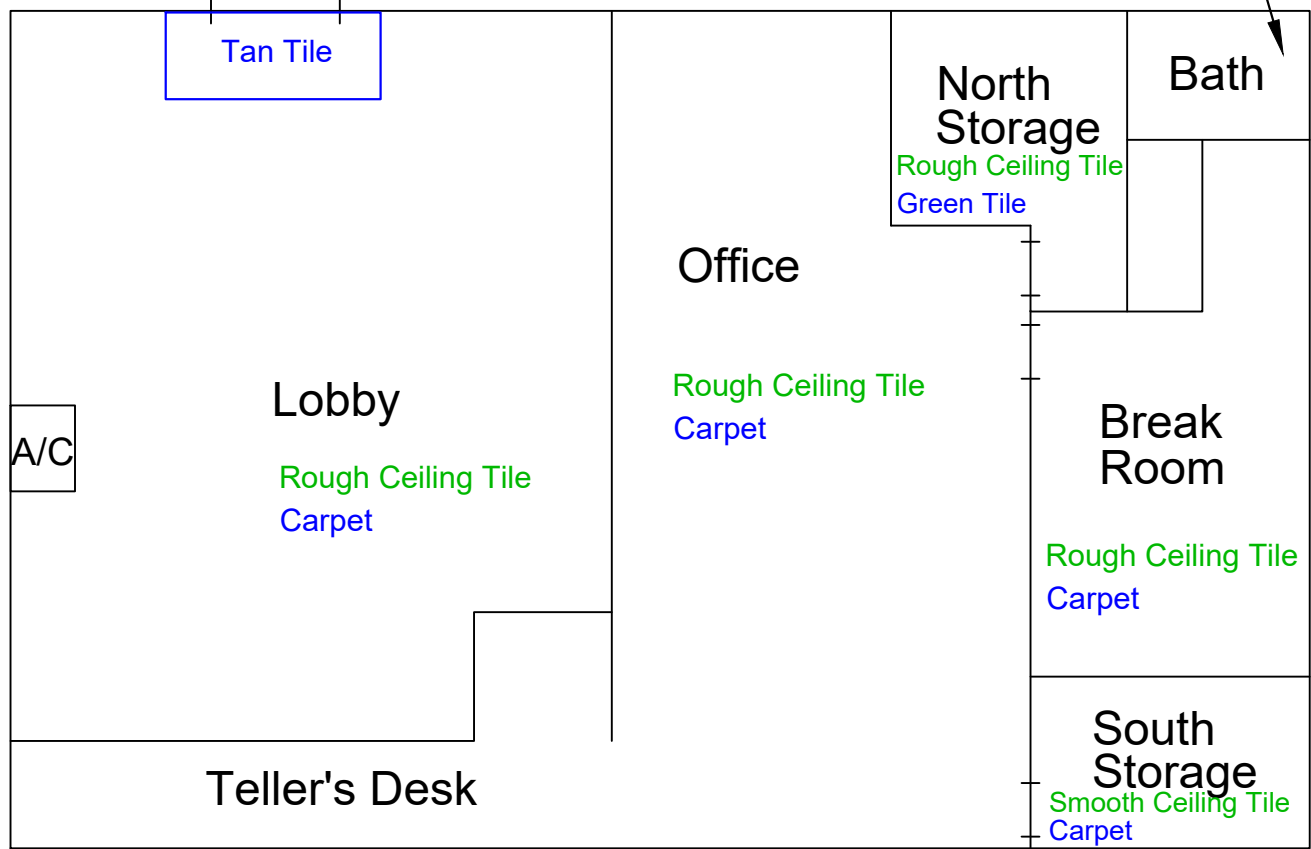
400 Mudd Ave.

NOTE: No Asbestos Containing Materials found on this Inspection.

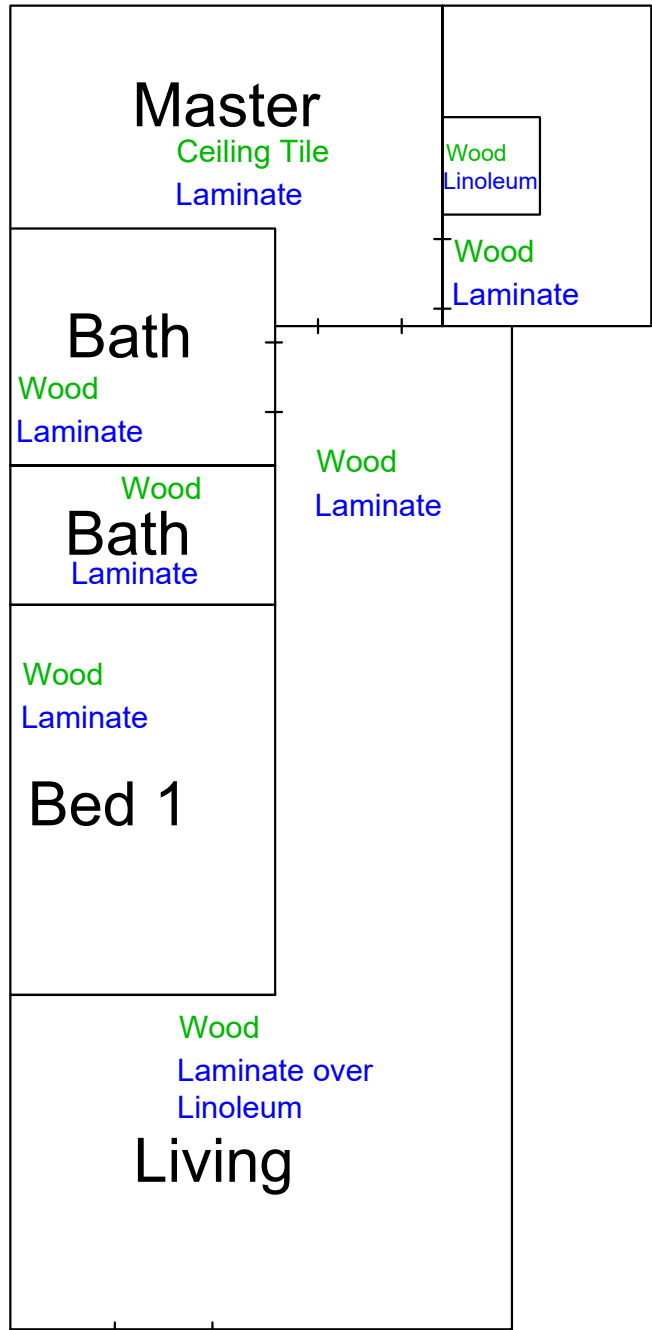
425 Sampson

NOTE: No Asbestos Containing Materials found on this Inspection.
