ASBESTOS SAMPLING REPORT

Lafayette Connector

400 Mudd Ave., 425 Sampson St., & 212 First St.
Lafayette, LA

SEMS Project #553-0032

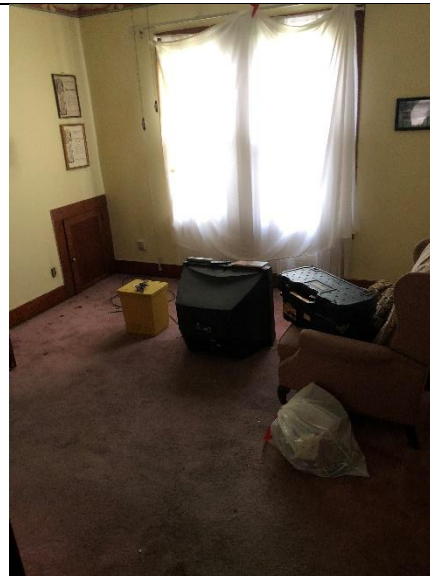
212 First St – Sitting room

FS-21-287-005	Sheetrock, compound, tape	Sitting room – SE	3% Chrysotile
FS-21-287-006	Sheetrock, compound, tape	Front Bedroom – NW	3% Chrysotile
FS-21-287-007	Linoleum and yellow mastic	Kitchen – North	None Detected
FS-21-287-008	Linoleum and yellow mastic	Kitchen – NE	None Detected
FS-21-287-009	Linoleum and yellow mastic	Kitchen – East	None Detected
FS-21-287-010	Linoleum and tan mastic	Master Bathroom – North	23% Chrysotile
FS-21-287-011	Linoleum and tan mastic	Master Bathroom – North	23% Chrysotile
FS-21-287-012	Linoleum and tan mastic	Master Bathroom – South	23% Chrysotile
FS-21-287-013	Linoleum and tan mastic	Hall Bath – North	23% Chrysotile

The texture material and joint compound are Category I non-friable asbestos-containing materials. This material will have to be removed by a licensed abatement contractor prior to demolition.

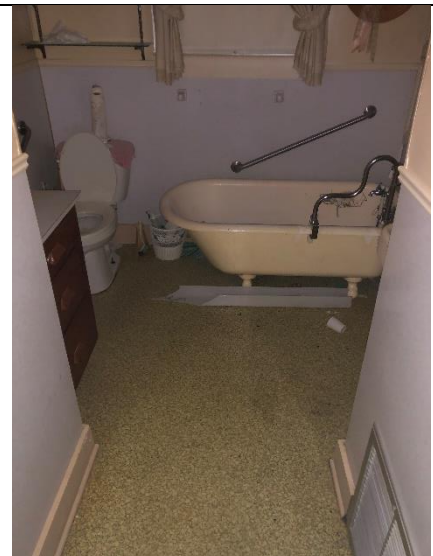
212 First St – Hall Bath

Sample ID	Material Description	Location	Result
FS-21-287-014	Linoleum and tan mastic	Hall Bath – North	23% Chrysotile
FS-21-287-015	Linoleum and tan mastic	Hall Bath – South	23% Chrysotile
FS-21-287-016	Fibrous insulation	Attic above Living room	None Detected
FS-21-287-017	Fibrous insulation	Attic above Living room	None Detected
FS-21-287-018	Fibrous insulation	Attic above Living room	None Detected

The floor tile and mastic are Category I non-friable asbestos-containing materials. The floor tile and mastic would need to be removed by a licensed abatement contractor prior to demolition.

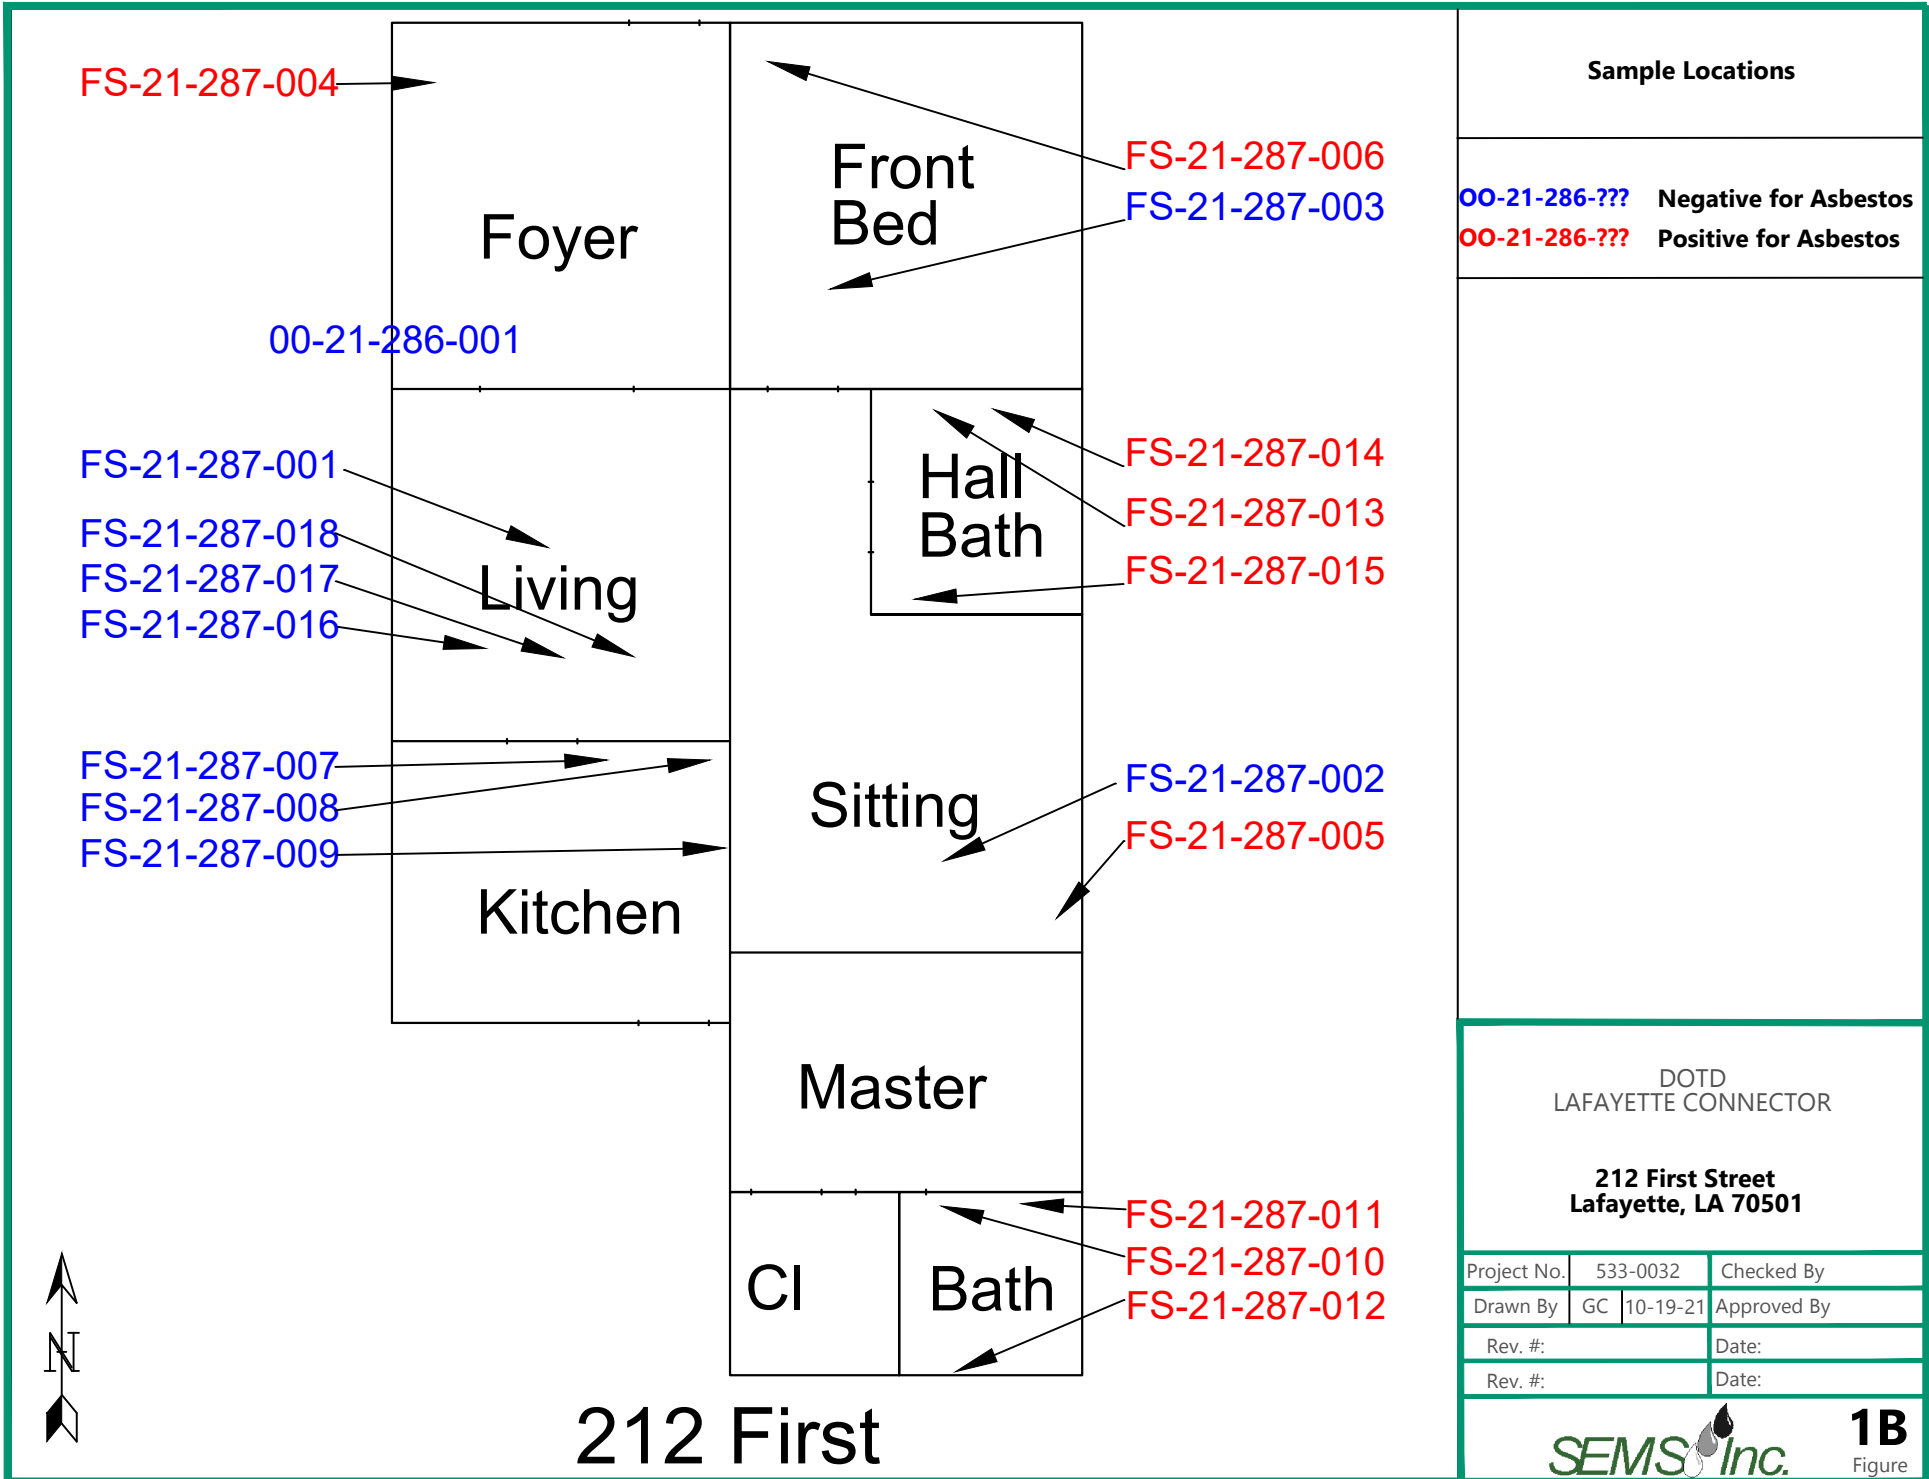
212 First

OO-21-286-??? Negative for Asbestos
 OO-21-286-??? Positive for Asbestos

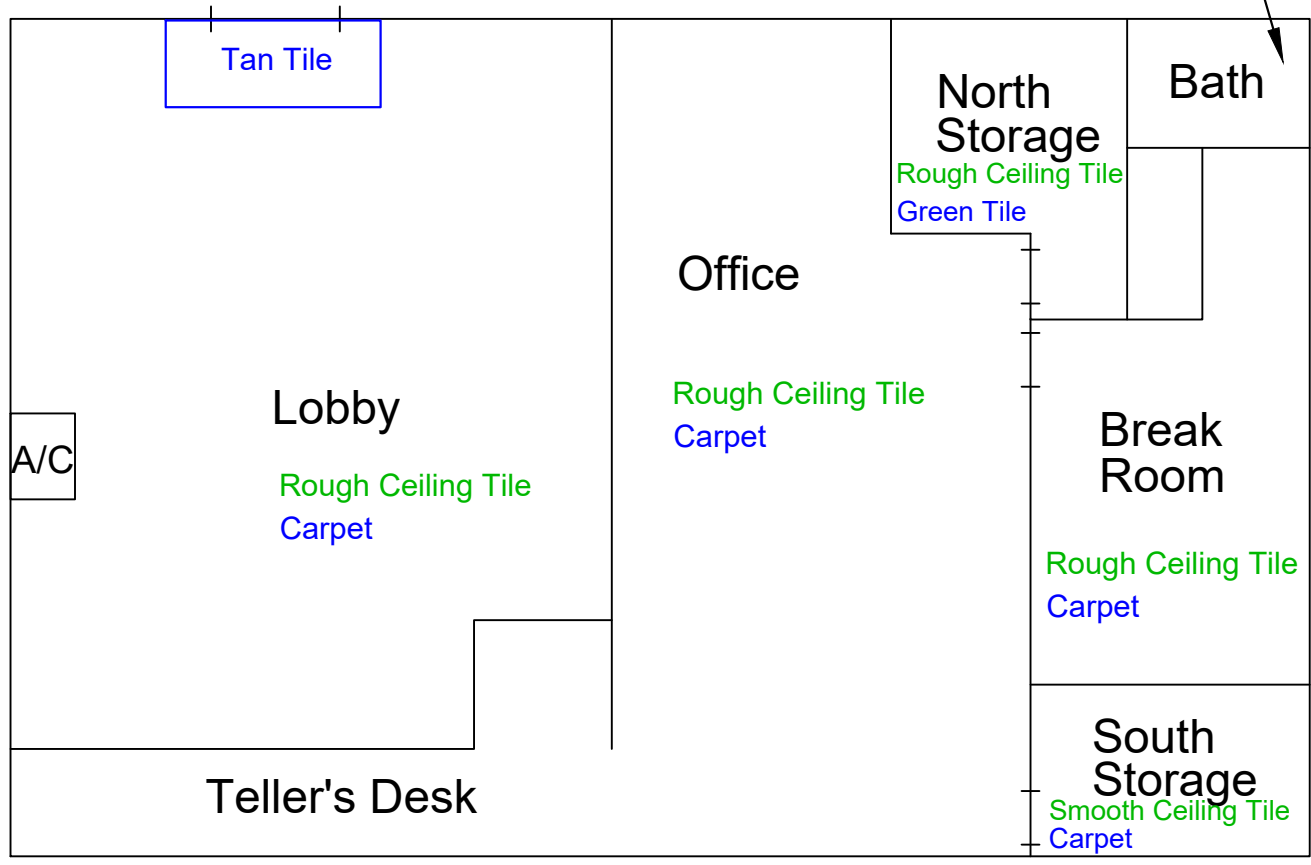
**400 Mudd Avenue
Lafayette, LA 70501**

NOTE: No Asbestos Containing Materials found on this Inspection.
