CONCRETE BRIDGE - FIRE DAMAGE EVALUATION – by Don Sorgenfri

Inspection and Repair of a Fire Damaged Prestressed Girder Bridge

RICHARD STODDARD, Washington State DOT, Olympia, WA

DAMAGE INSPECTION REPORT 12/12/02

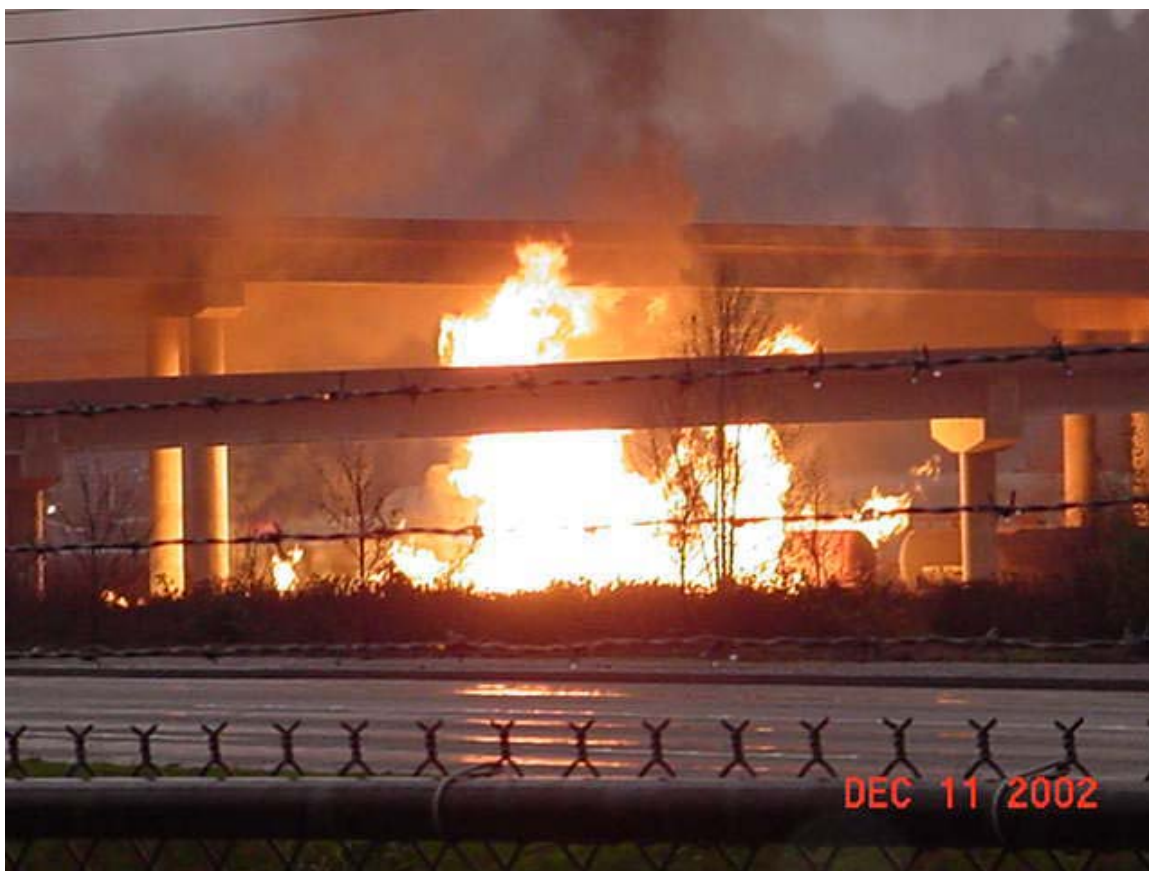
Photo 1. Puyallup River Bridge Railroad Tanker Fire

On December 11, 2002, at approximately 4:00 pm, a railroad tanker collision caused a fire under a prestressed girder bridge that consumed 30,000 gallons of mythanol, (photo 1). This section of the bridge was a relatively new continuous three span frame constructed in 1997. The girders had a span length of 146 feet, a 28 day concrete strength of 7000 psi, and 0.5” diameter 270 ksi steel strands. The bridge deck and columns were constructed using 5000 psi concrete and 60 ksi mild steel. Confinement reinforcement in the columns was provided by tightly wound spiral cages.

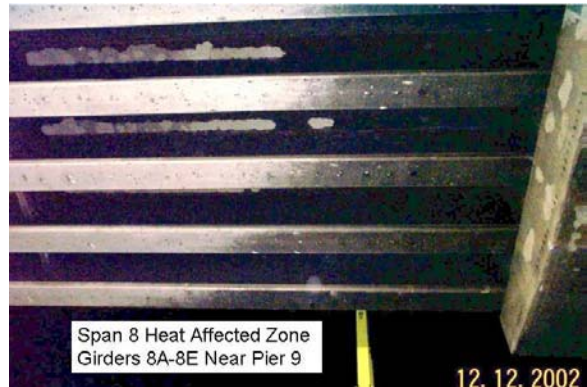
Photo 2. Span 8 Heat Damaged Flanges

All 15 lines of girders in Span 8 were damaged by the fire. The color of the bottom flange soffit was a whitish-gray, (photo 2). The whitish-gray concrete at the corners of the bottom flange could be easily removed to expose the outermost prestressing strands for a length of more than 94 feet, (photo 3). There were 0.5 inch deep concrete spalls in the top flange and webs of girders.

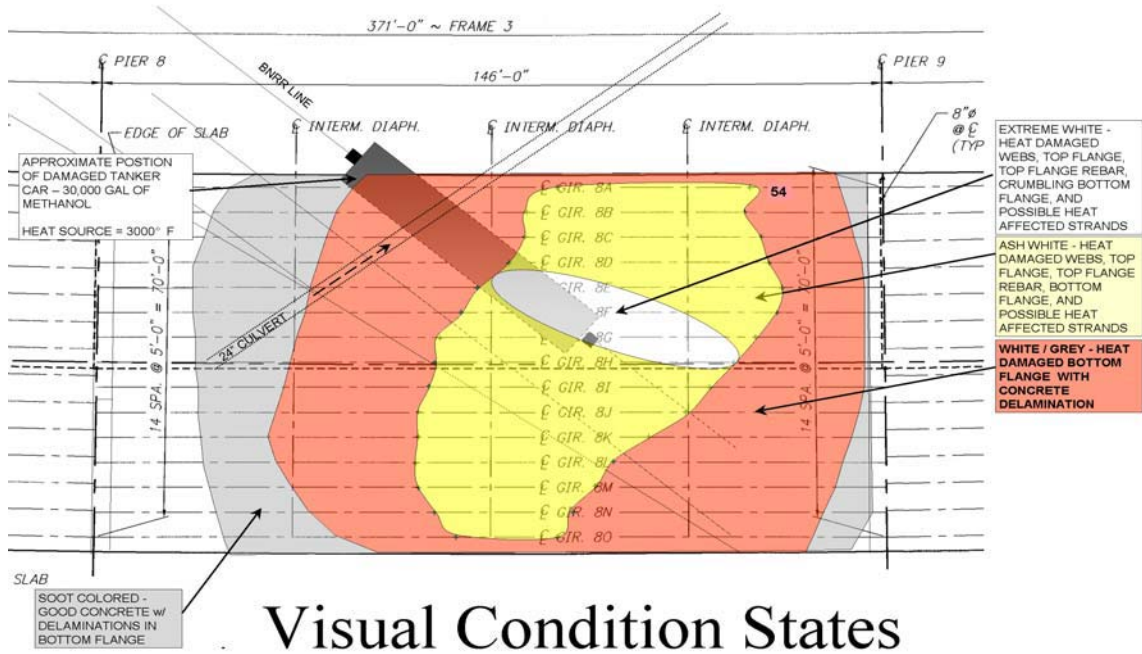
Figure 3. Bottom Flange Visual Condition States

Visual inspections of the damage in Span 8 made note of concrete color variations on the soffit of the bottom flanges that corresponded to changes in concrete condition states. Figure 3 contains a map that was produced to display the boundaries of four fire induced color regions. The color regions were described as Extreme-White, Ash-White, White-Gray, and Soot.

The Ash-White bottom flange region encompassed approximately 30% of the Span 8 area and included all fifteen (15) girders. The North and South boundaries were relatively easy to see from the ground. Their position was measured from the center of Pier 9. Concrete on the soffit of the bottom flanges crumbled or spalled when tapped with a rock hammer. Prestressing strands on the edges of the bottom flange were easily exposed. Concrete spalls were noted in the webs and the top flanges. Web spalling occurred only on the side facing the heat source, due to shadowing effects from the adjacent girders. The density and extents of spalling on the webs appeared to increase with distance from the heat source. This is probably another demonstration of shadowing effects that occurred near the heat source. The girder webs furthest away from the fire were actually more exposed to the radiant heat than were the webs nearest to the fire. Web spalling and top flange spalling did not occur outside of this color region. The nylon reinforcing chairs in the girders had melted with some indication of being burned during the fire. Melted nylon formed stalactites and pockets of charred nylon were visible.

The White/Gray bottom flange region encompasses approximately 30% of the Span 8 area and included all fifteen (15) girders. This region was characterized by obvious delamination sounds in the bottom flanges when struck with a rock hammer. Concrete spalling could be produced with forceful strikes using a rock hammer. The concrete did not crumble and the spalled pieces were 6 inches to 12 inches in size. Prestressing strands on the edges of the bottom flange were difficult to expose using a rock hammer. The web and top flanges were covered with soot but appeared to have sound concrete. The nylon reinforcing chairs in the girders had melted during the fire leaving long nylon stalactites.

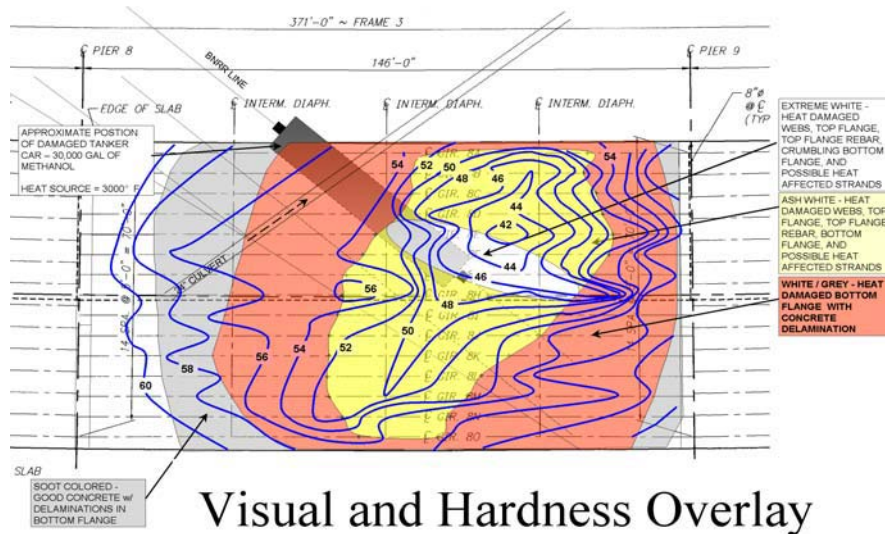
Figure 4. Visual Condition States and Flange Hardness Contours

Two locations in Span 9 were tested to provide an expected hardness value for concrete not affected by the fire. The average rebound hammer reading for the soffit of the bottom flange in Girder 9N was 61.4. The rebound hammer readings for the soffit of the bottom flanges in Span 8 ranged from a low of 42.0 to a high of 60.9. The minimum hardness reading was found to be directly over the heat source and in general, flange hardness increase with distance

away from the heat source. A contour map overlay was added to the flange color variations to check for correlations. As can be seen in Figure 4, the hardness measurements were consistent with the visual damage assessments.

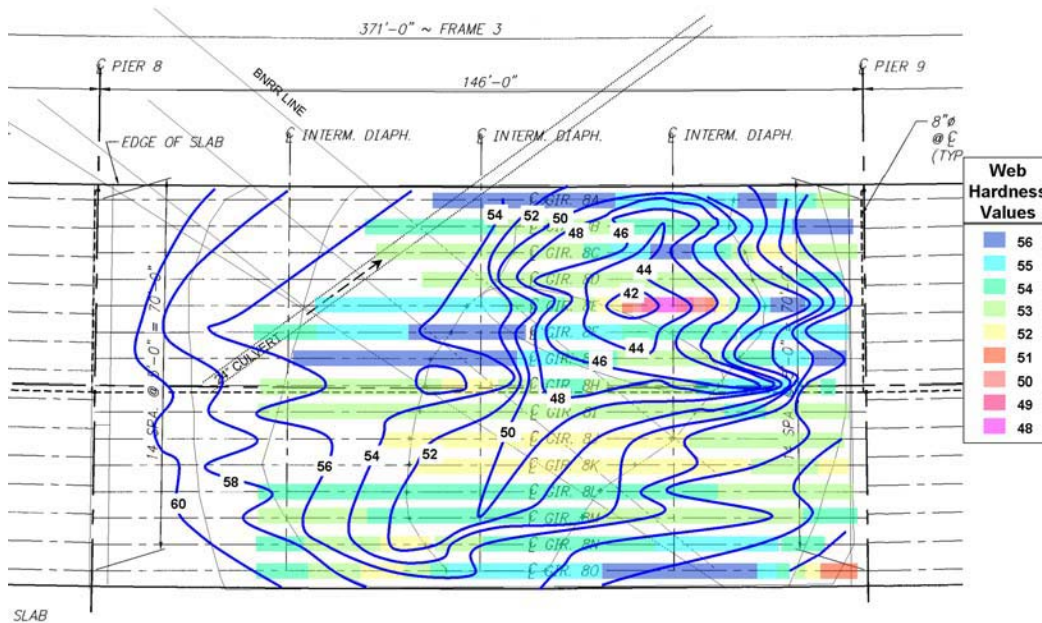
Figure 5. Flange Hardness Contours and Web Hardness Color Bands

The average rebound hammer readings for Girder 9N was 54.4. The rebound hammer reading in the webs of Span 8 ranged from a low of 47.9 to a high of 57.4. The web harness reading proved impossible to represent with a contour map because values did not follow a pattern of regular change. Color bands were developed as a method to display the hardness changes on a map. Figure 5 overlays the Web Hardness Color Bands and the Flange Hardness Contours to show that the location of the lowest web hardness values corresponds with the lowest flange hardness values. In general, web hardness increases with distance from the source of the fire but shadowing affected the distribution of web damage. Webs lying outside of the small circle in the center of the heat source were damaged by heat if they were not shadowed and if their angle of exposure to the heat source was less than 40 degrees. One could see how the shadowing occurred by standing at the location of the tanker during the fire. Webs directly above and near that location could not be seen because they were blocked by the bottom flanges. Webs of the exterior girders became more visible resulting in a greater exposure to radiant heat. The web damage (reduced hardness) outside of the Extreme White color region actually increased with distance from the fire.

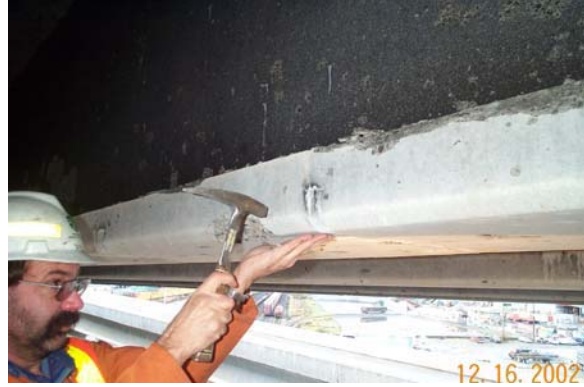
Photo 4. Crumbling Concrete Girder 8E

Concrete in the bottom flanges surrounding the straight prestressing strands was easy to remove with the use of a light rock hammer, (photo 4). A small hand held air powered impact hammer was used to remove concrete to exposed prestressing strands in Girder 8F directly above the tanker fire, referred to as location F2. The concrete around strands labeled as number 2, 8, 16, and 18 was removed without difficulty. The color of the exposed concrete varied from ash-white at the surface to light tan (buff color) to a depth of about 0.25 inches, and then a normal gray concrete color on the interior. Beyond a depth of about 1 inch, the concrete became difficult to remove with the rock hammer but remained very easy to remove with the air hammer.

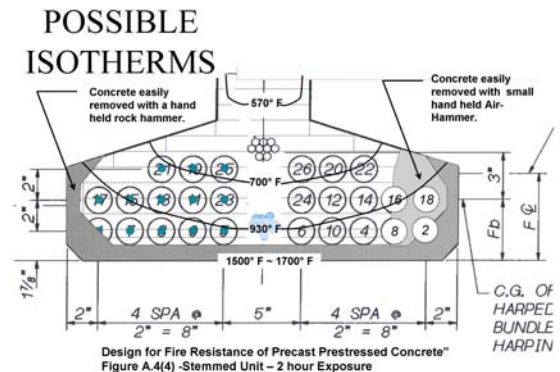
Figure 6. Possible Isotherms in Bottom Flanges

Possible temperature isotherms shown in Figure 6, were developed by combining visual observation of the concrete color, estimated flame temperatures, ease of concrete removal, and the use of Figure A.4(2) on page 77 of PCI Publication – *Design for Fire Resistance of Precast Prestressed Concrete*.² The buff colored 0.25 inch shell indicates possible temperatures of 1700°F. The ease of concrete

removal indicates that concrete temperatures surrounding the lower row of prestressing strands and the exterior strands of the second row exceeded 900°F (strands 1 thru 10 and strands 17 and 18). Contract plans also revealed that the bottom flange soffit provided only 2 inches of cover for the lower bundle of harped strands. Additional observations of warped mild steel reinforcement in the top flanges supported the concern for a temperature induced relaxation of the prestressed strands.

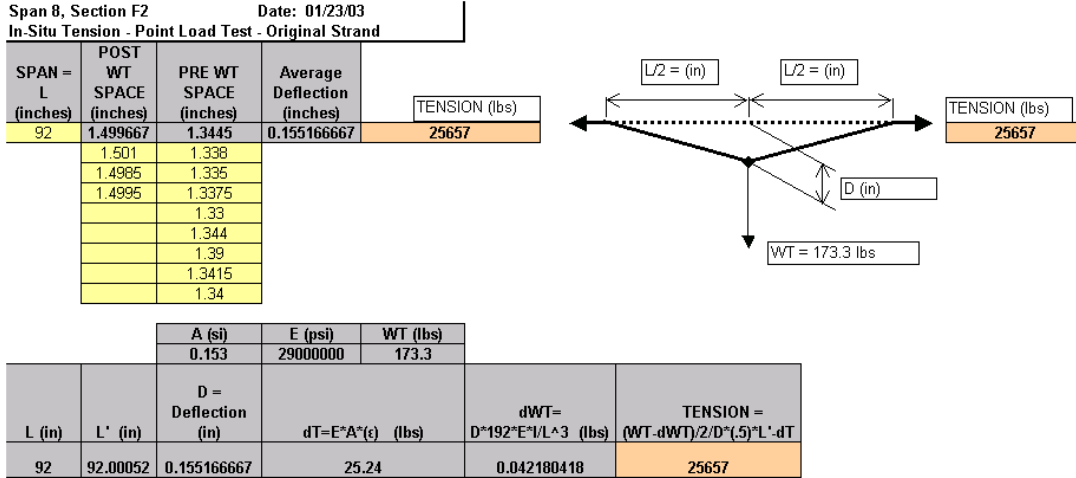
Figure 7. Calculation of Strand Tension from Displacement Test

Conclusions: The prestressed strand force in girders 8F and 8N appeared to be unaffected by the heat of the fire. Strands within the hot zone at locations F2 and N2, (Figure 8), appeared to have retained 100% of their design force despite high temperatures in the surrounding concrete. We have theorized that the steel strands were able to conduct heat to cooler concrete away from the hot zone and prevent a substantial reduction in the yield stress. Transmission of heat away from the hot zone through the steel strands provides an explanation for the delaminations that have been detected in bottom flanges in the Soot colored region shown in

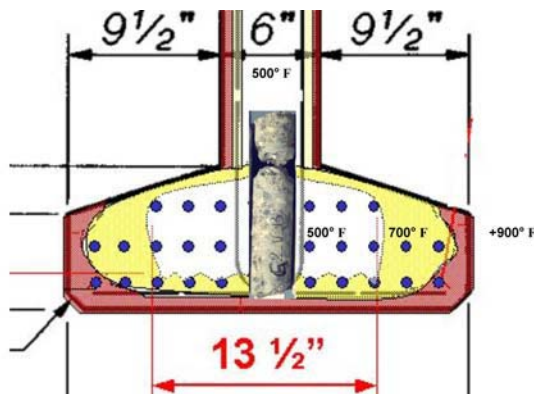
Figure 11. Core Sample G2-V-B – Taken from Extreme-White Color Region

Core No. G2-V-B: Outer 3½ inches fair condition (up to ±500°F); remainder appears sound.

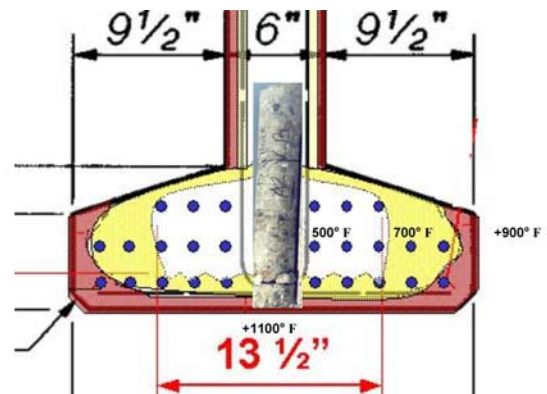
Figure 12. Core Sample A2-V-B – Taken from Ash-White Color Region

Core No. A2-V-B: Outer 2 inches poor condition (±700°F-900°F); remainder appears sound.

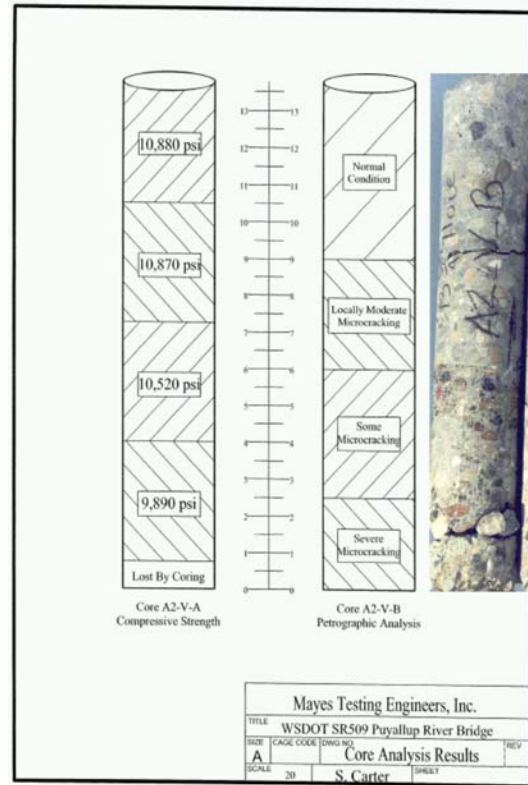
Figure 13. Compression Test Profile Core A2-V-A⁸, Petrographic Profile Core A2-V-B⁸, Photo Core A2-V-B⁷.

Compression tests⁸ performed on the core samples indicated that much of the girder core has excellent strength with compressive strengths that exceed 9000 psi. Figure 13 shows the strength test profile and petrographic analysis profile for location A2. However, concrete core samples taken from Girders 8A, 8F, and 8G showed numerous physical signs of concrete degradation. For example, the drilling operation was easier to perform than in regions away from the hot zone. The cores were missing 0.75 inches of concrete from the flange soffit, (Figures 11 and 13). They fractured during the drilling process at the bottom row of strands and at the interface of the web and the flange, (Figures 11 and 12). The cores broke at additional locations if not handled with care. Core samples taken at location F1, in the Soot colored region away from the hot zone, were exceptionally difficult to drill and were very

durable when handled. These differences indicated significant heat damage, but the compression tests did not indicate much change or a performance problem.

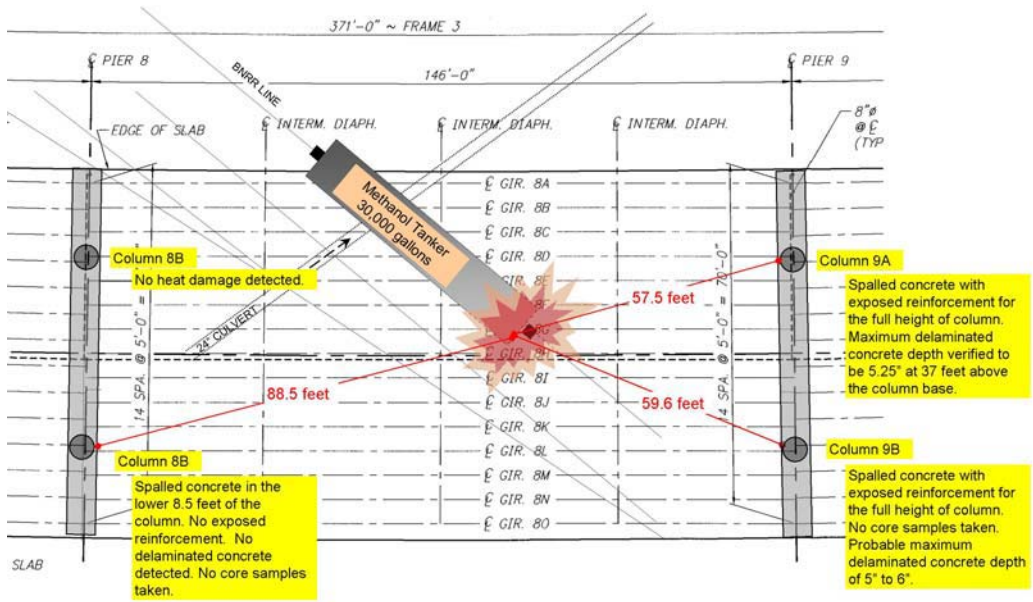
Figure 14. Pier 8 and Pier 9 Heat Exposure and Damage

Column 8B was approximately 88 feet from the source of the fire at the railroad tanker, (Figure 14), and showed no significant effects on the side facing the tanker. However, the east face was exposed to methanol flames emanating from the adjacent drainage ditch. Concrete spalling occurred in the bottom 8.5 feet of the column, Photo 8. The concrete spalls were found to be less than 1 inch in depth. No reinforcement was exposed and no concrete delaminations were discovered. The remaining concrete was not discolored and appeared to have serviceable strength.

Columns 9A and 9B were approximately 60 feet from the source of the fire, (Figure 14). Concrete spalling occurred for the full height of the columns on the south face of Column 9A and the southwest face of Column 9B. The spalled concrete thickness frequently exceeded 1½ inches resulting in areas of exposed spiral reinforcement. The remaining concrete was not discolored and appeared hard but delaminated. Exposed aggregate appeared to be in good condition except for one specific type of red rock. This rock was found in many locations to be highly fractured and could be crumbled between a person's fingers. The rock was similar in appearance to red brick and contained a white colored mineral or granule. Efforts were made to remove all of the delaminated concrete from the columns with the use of air hammers but the removal process was stopped at the outer edge of the vertical reinforcement at a depth of approximately 2¼ inches. Many areas of the remaining concrete in both columns sounded hollow indicating that delamination fractures continued inside the column reinforcement cage. A core sample taken from Column 9A at 37 feet above the base of the column (12.92 feet below the top of the column) showed concrete delamination had occurred at a depth of 5¼ inches from the original surface of the column.

The recommended repair strategy for the damaged area of Column 8B is to perform a simple concrete pour-back with dry concrete mix to provide environmental protection for the column reinforcement. The concrete repair must be performed according to WSDOT repair procedure, ie;

The recommended repair strategy for Column 9A and Column 9B is to perform a seismic column retrofit using a steel confinement shell and grout to fill the annular space between the steel shell and the column. The delaminated concrete in Column 9A and 9B present a concern for the performance of the columns during a seismic event. Providing a steel shell will assure confinement of the column core and assist with the placement of grout or concrete to protect the exposed reinforcement.

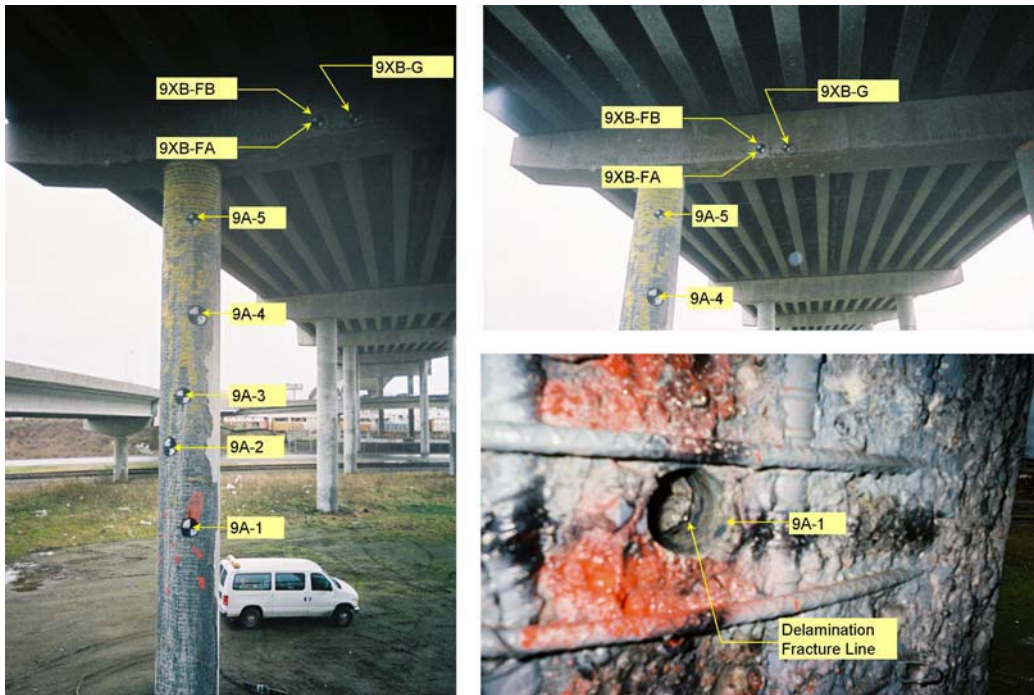
Photo 9. Pier 9 Core Sample Location

Core samples from Column 9A confirmed the existence of delamination fractures in the interior core of the column. The maximum depth of a delamination fracture was found to be 5” from the original surface and more than 1inch inside of the vertical column reinforcement, Photo 12. Aside from the delamination fractures, the concrete remaining on Column 9A appeared to have very good strength.
