# Historic Bridge Management Plan for the Judge Seeber Bridge

Recall Number: 020375

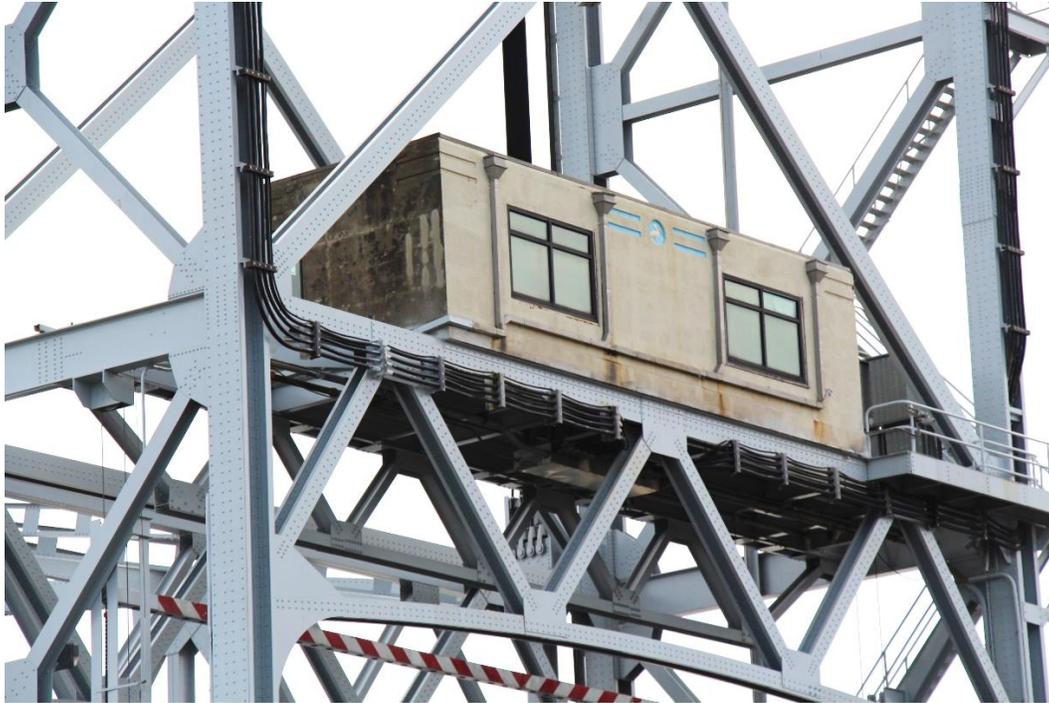
*Historic Fabric Photo 4: Bridge operator's house on west lift tower. Minor alterations to historic fabric include replacement windows within original window openings.*

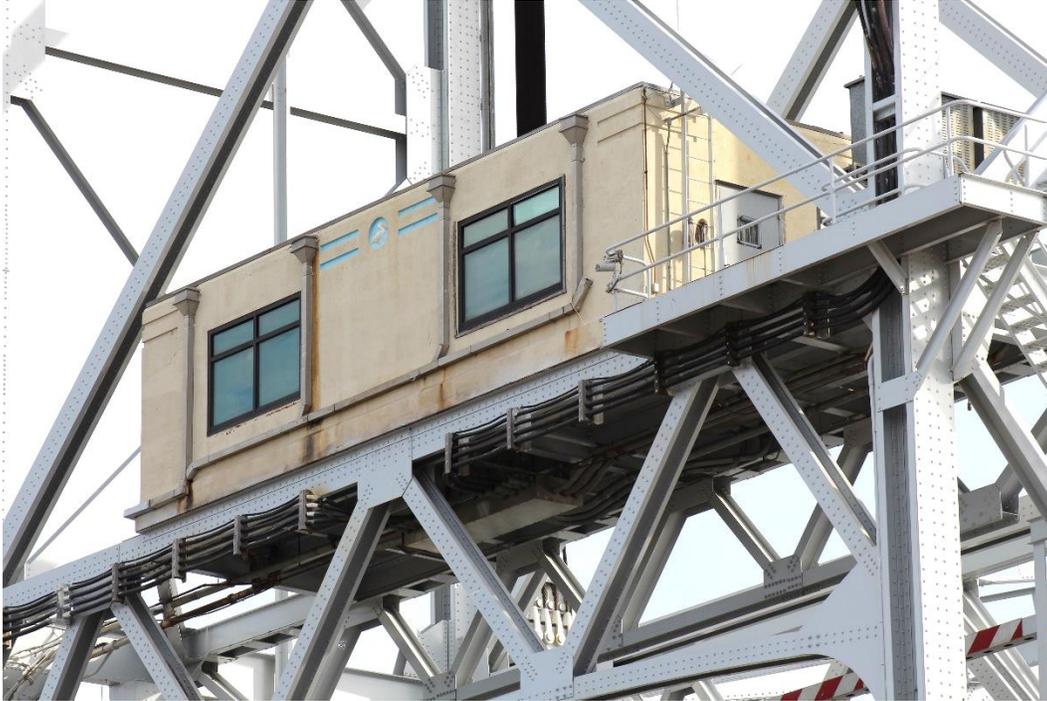
*Condition Photo 1: Operator's house, including electrical conduit and access platform on west tower.*

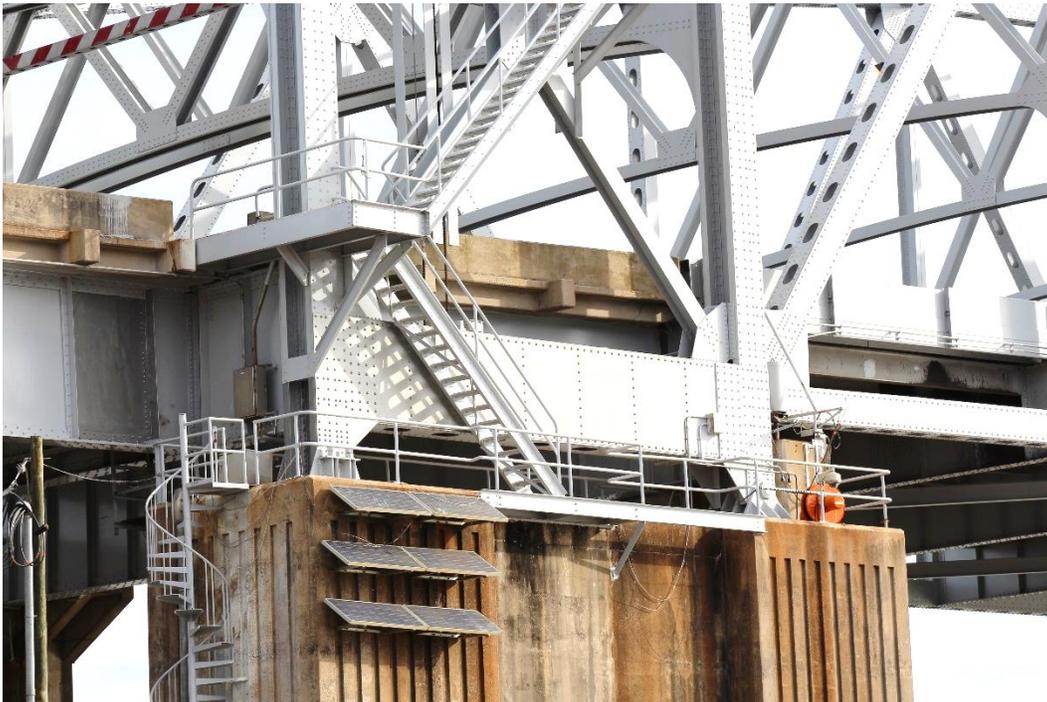
*Condition Photo 2: West tower span, stairs, platforms, and pier.*

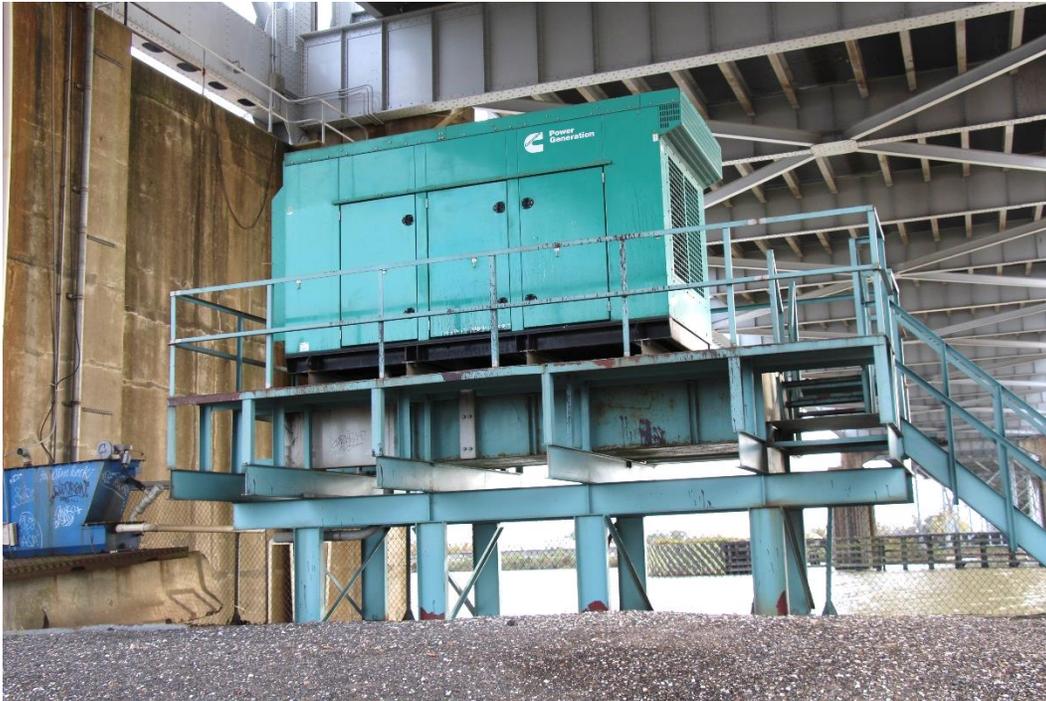
*Condition Photo 3: Emergency generator under west tower.*

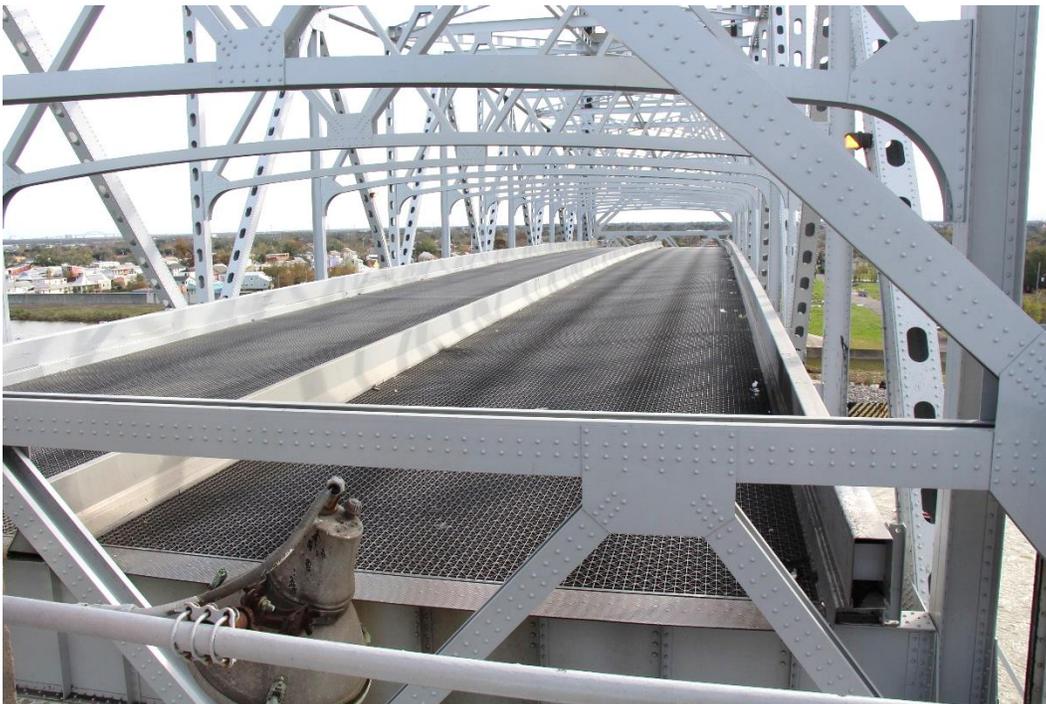
*Condition Photo 4: General condition of lift span open steel grid deck, barriers, and painted steel members.*

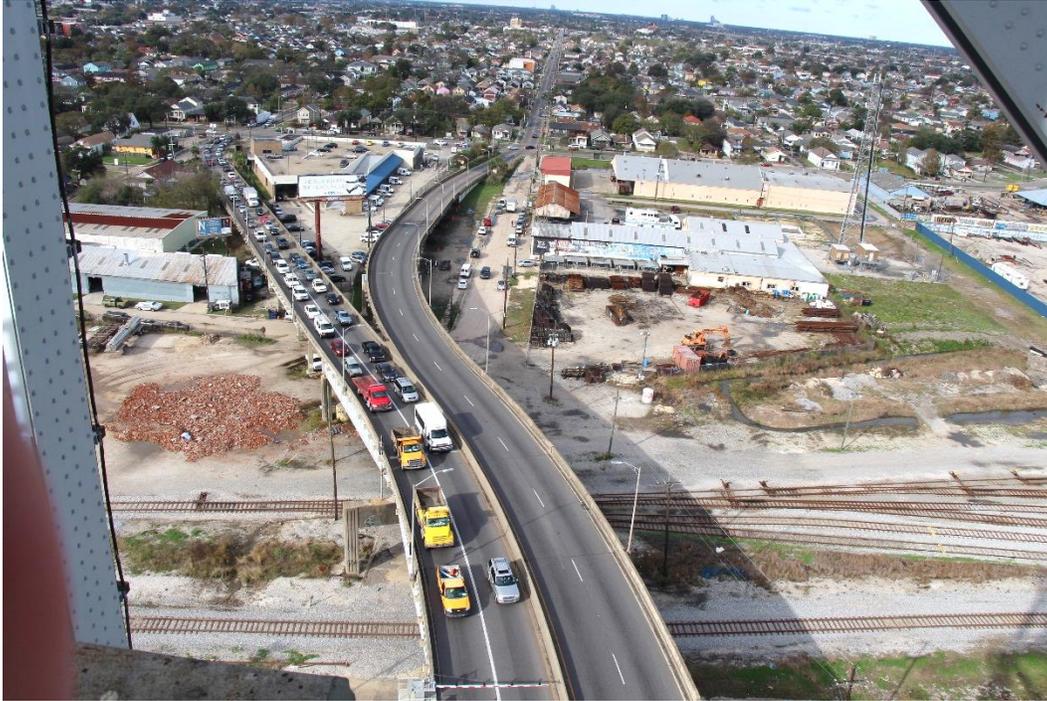
*Condition Photo 5: Aerial view of westerly approach spans; bridge is contiguous with Recall No. 001610 (south approach, at left) and Recall No. 020377 (north approach, at right) to the west.*

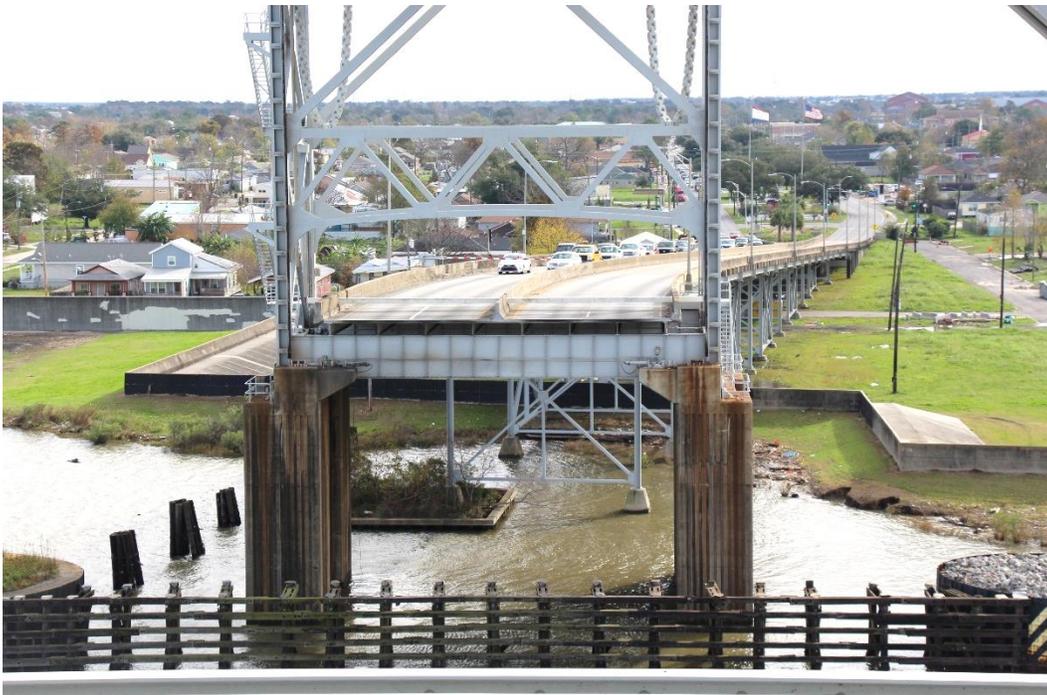
*Condition Photo 6: Easterly approach spans, timber fender system, east tower, and east pier.*

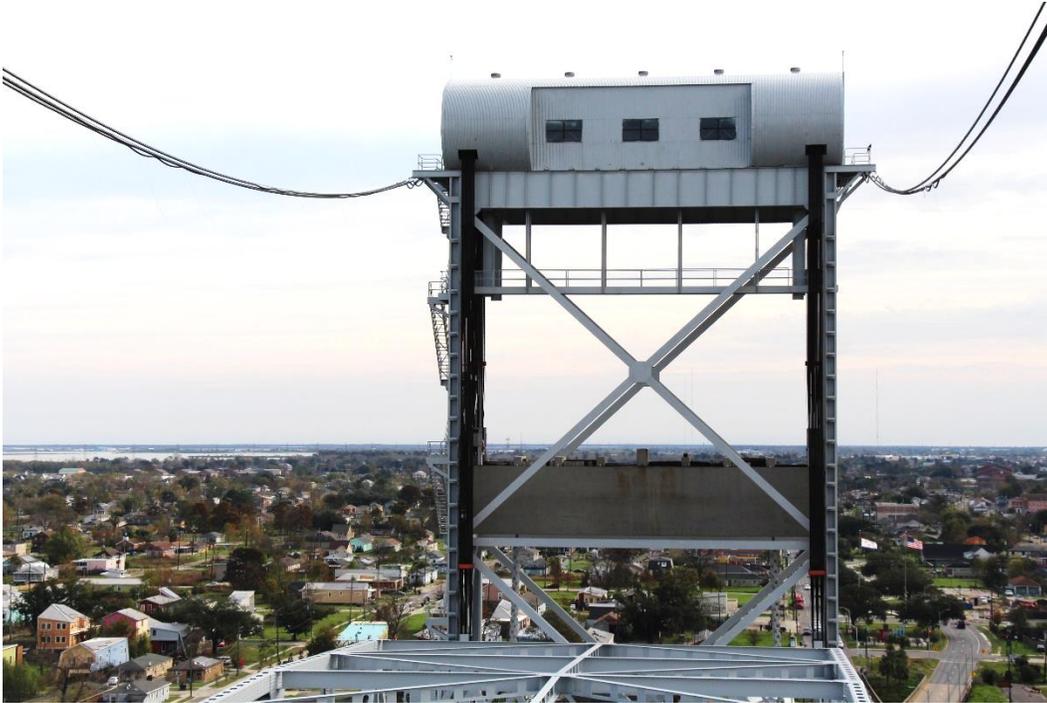
*Condition Photo 7: East tower machinery enclosure (west tower is similar).*

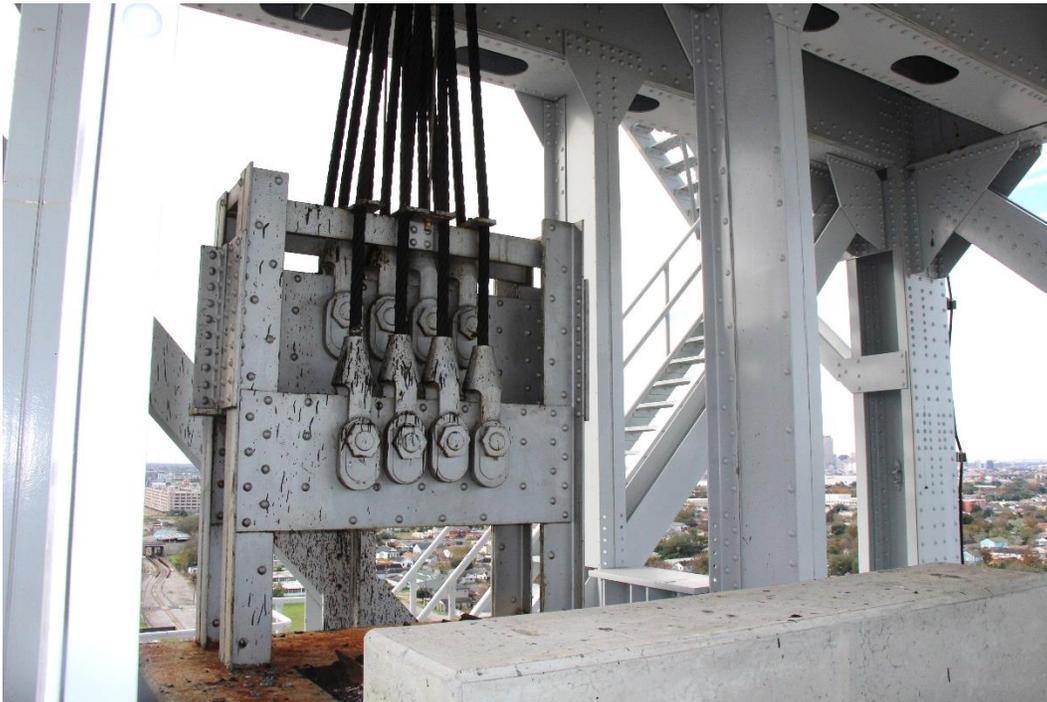
*Condition Photo 8: Cables and attachment sockets to counterweight.*

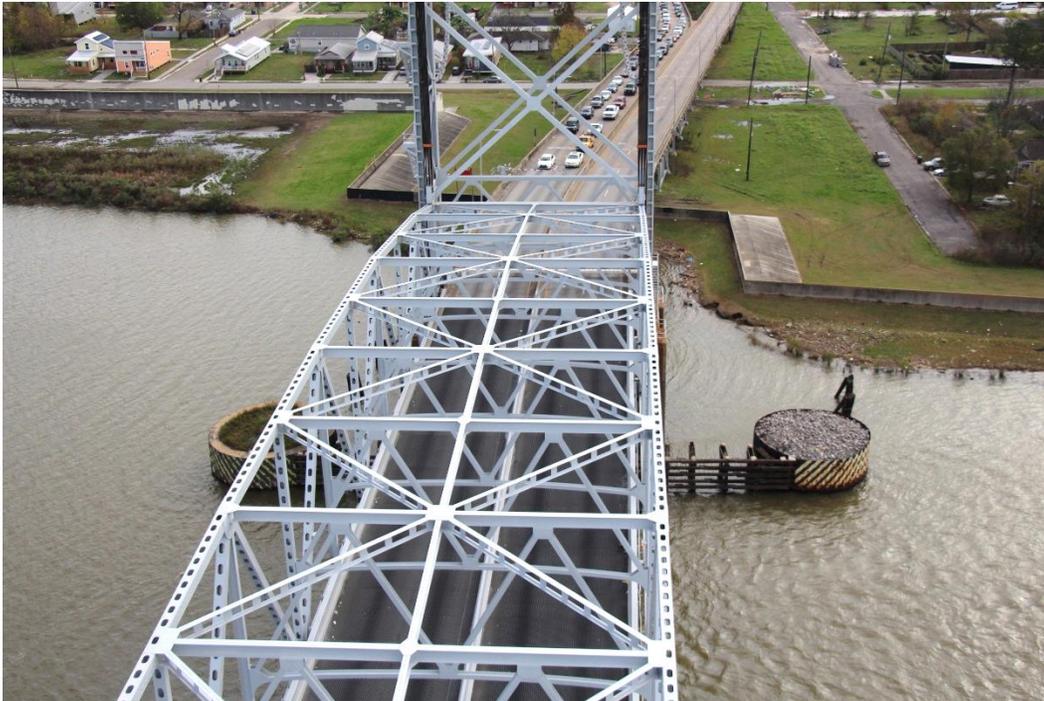
*Condition Photo 9: Top of lift span, pier protection system, and easterly approach spans, looking east.*

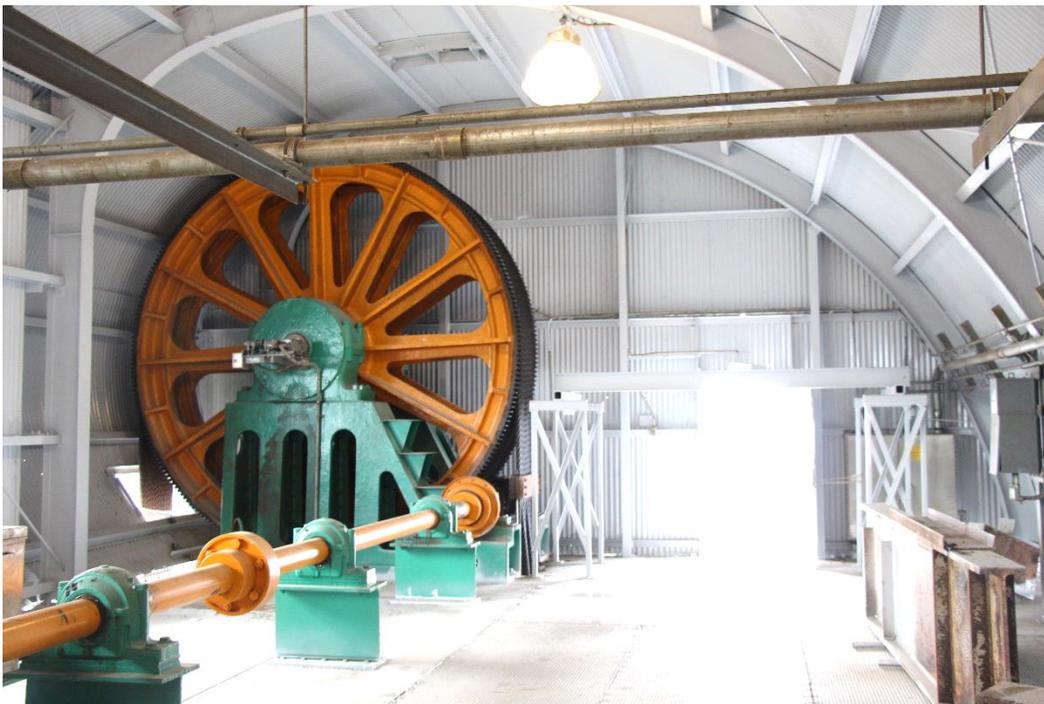
*Condition Photo 10: Inside machinery enclosure on west tower.*

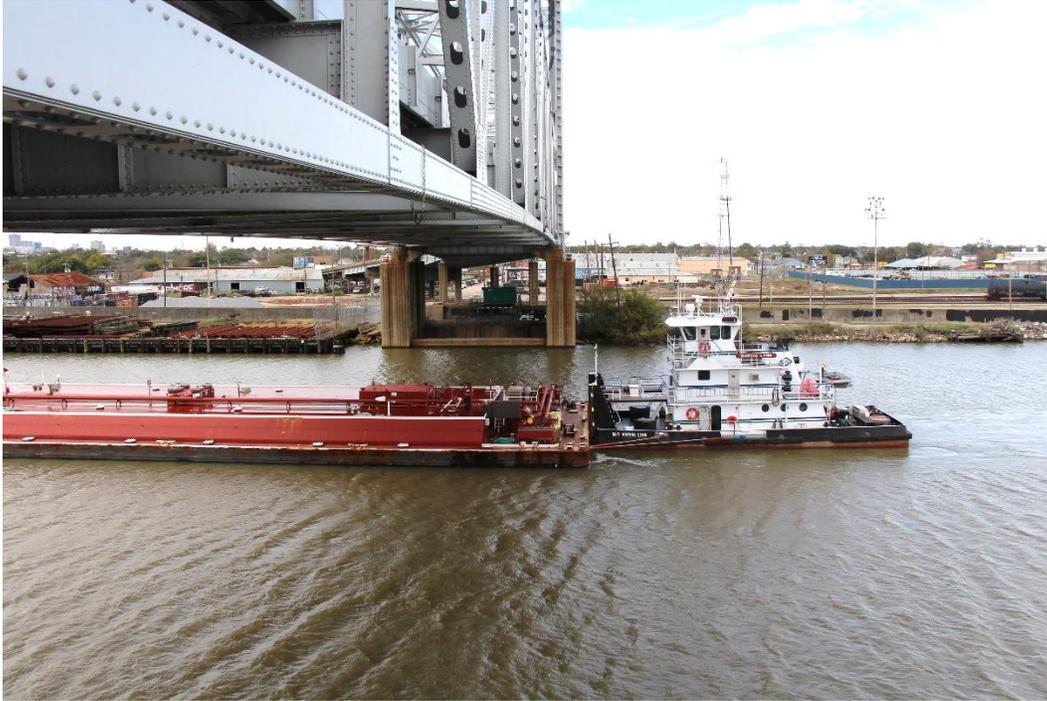
*Condition Photo 11: Vessel passing under bridge; bridge does not need to be raised for all vessels.*

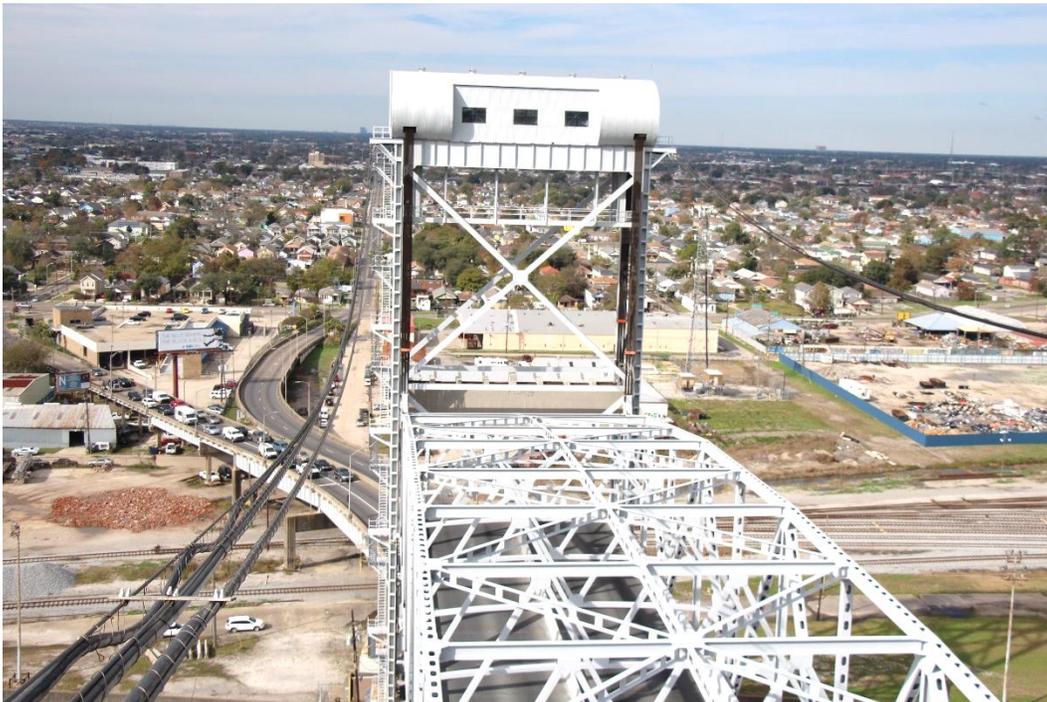
*Condition Photo 12: Overview of bridge looking west at west tower.*

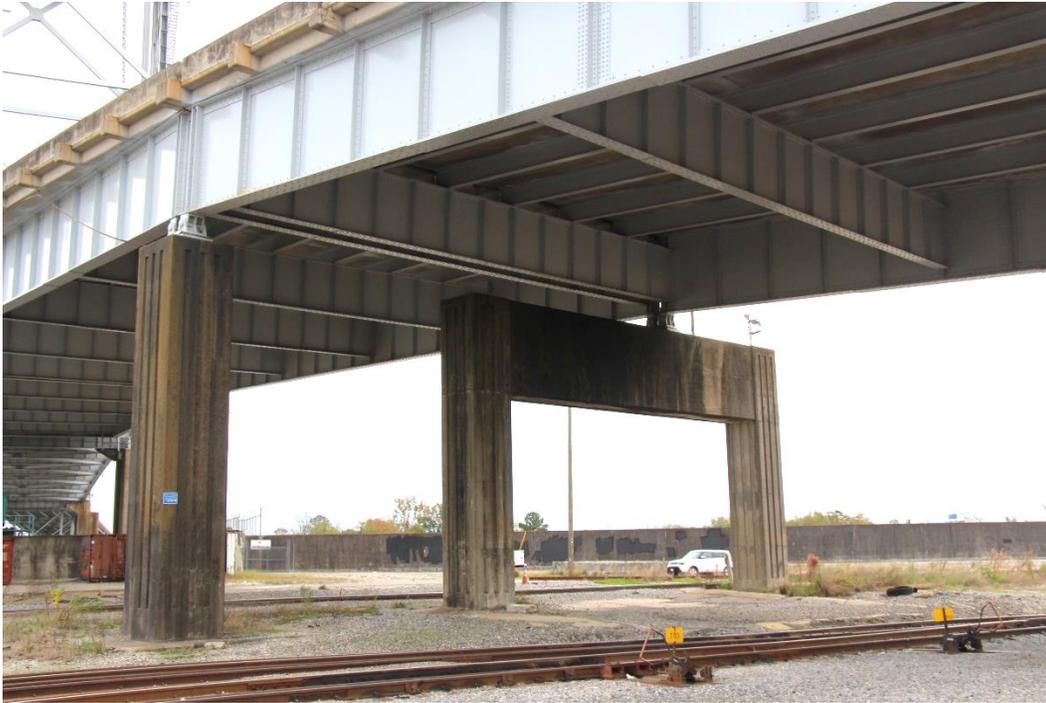
*Condition Photo 13: Westerly approach spans superstructure and substructure, looking northwest.*

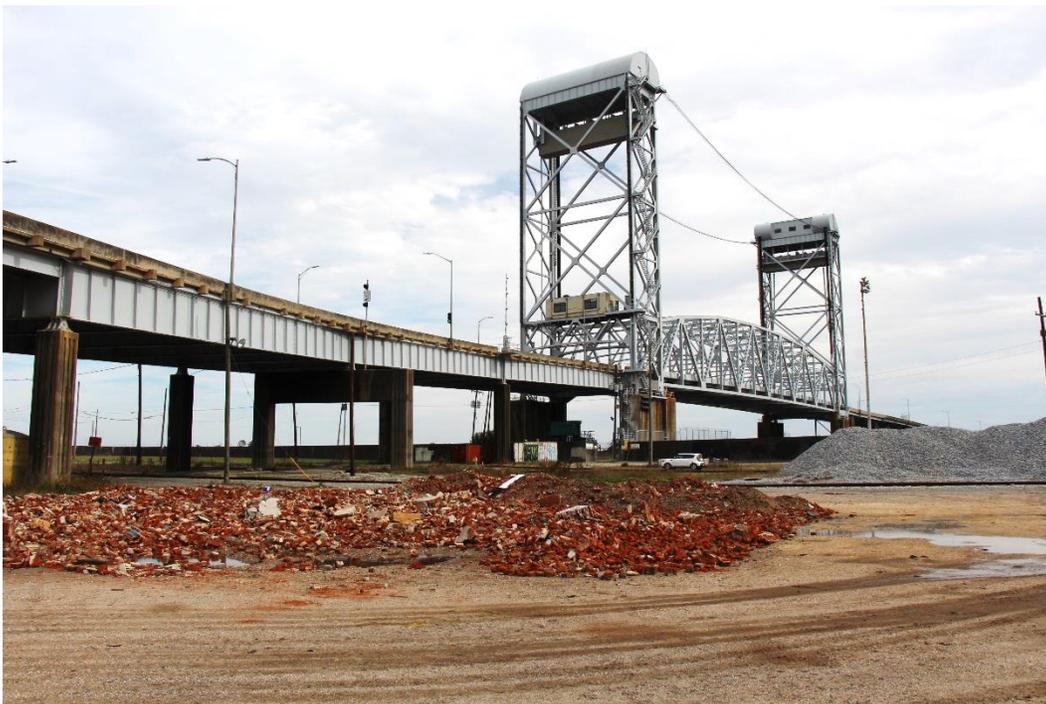
*Condition Photo 14: Westerly approach spans overview, looking east.*

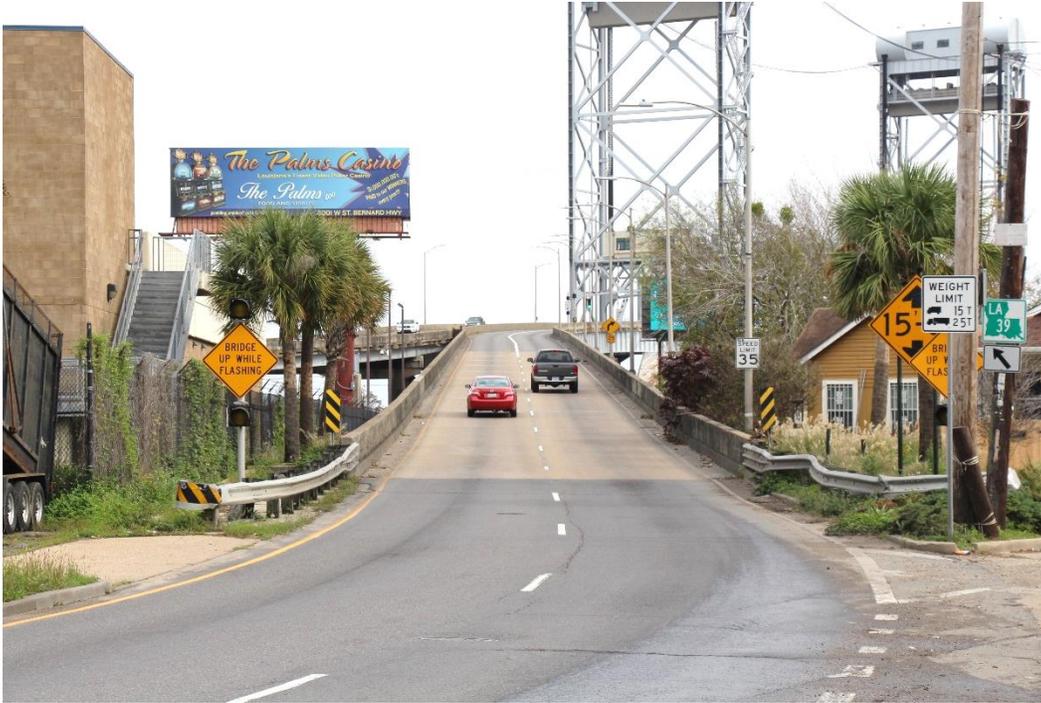
*Condition Photo 15: Westerly approach spans of Recall No. 001610, leading up to Recall No. 020375 (Judge Seeber Bridge), looking east.*

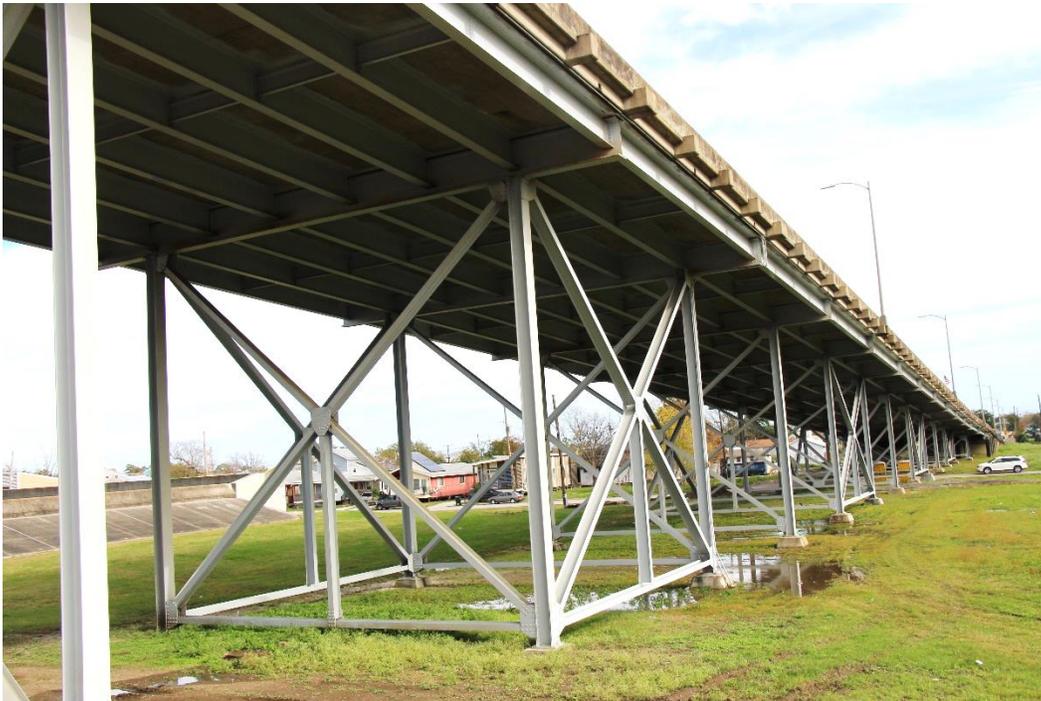
*Condition Photo 16: Easterly approach spans superstructure and bents.*

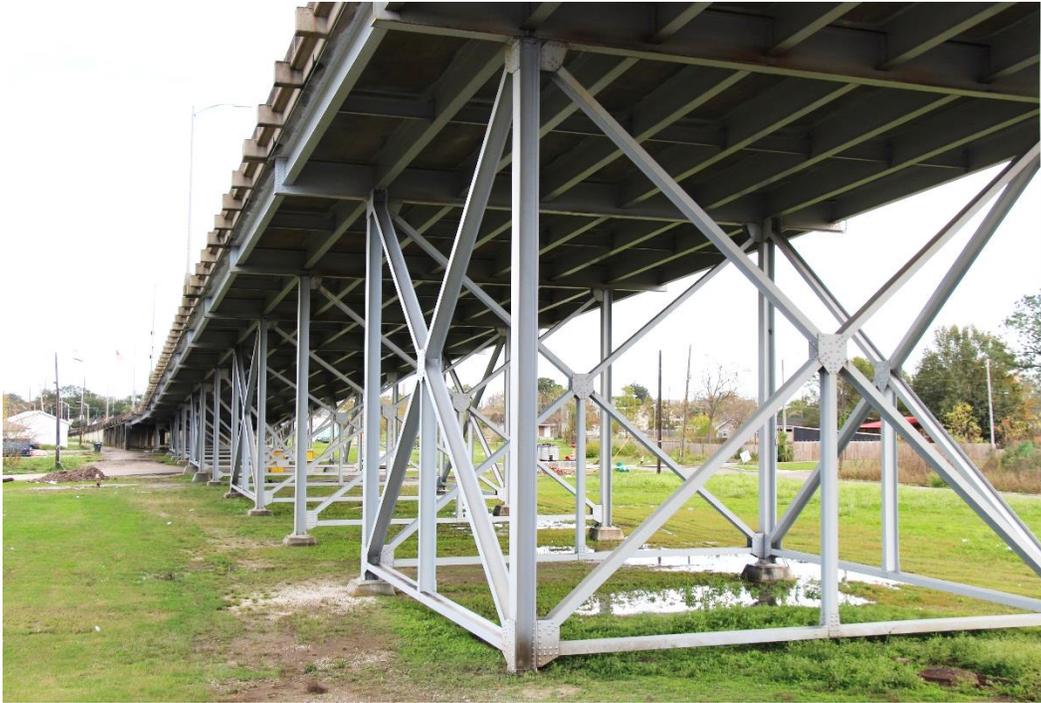
*Condition Photo 17: Easterly approach spans superstructure and bents.*

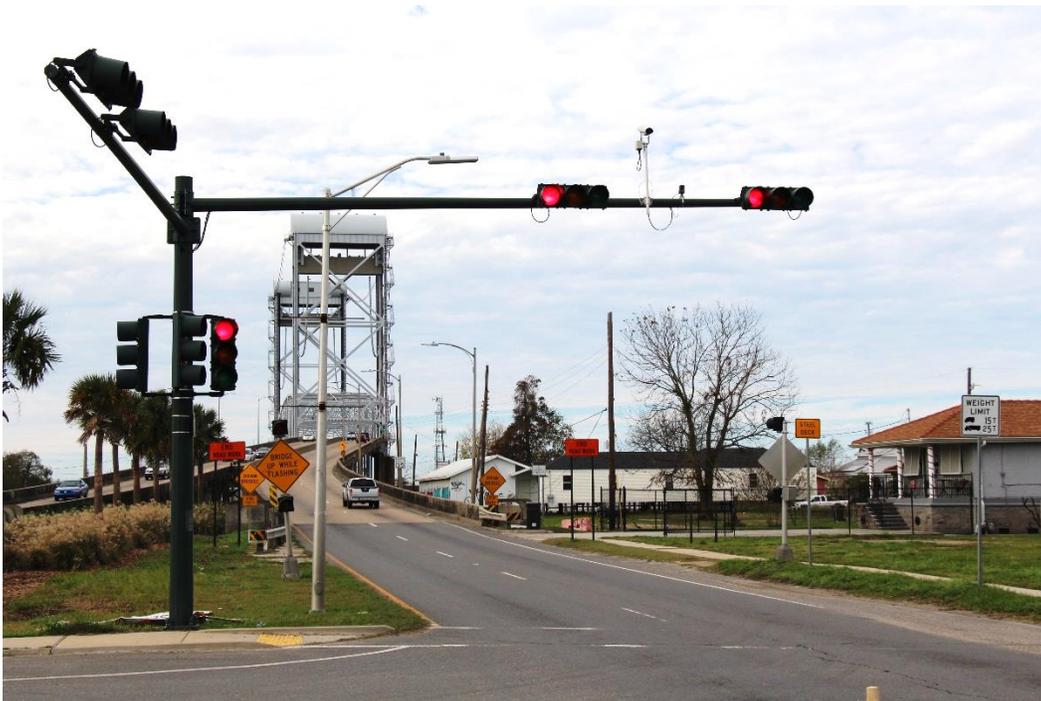
*Condition Photo 18: Signalized intersection at east end of bridge, looking west. Note weight limit sign 15T-25T, and note signals, signing, and traffic control devices, all in good condition. The approach roadway is to Recall No. 020378, which is not covered under this Plan, but is contiguous with Recall No. 020375.*

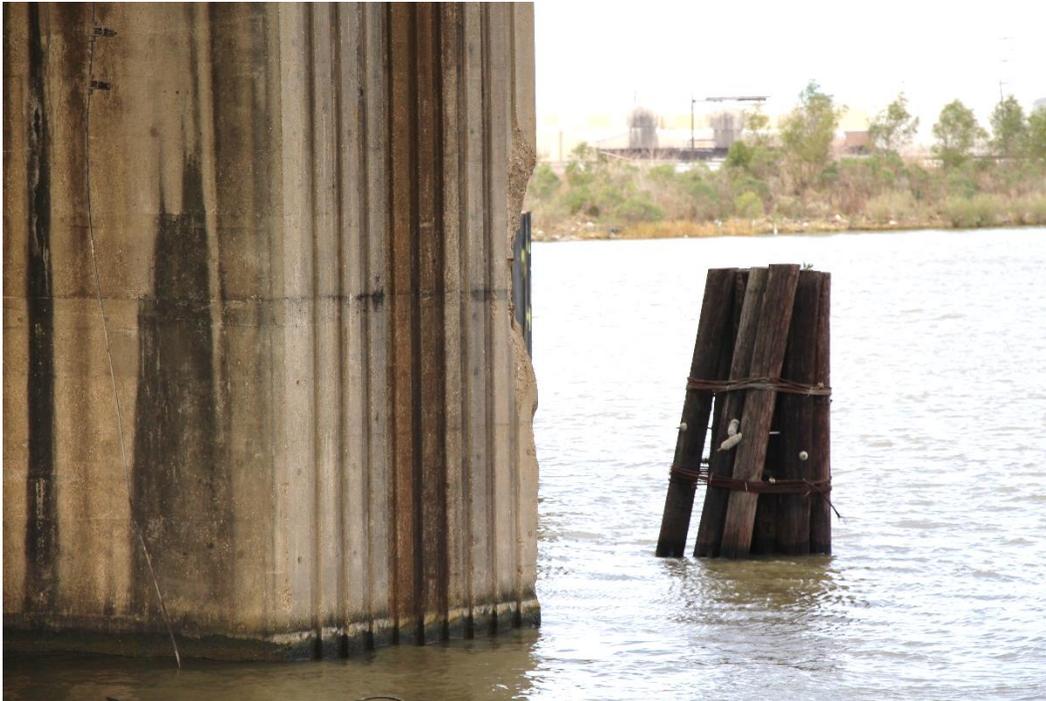
*Condition Photo 19: Spalled concrete and exposed rebar at northeast corner of east tower pier.*

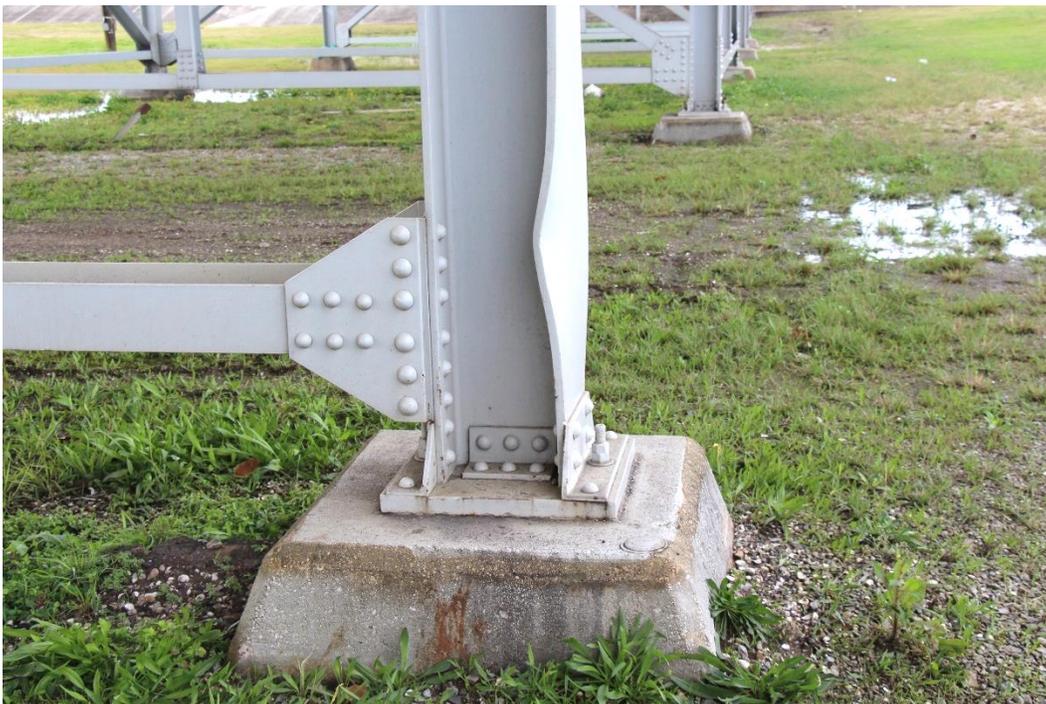
*Condition Photo 20: Bent 16, north Column 1 at Jourdan Avenue has collision damage.*

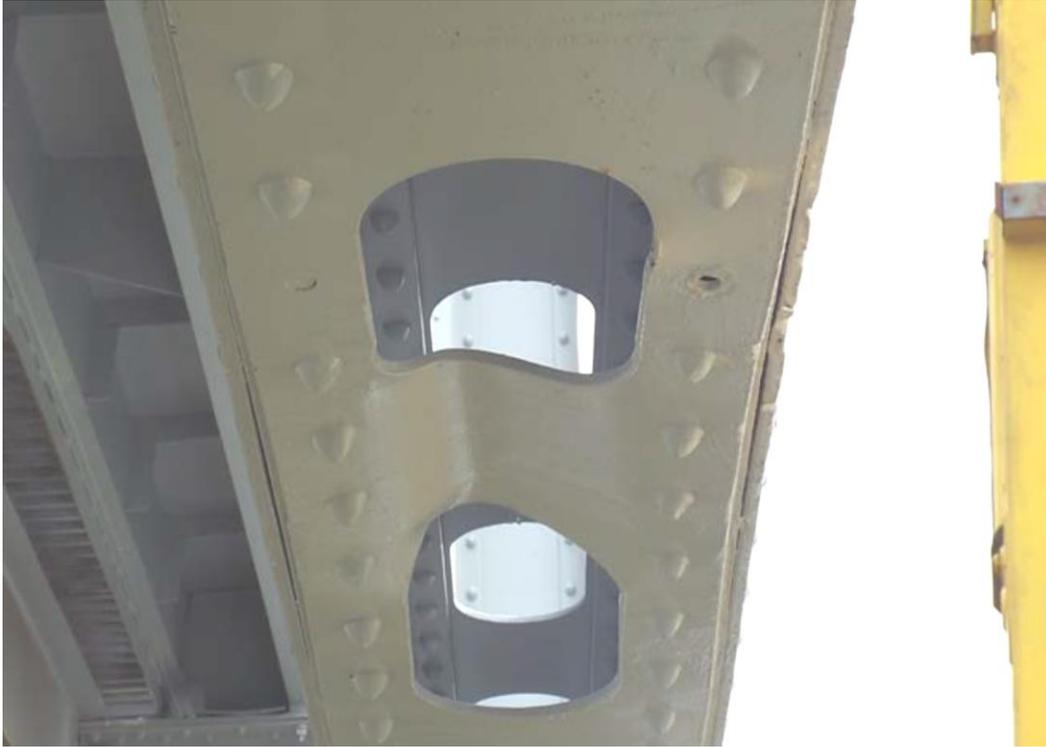
*Condition Photo 21: Right side of lift span bottom chord at Floorbeam 7 has collision damage and is missing two rivets. Photo courtesy of the LADOTD.*

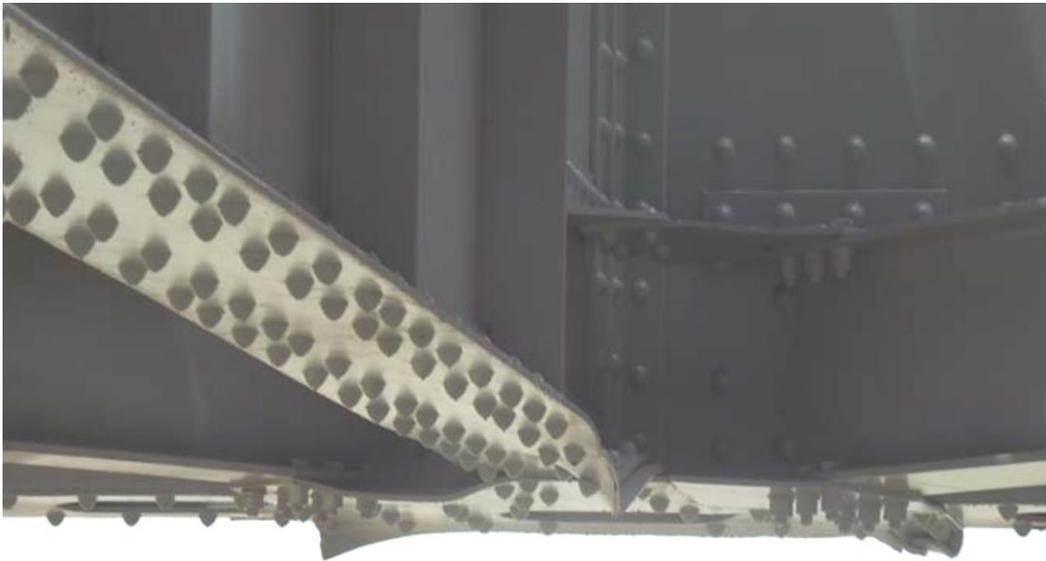
*Condition Photo 22: Floorbeam 7 of the lift span left and right side has collision damage. Photo courtesy of the LADOTD.*

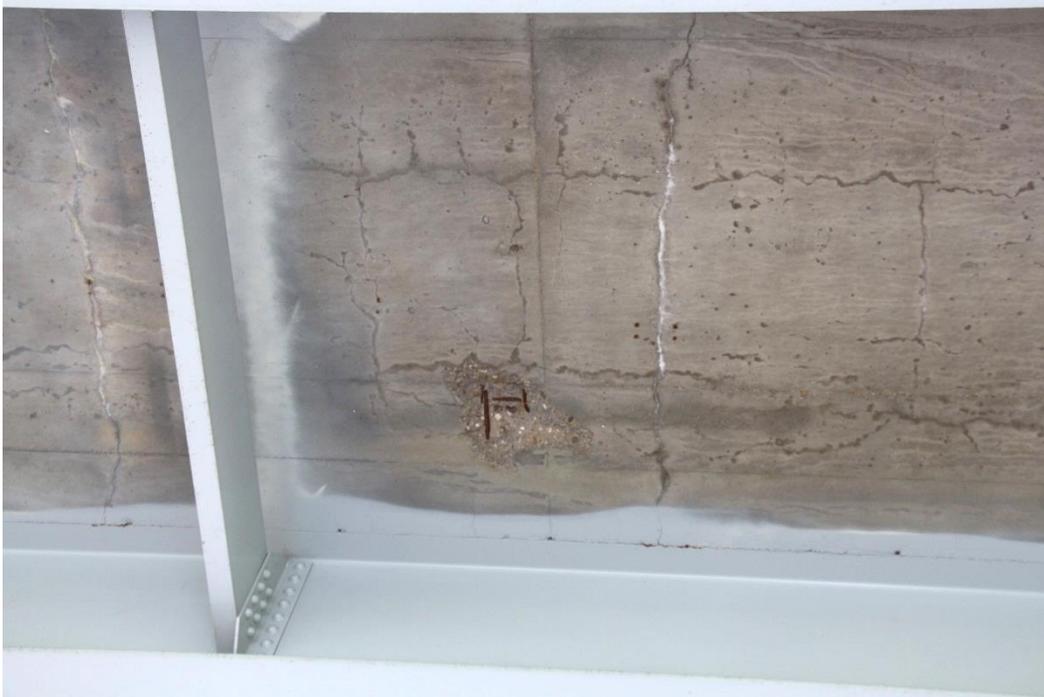
*Condition Photo 23: Spalls with exposed rebar in middle of concrete deck on the underside, typical in Spans 17 to 20.*

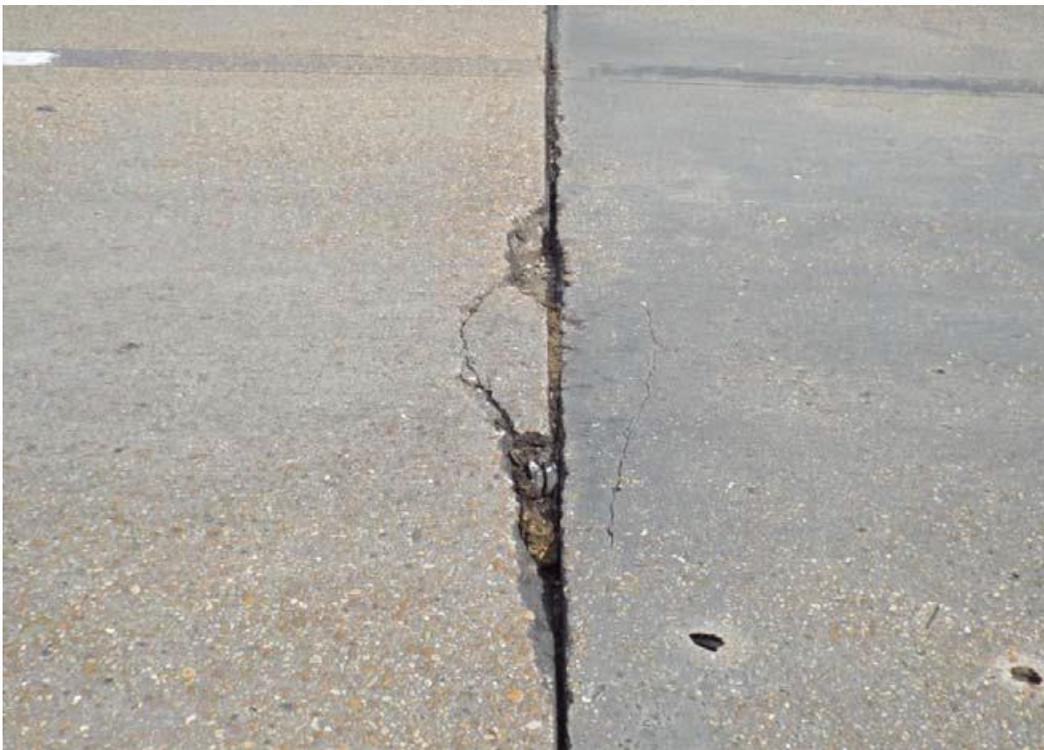
*Condition Photo 24: Deck joint seals are failing and minor spalls are developing at the joints in the easterly approach spans.*
