# Historic Bridge Management Plan for the Bobtown Bridge

**Recall Number: 200868**

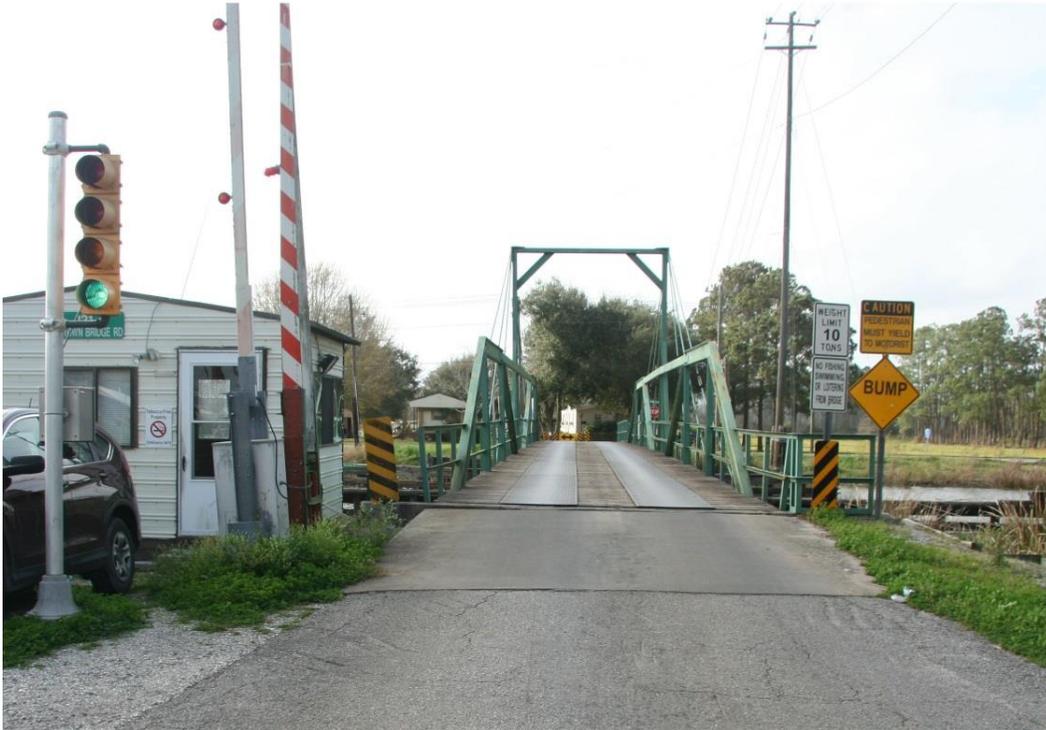
*Condition Photo 1: East approach roadway to bridge.*

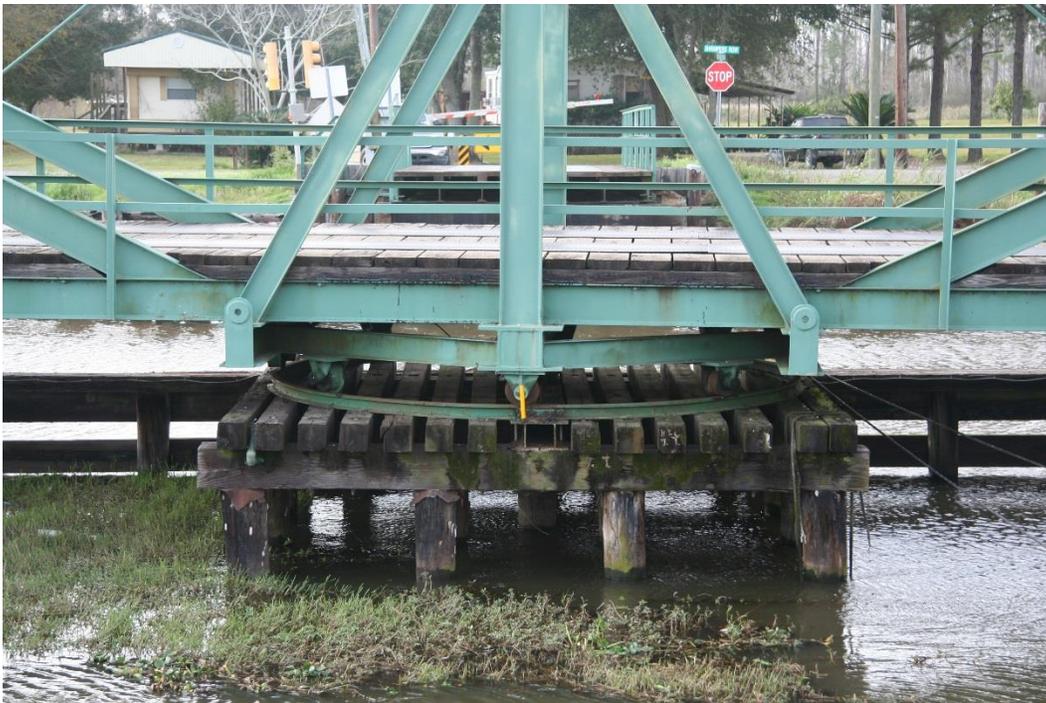
*Condition Photo 2: Center pivot mechanism and pivot pier.*

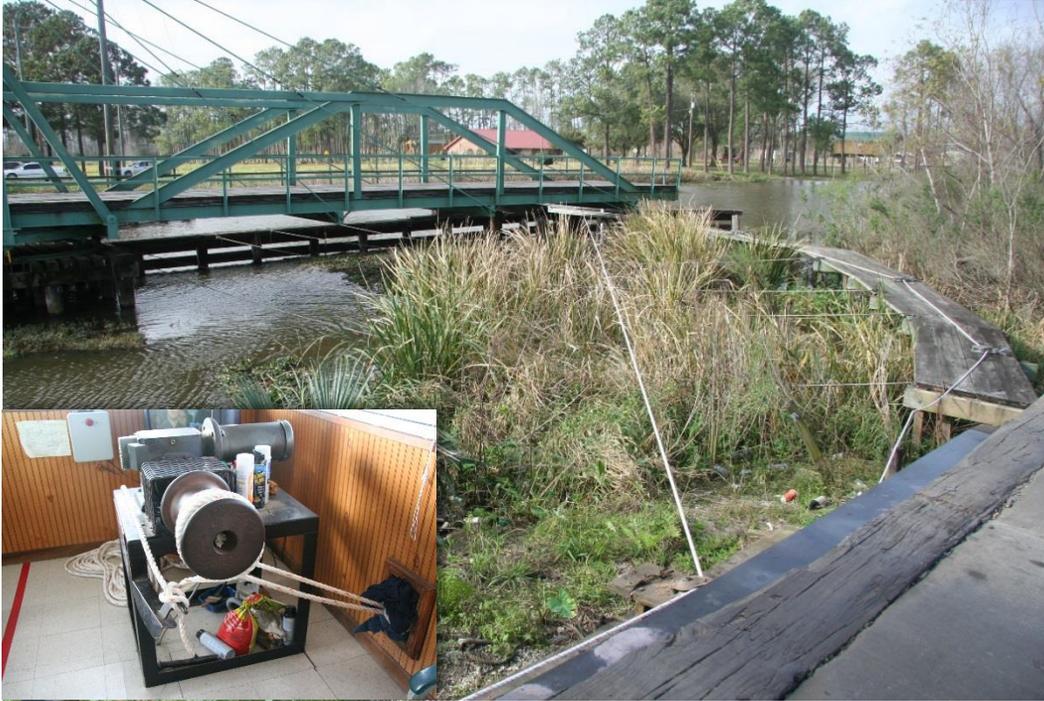
*Condition Photo 3: Rope and pulley system on a timber platform, which guides the bridge as it opens and closes. Inset: Motorized winch inside the operator's house.*

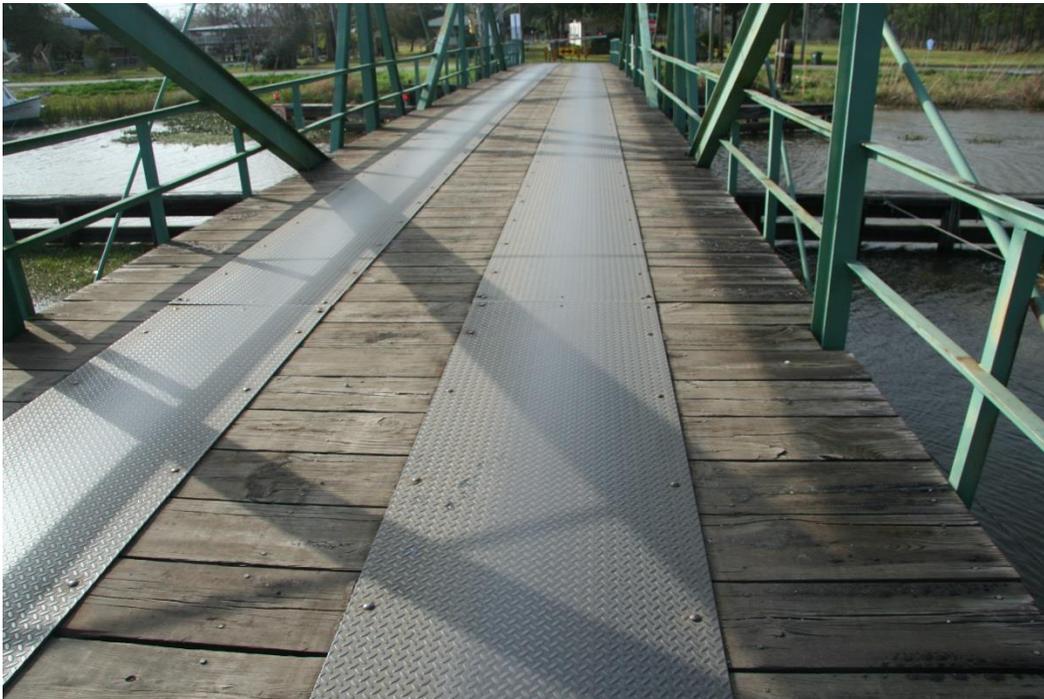
*Condition Photo 4: Deck (steel running plates and timber planks) on swing span.*

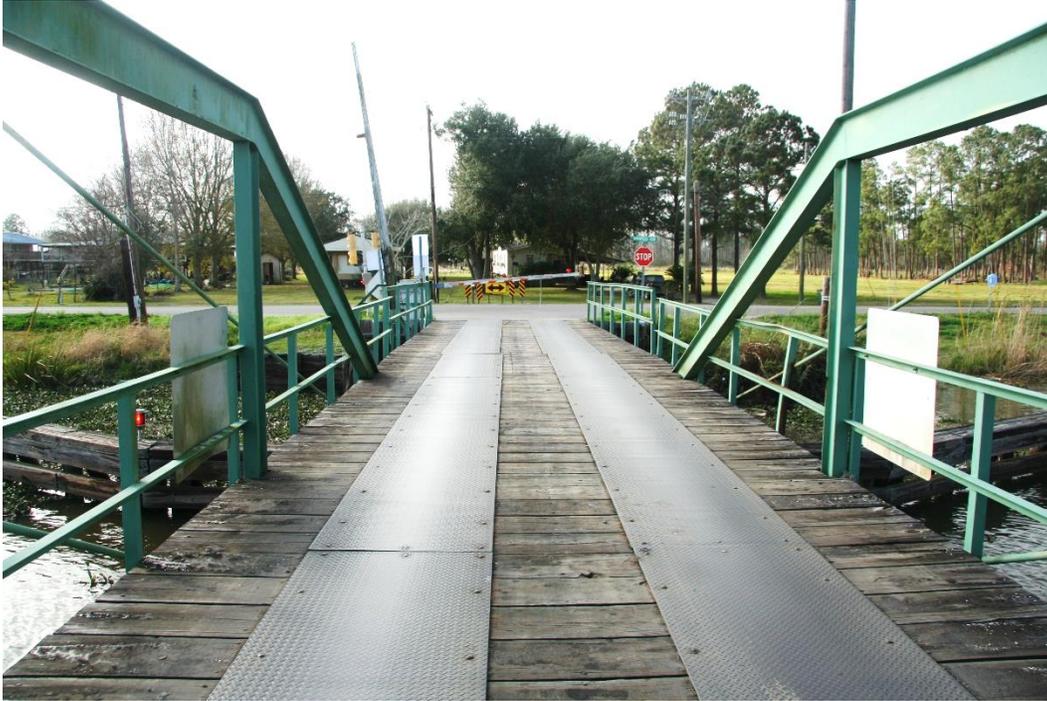
*Condition Photo 5: Looking across the bridge to the west intersection with Shrimpers Row.*

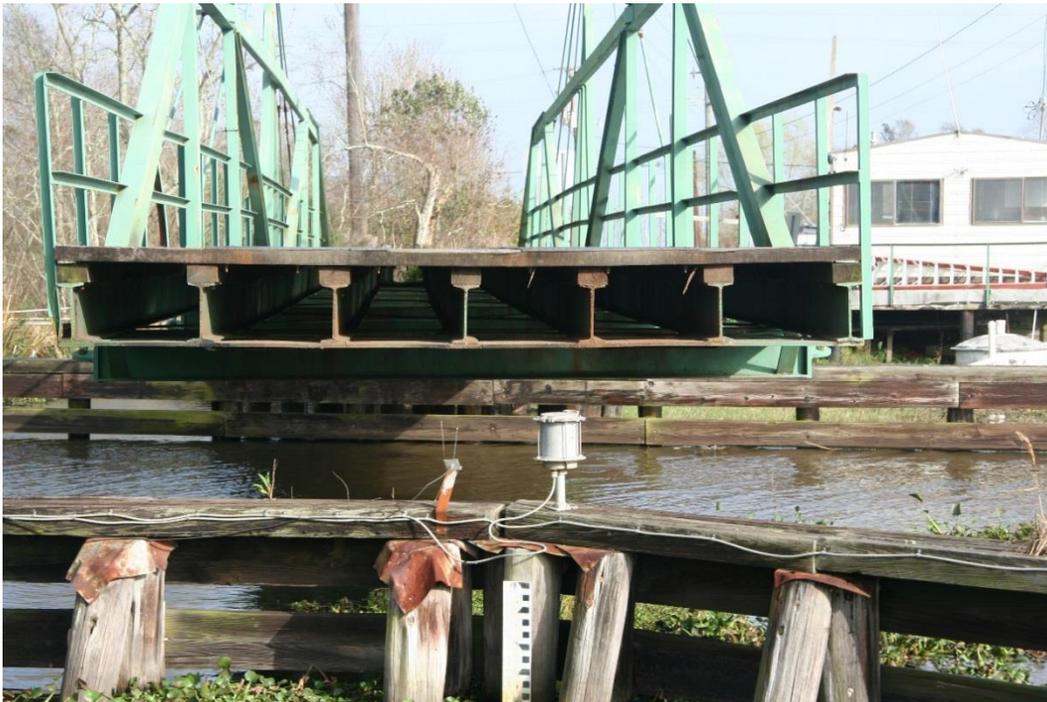
*Condition Photo 6: Swing span deck cross section, shown while the bridge is opening.*

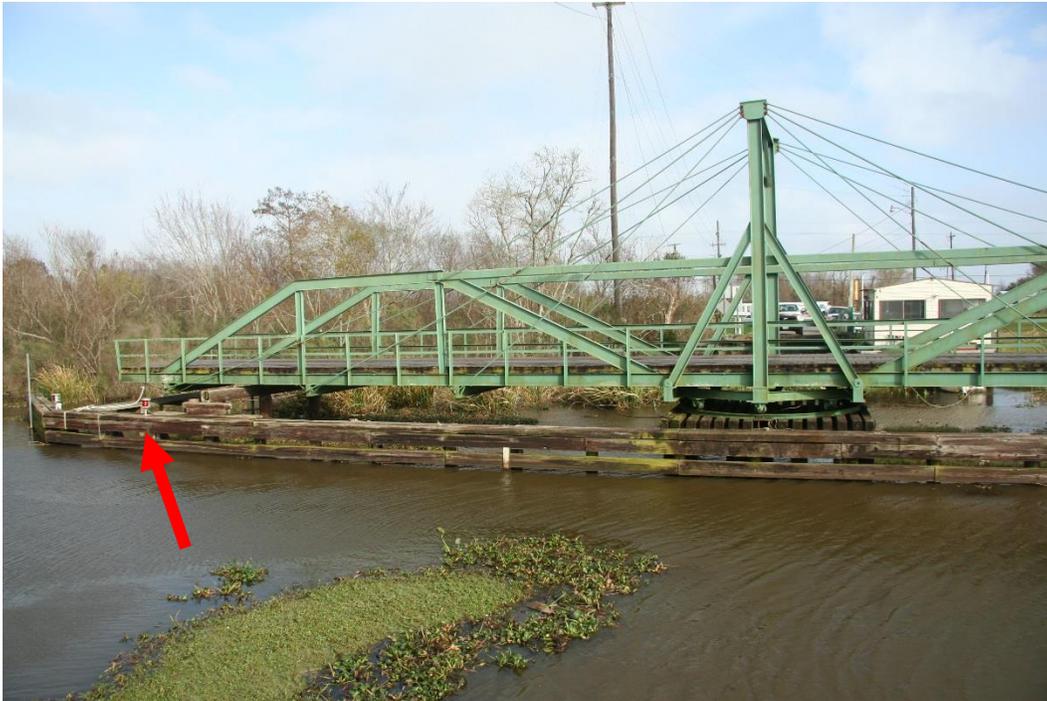
*Condition Photo 7: Timber fender system.*

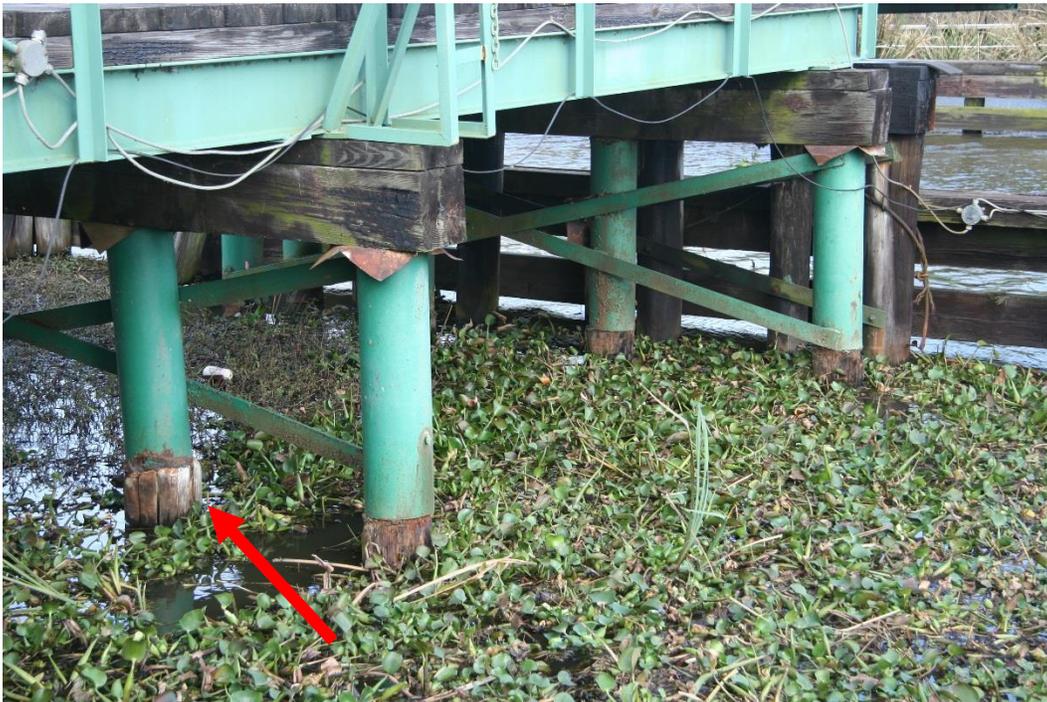
*Condition Photo 8: West approach span superstructure and substructure. Note deteriorated condition of timber piles and metal circular jackets for pile splices.*

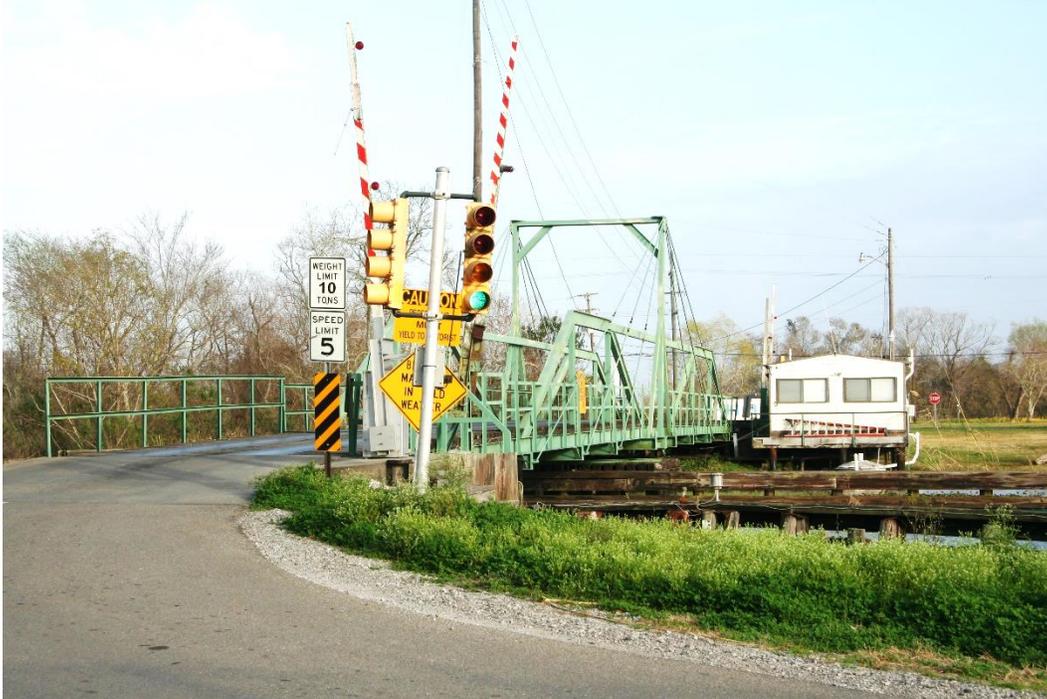
*Condition Photo 9: West approach to the bridge. Note traffic gates and signals and signage.*

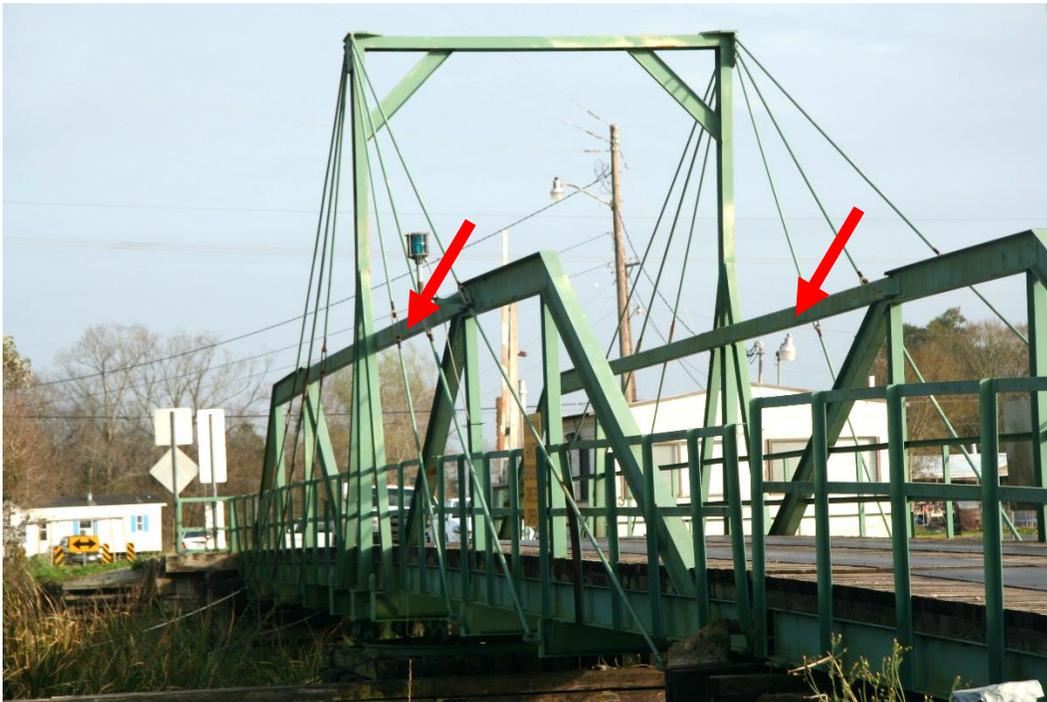
*Condition Photo 10: Profile of swing span. Horizontal top chord members on each truss are new from 2001 rehabilitation.*

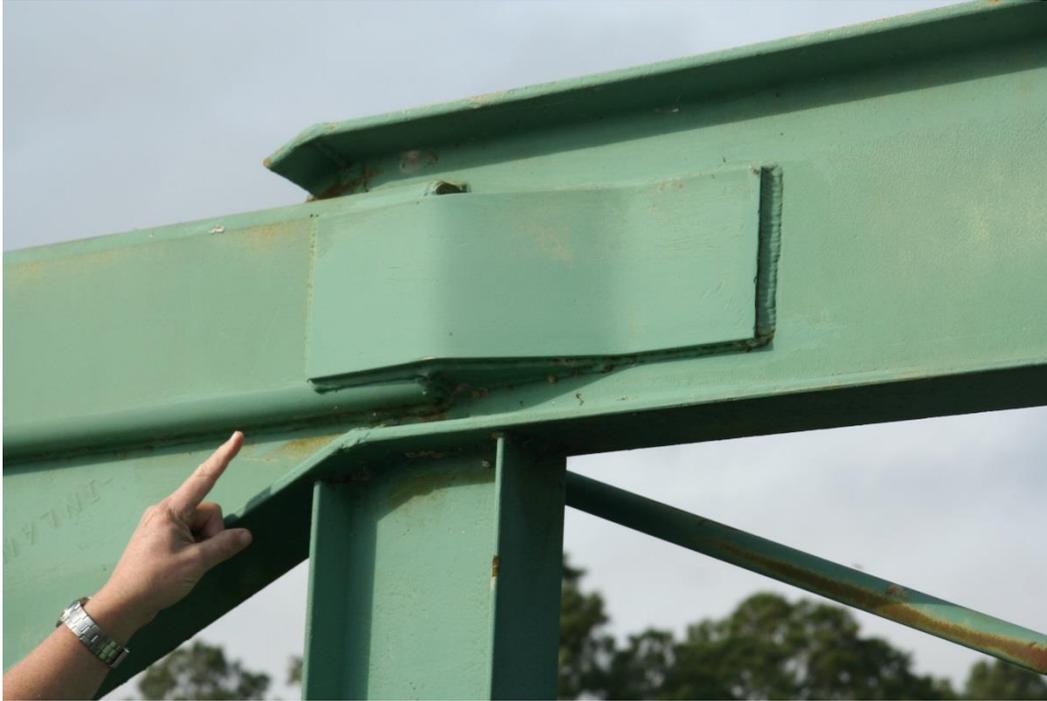
*Condition Photo 11: Close-up of welded connection of horizontal member from 2001 rehabilitation.*

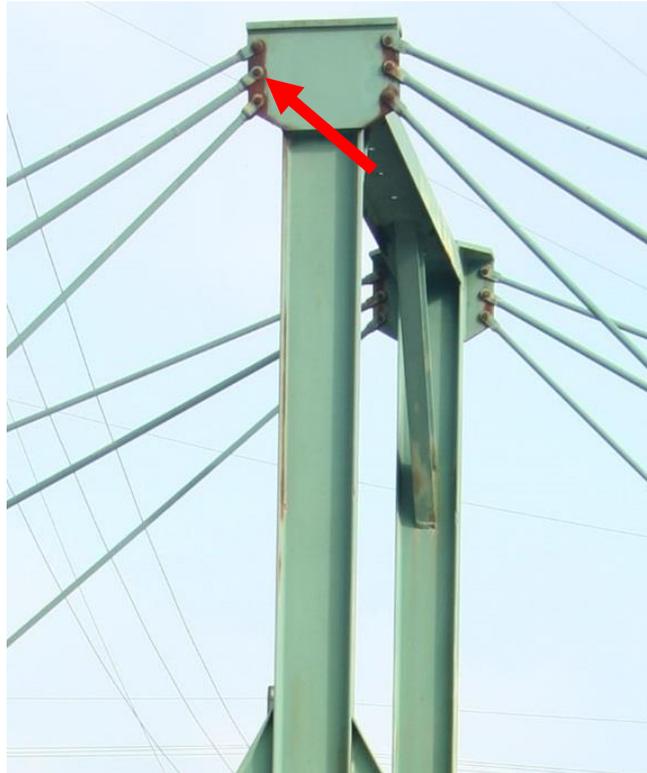
*Condition Photo 12: Condition of stay-cable attachments at top of tower in middle of swing span.*

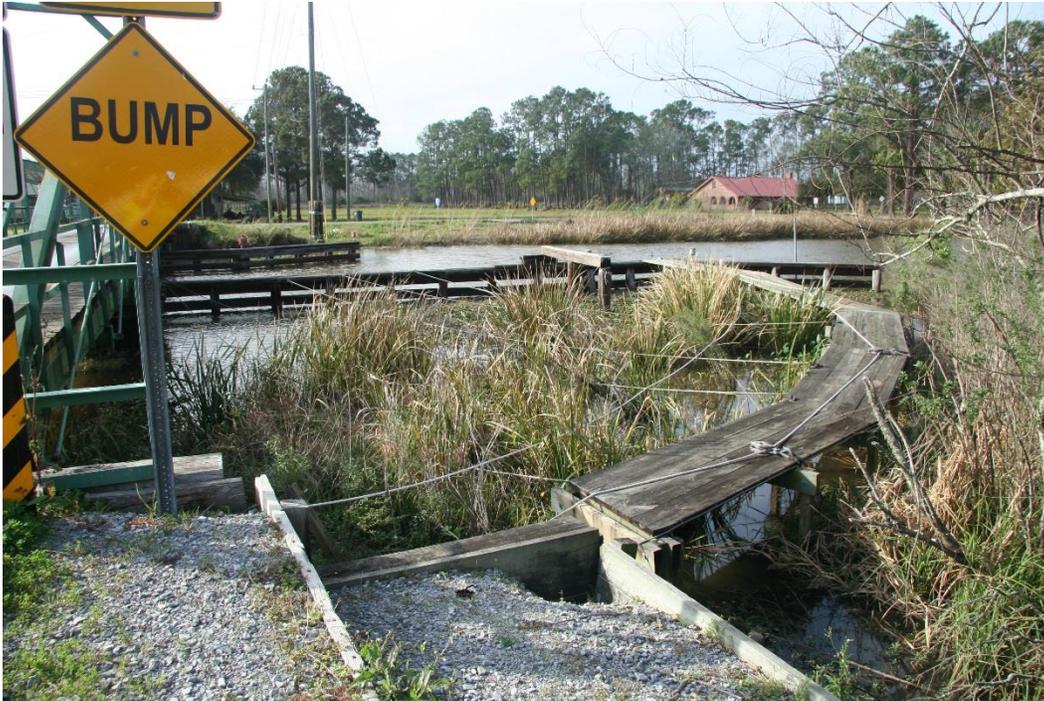
*Condition Photo 13: Condition of timber stairway and gravel path to access timber plank platform for the ropes and pulleys of the bridge operating system.*

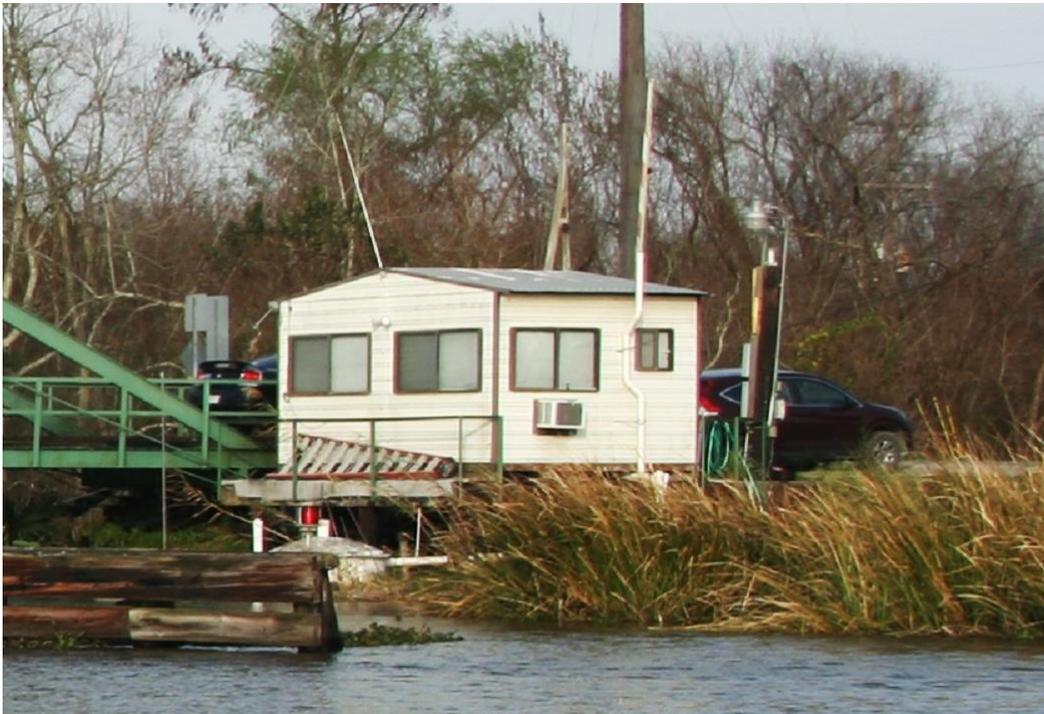
*Condition Photo 14: Operator's house exterior condition.*

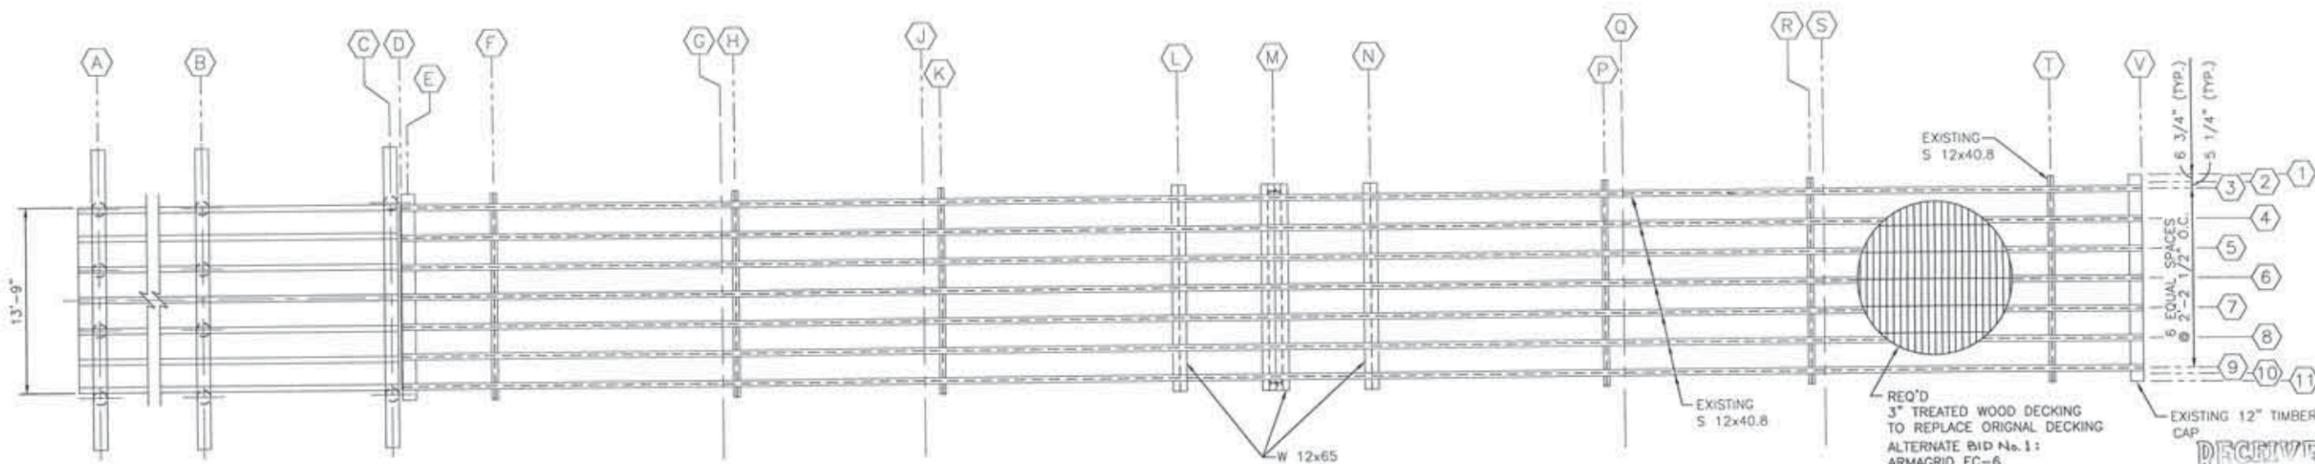
**PLAN**  
SCALE: 3/16"=1'-0"
