Historic Bridge Management Plan for the Atchafalaya Floodway at US 190 Bridges (Eastbound and Westbound)

Recall Numbers: 007300 and 007310

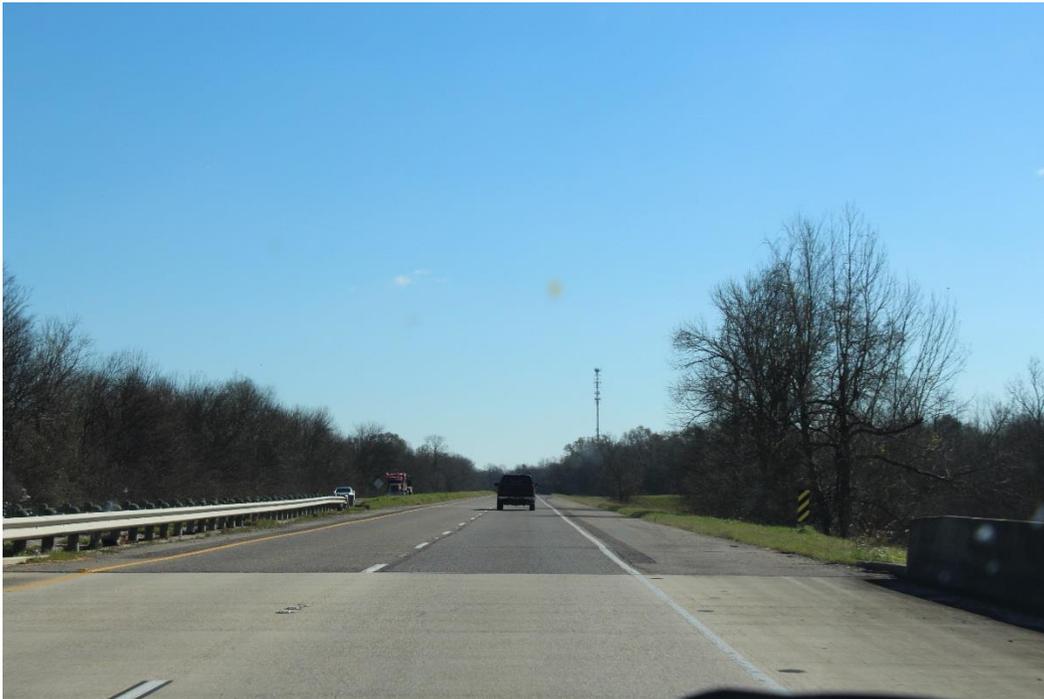
Condition Photo 1: West roadway approach looking east.

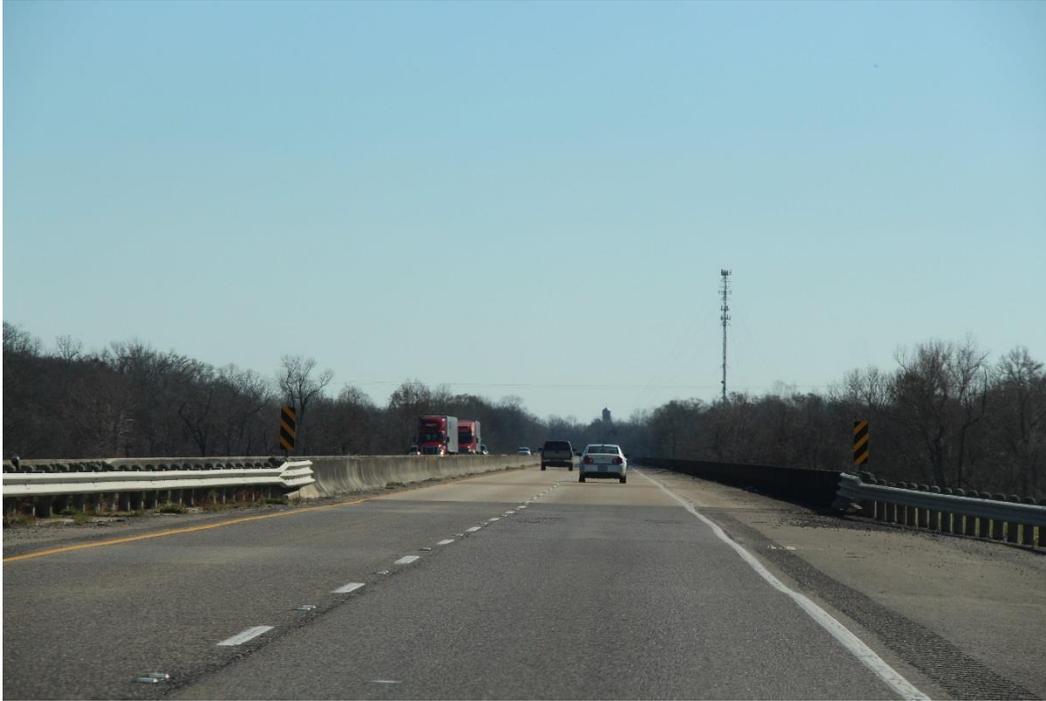
Condition Photo 2: East roadway approach looking east.

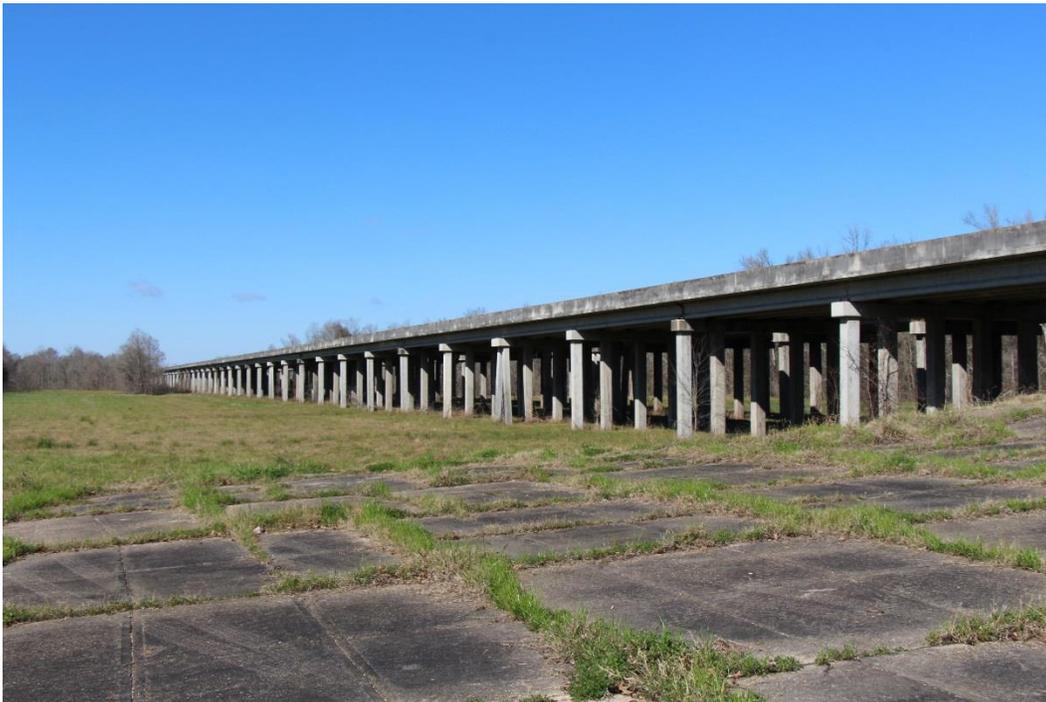
Condition Photo 3: Elevation view looking west.

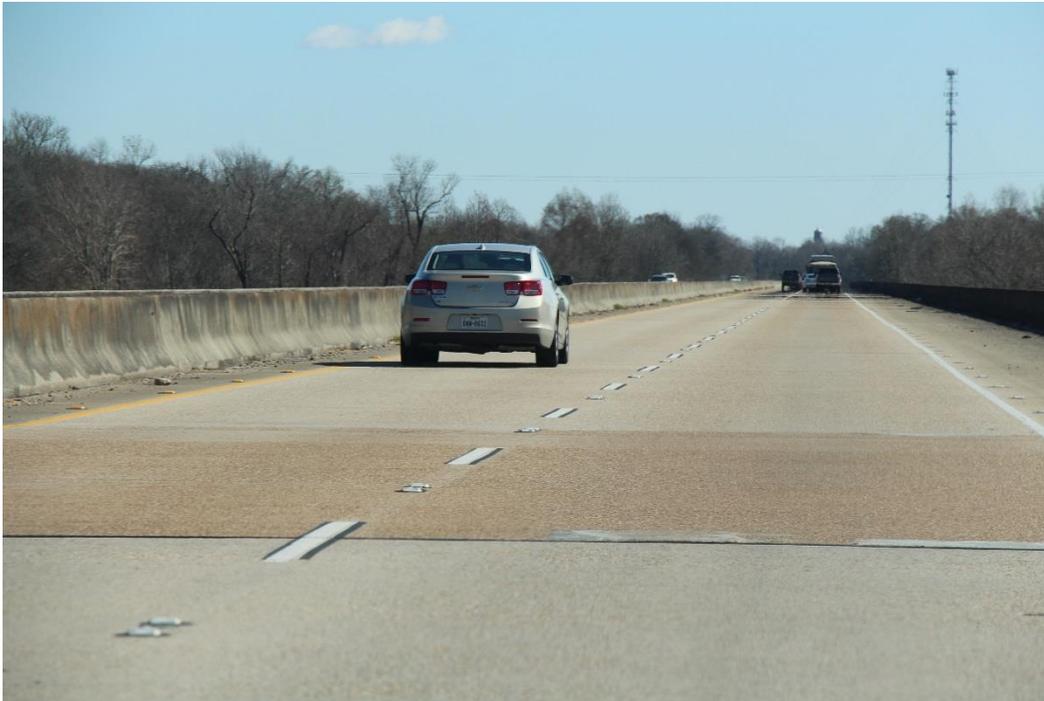
Condition Photo 4: Typical top of deck roadway surface looking east.

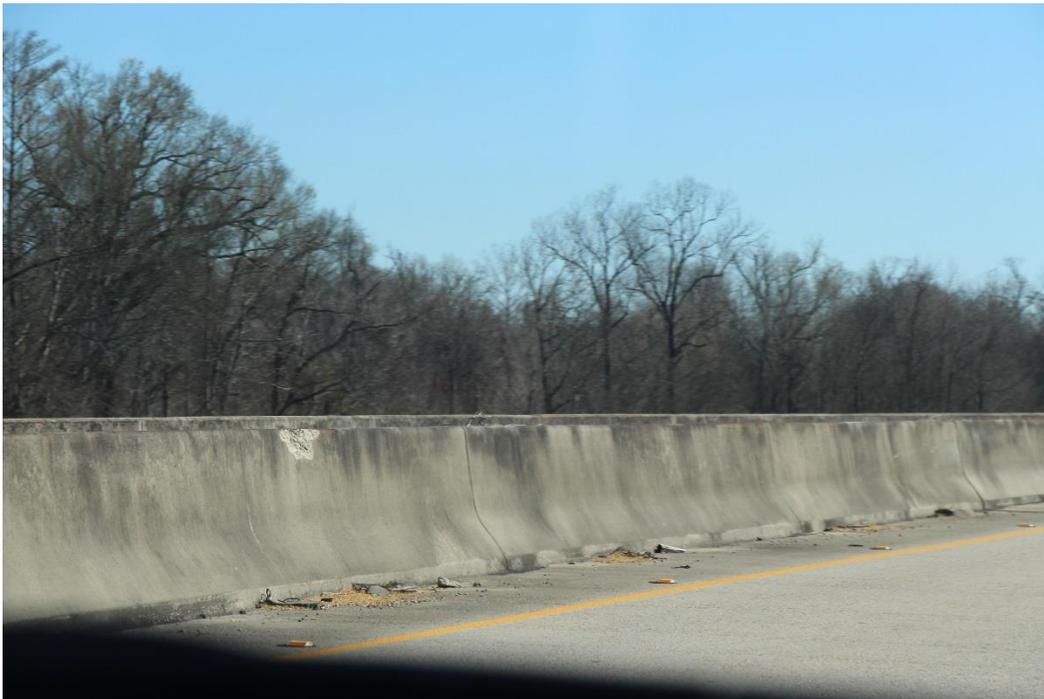
Condition Photo 5: Concrete spall on barrier and typical debris on shoulder.

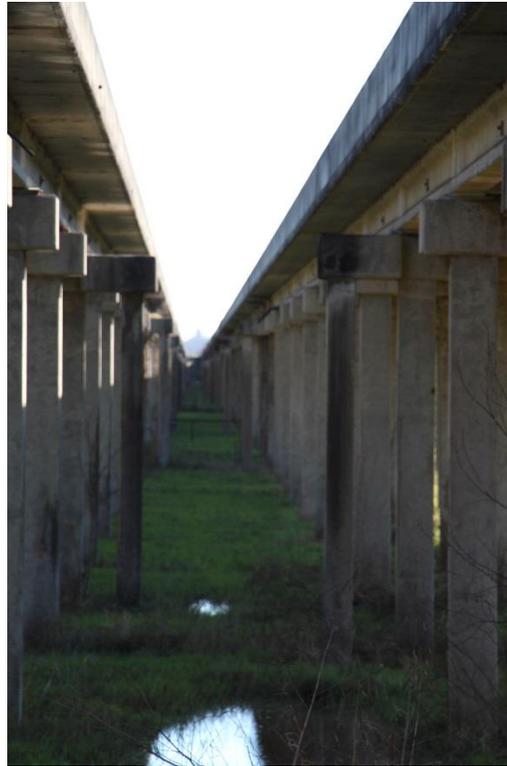
Condition Photo 6: Elevation of bents from between the two bridges showing the extension of the bents for both bridges.

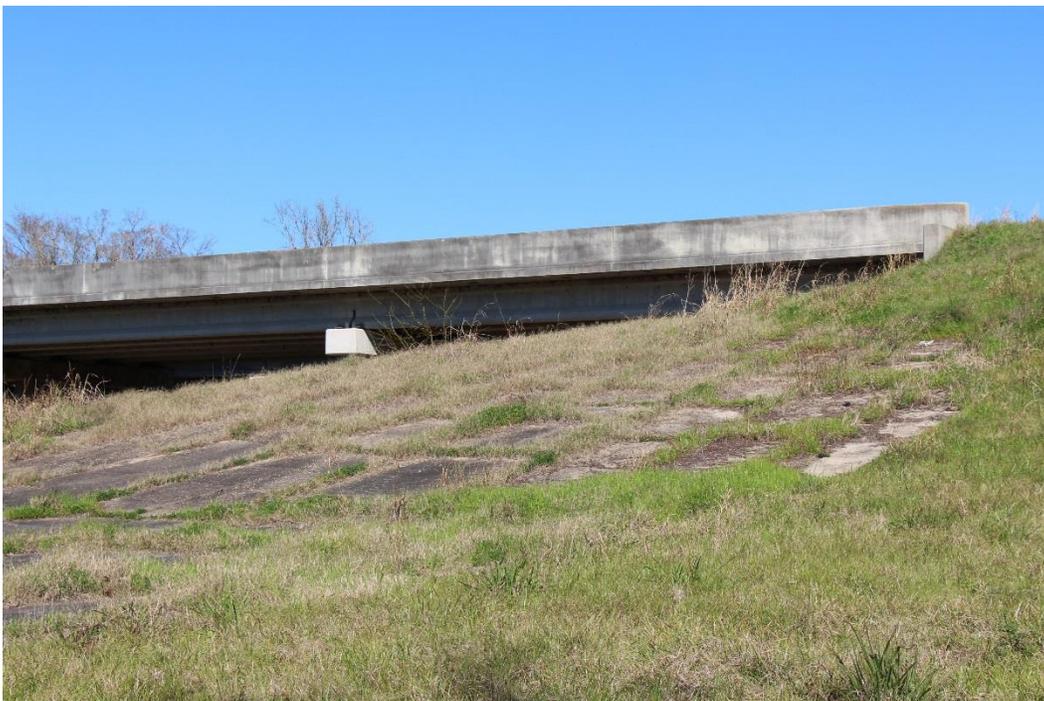
Condition Photo 7: Typical vegetation growth on the concrete slope protection.

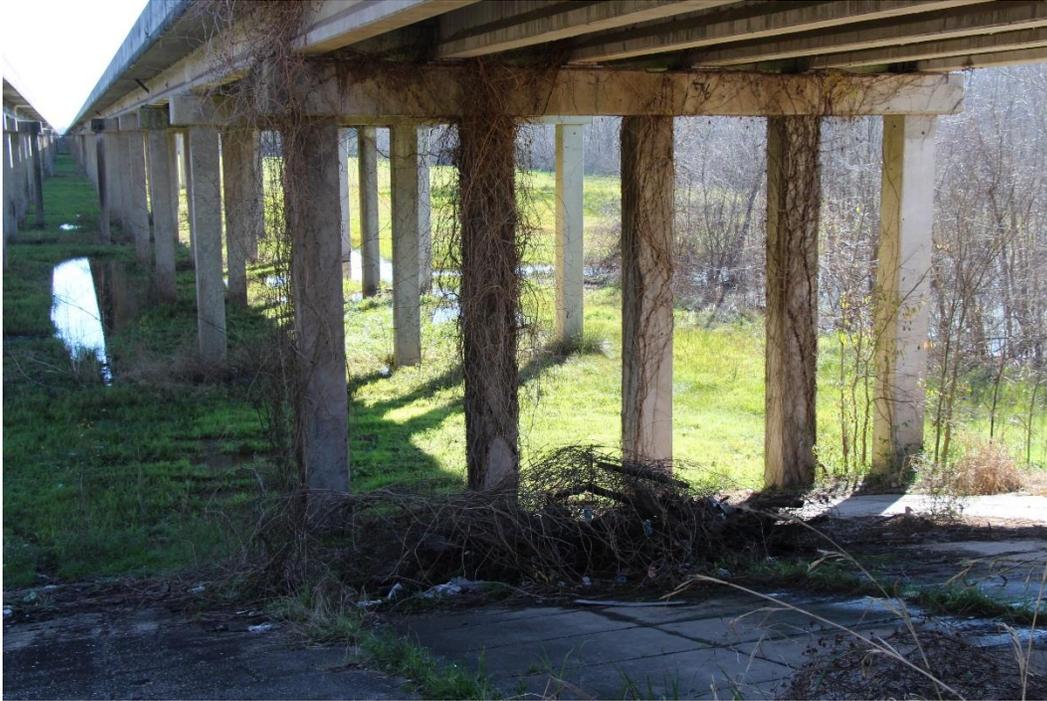
Condition Photo 8: Typical vegetation growth on the substructure units and part of the superstructure.

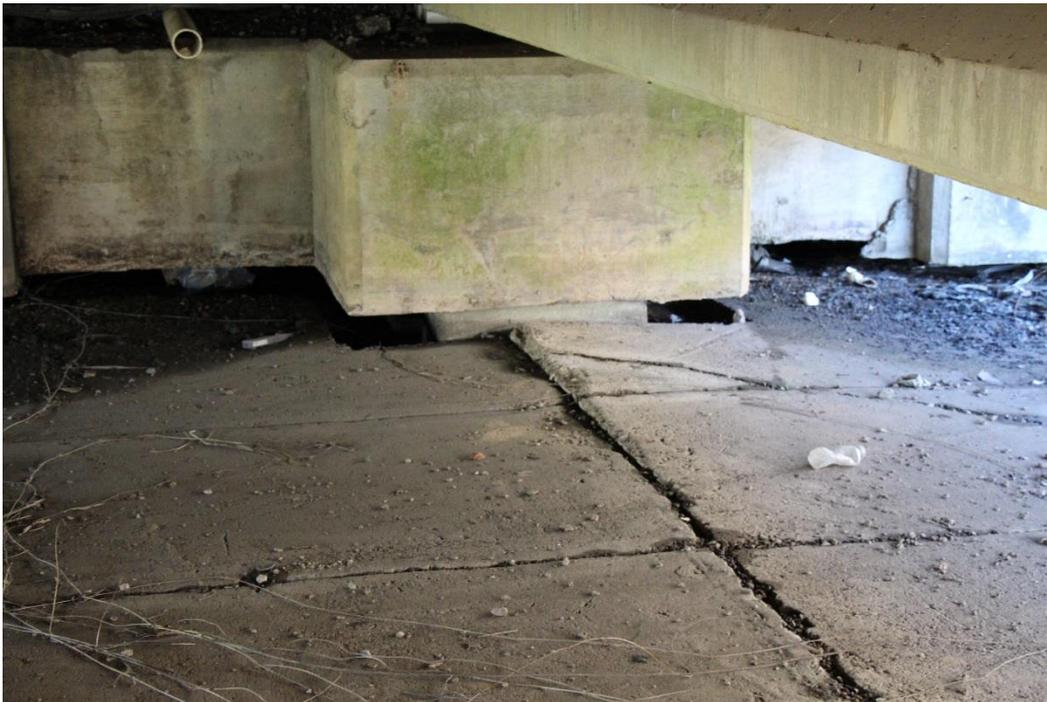
Condition Photo 9: Erosion and exposed precast concrete pile at end bent 1 and failed concrete slope protection.

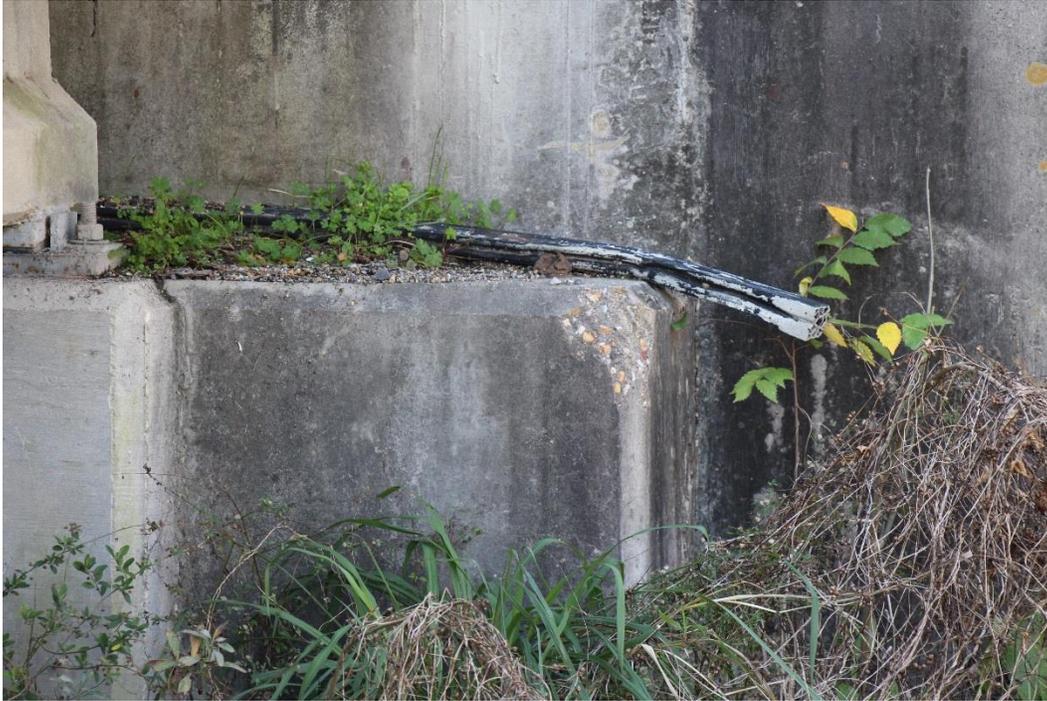
Condition Photo 10: Debris and vegetation on the end bent 1 seat and the failed compression seal strip.

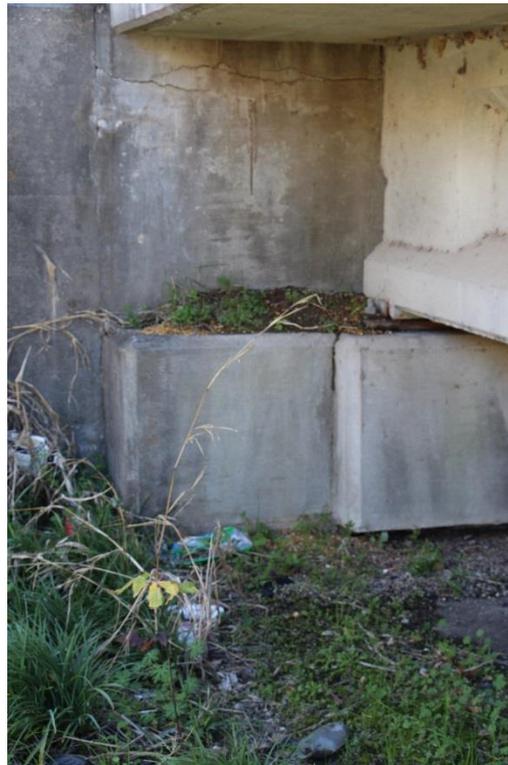
Condition Photo 11: Horizontal cracks on the end bent 78 backwall, dirt daubers on the concrete beams, and debris and vegetation on the beam seat.

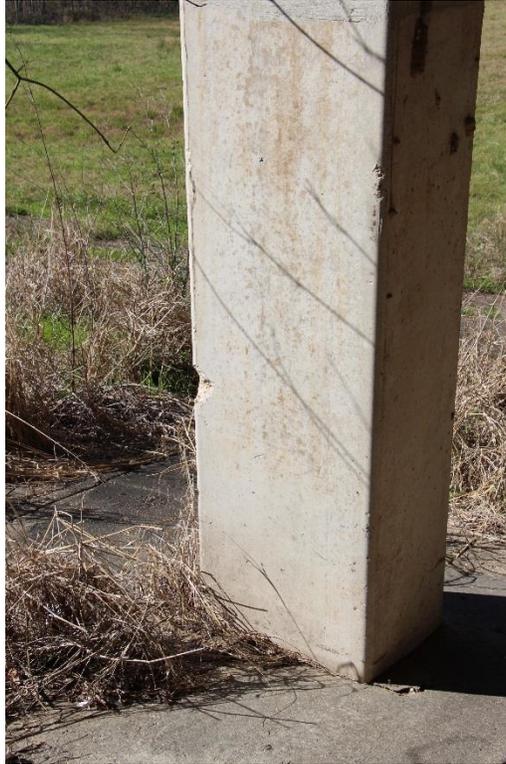
Condition Photo 12: Concrete spall on intermediate precast concrete bent pile.

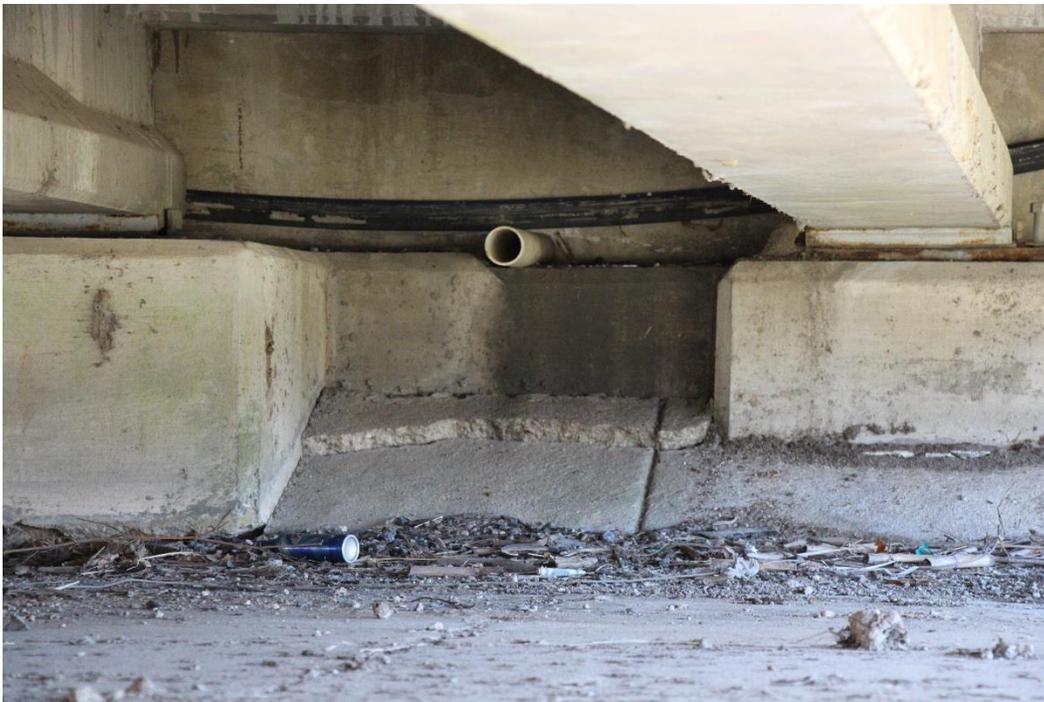
Condition Photo 13: Failed compression joint and failed concrete slope protection.

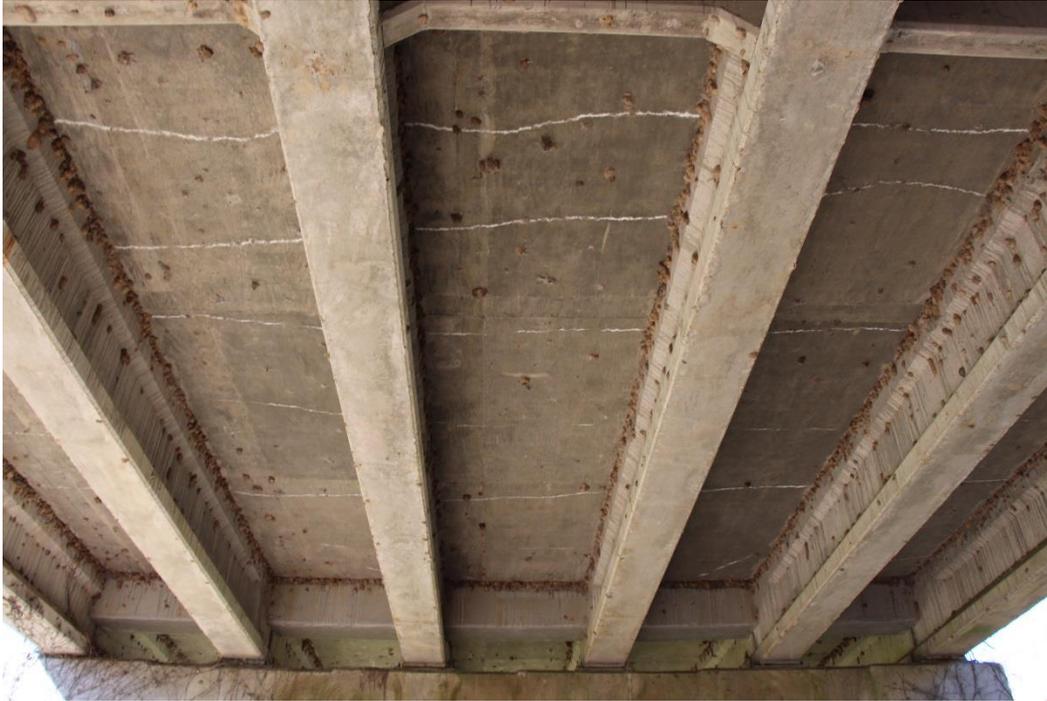
Condition Photo 14: Dirt dauber on the underside of the superstructure and cracking with efflorescence.

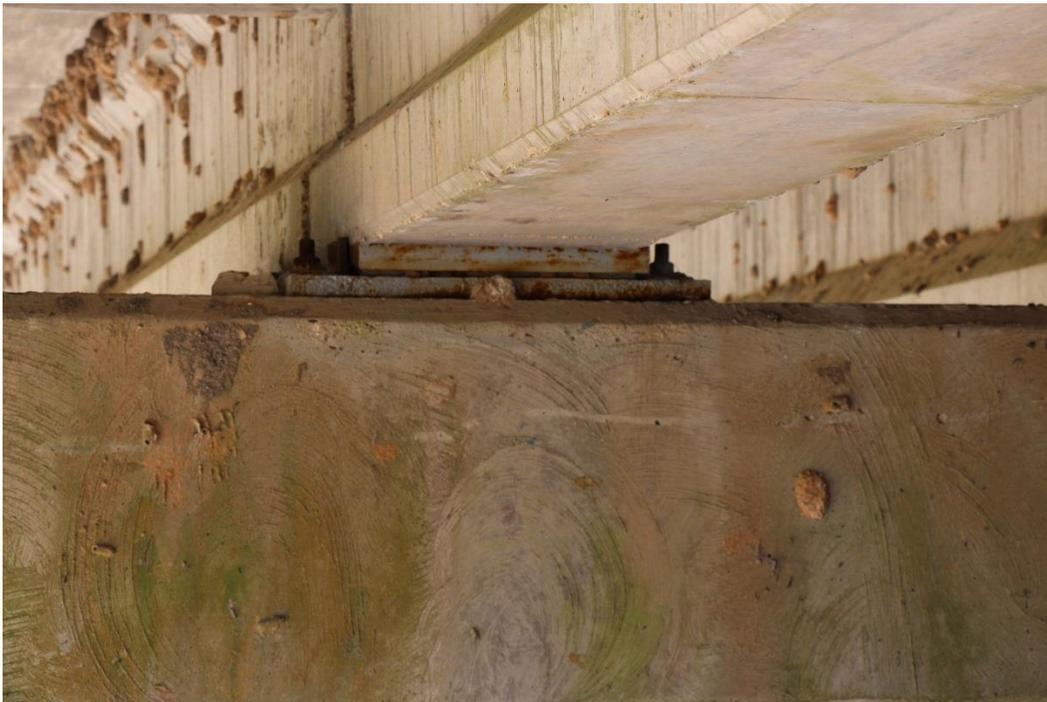
Condition Photo 15: Corrosion on the bearing assembly on the bents, typical.

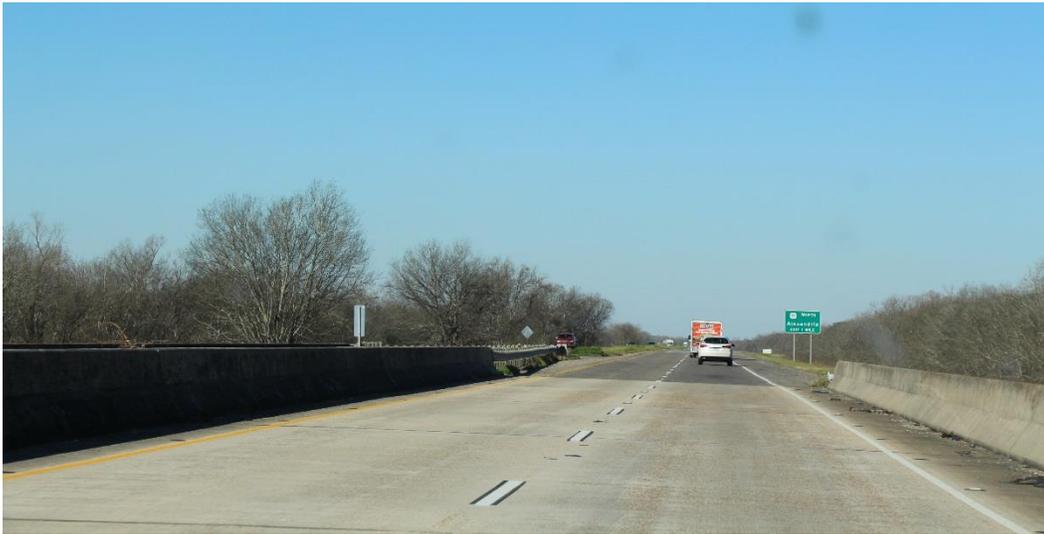
Condition Photo 16: West roadway approach looking west.

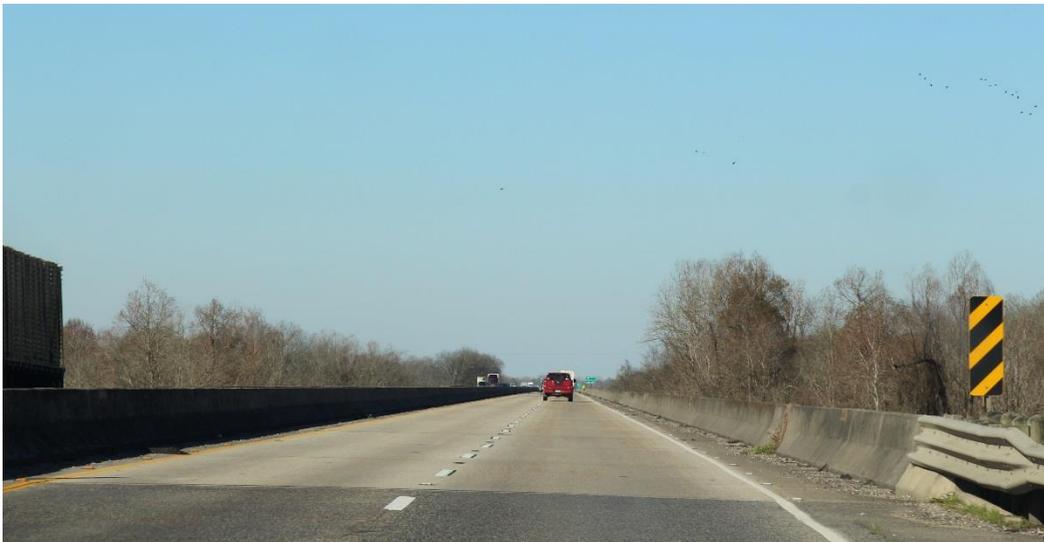
Condition Photo 17: East roadway approach looking west.

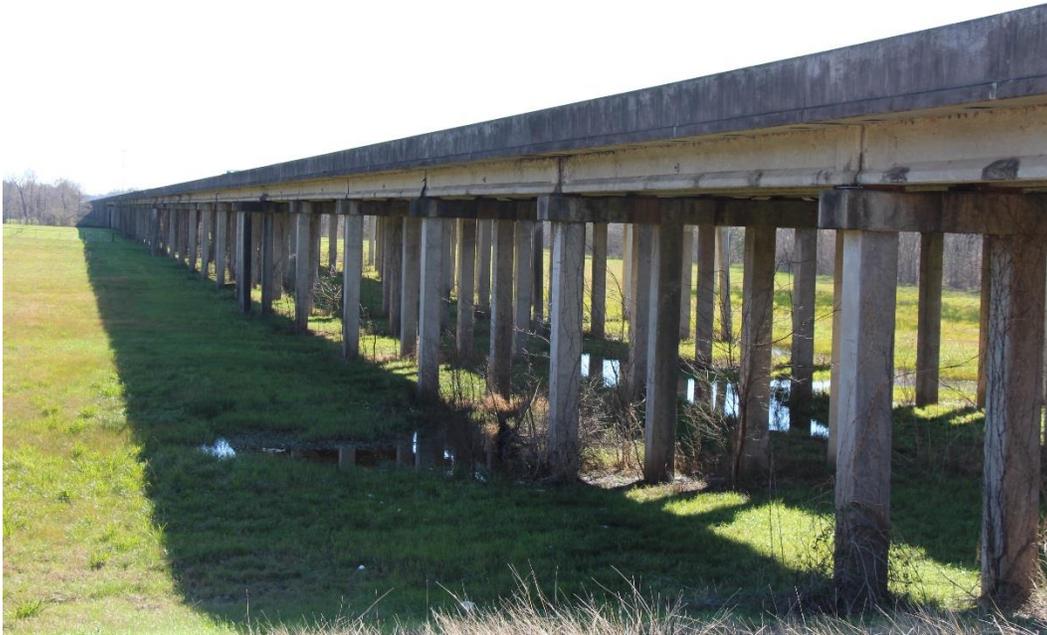
Condition Photo 18: Elevation view looking east.

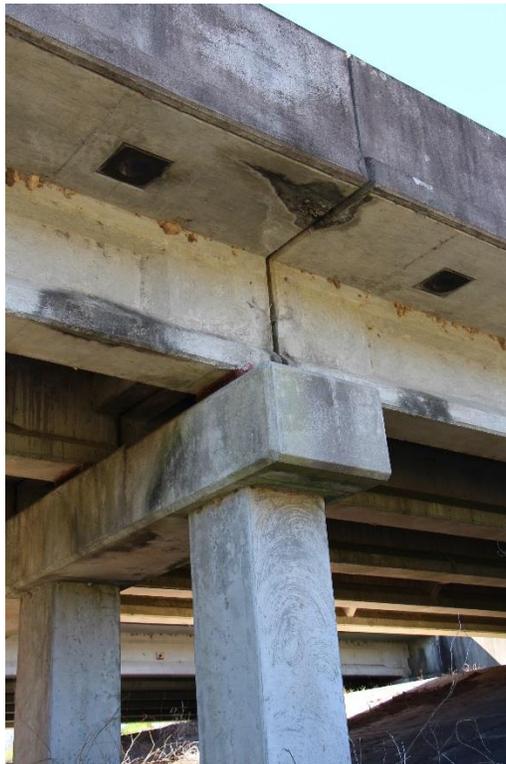
Condition Photo 19: Spall in concrete deck overhang.

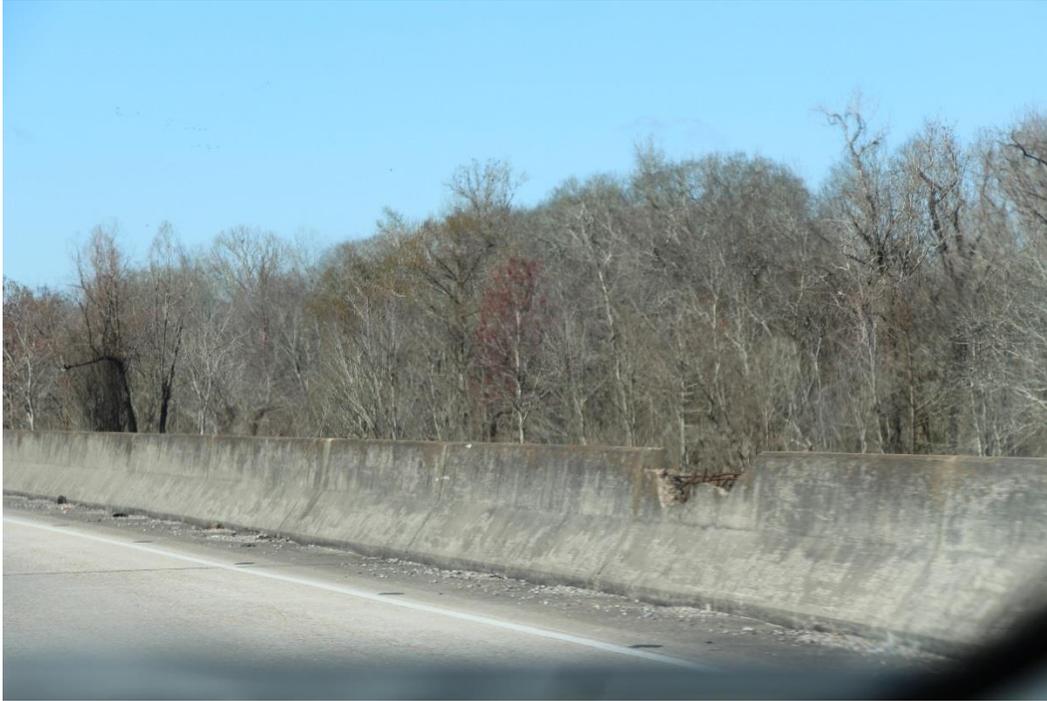
Condition Photo 20: North concrete barrier collision damage with exposed steel.

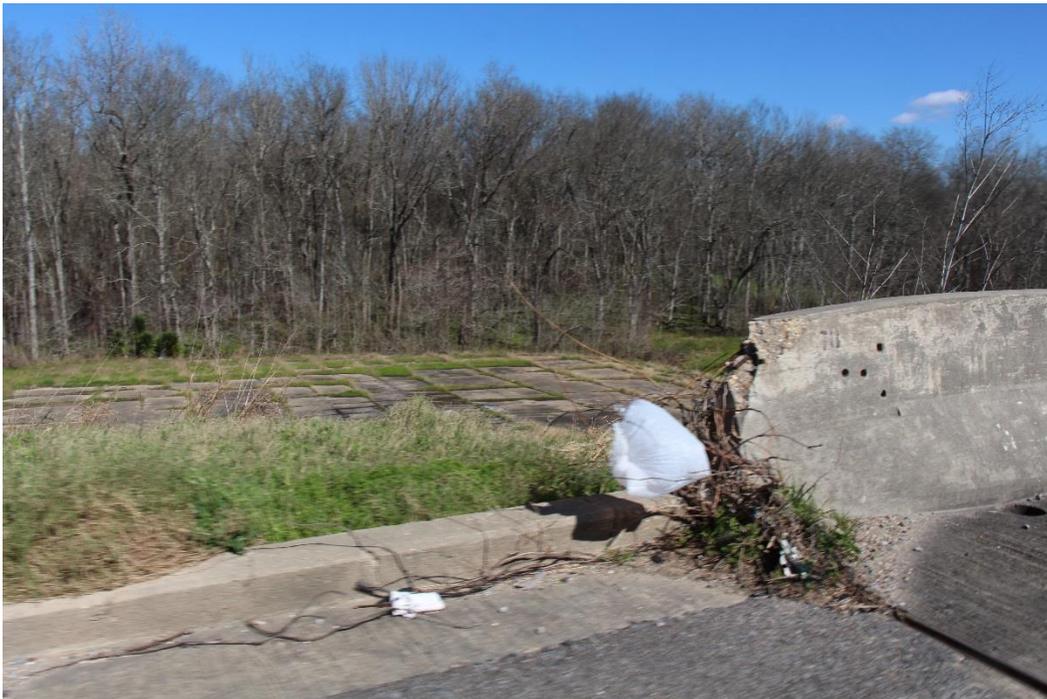
Condition Photo 21: Collision damage and exposed concrete on the barrier terminal wall.

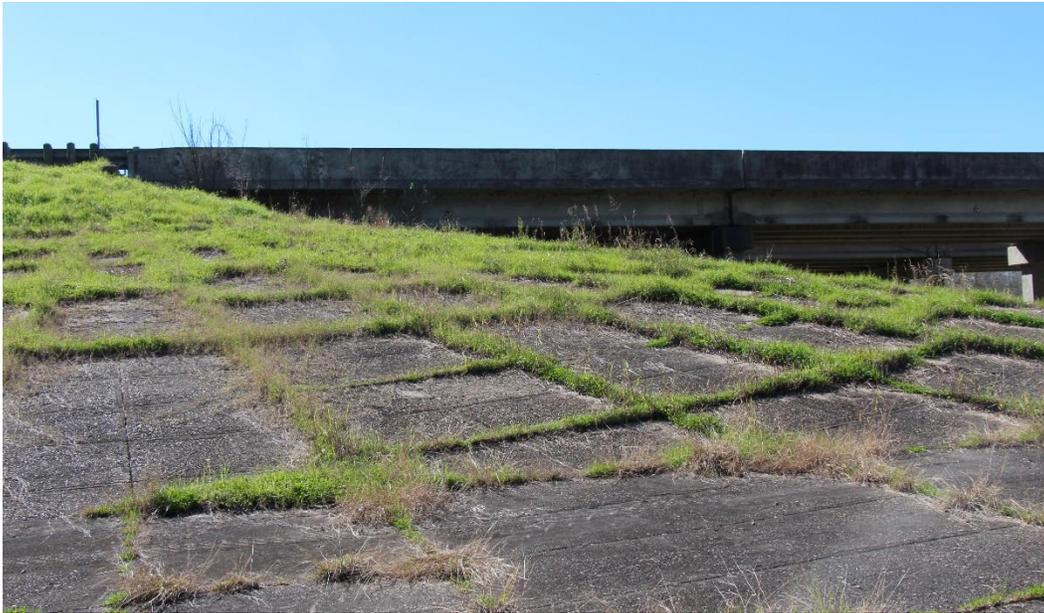
Condition Photo 22: Typical vegetation growth on the concrete slope protection.

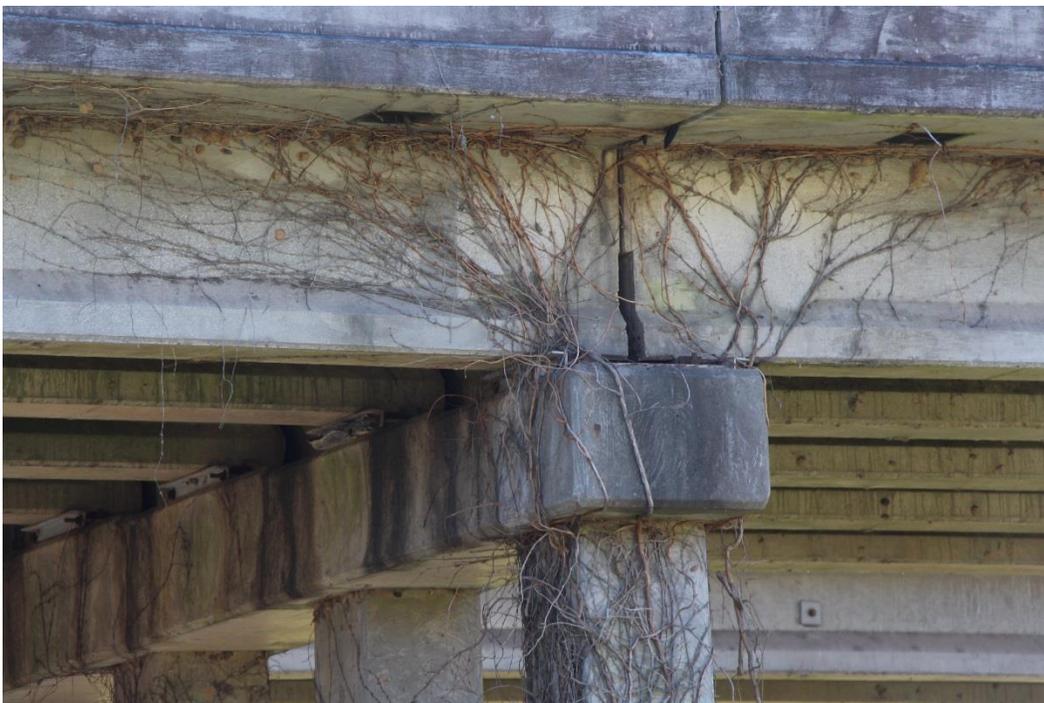
Condition Photo 23: Typical vegetation growth on the substructure units.

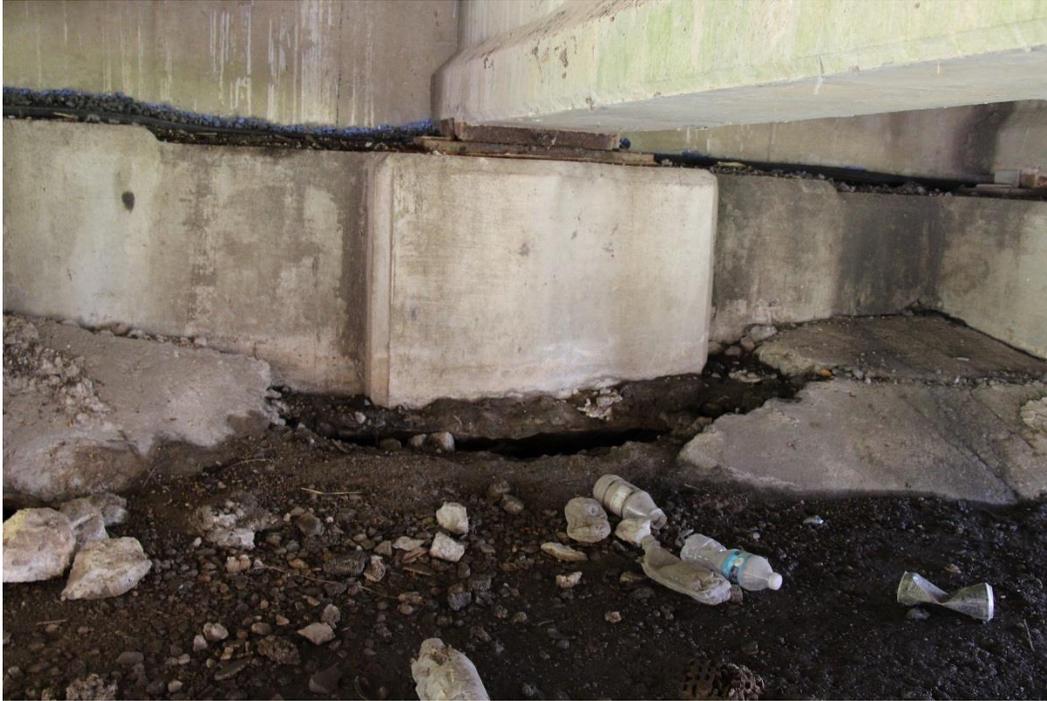
Condition Photo 24: Erosion and exposed bottom of end bent 1 and failed concrete slope protection.

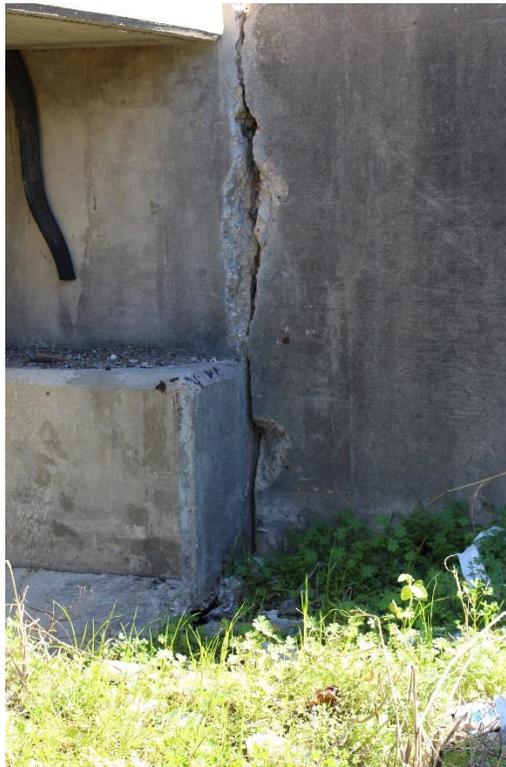
Condition Photo 25: Concrete spalled end bent 78 on the south side.

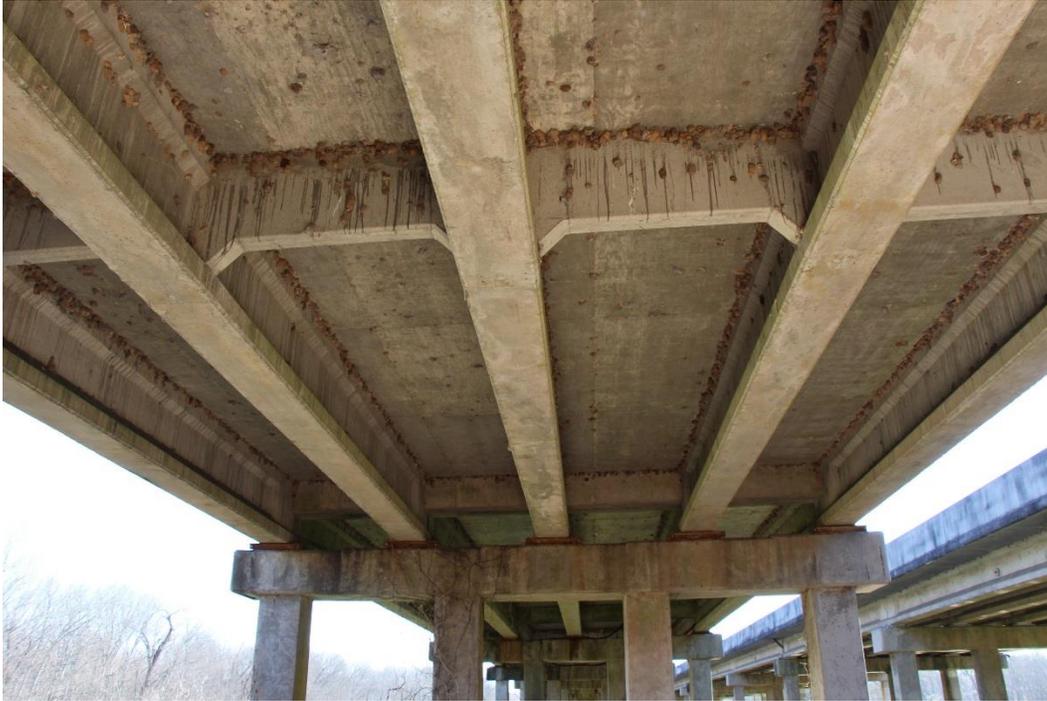
Condition Photo 26: Dirt dauber nests on the underside of the superstructure and cracking with efflorescence.

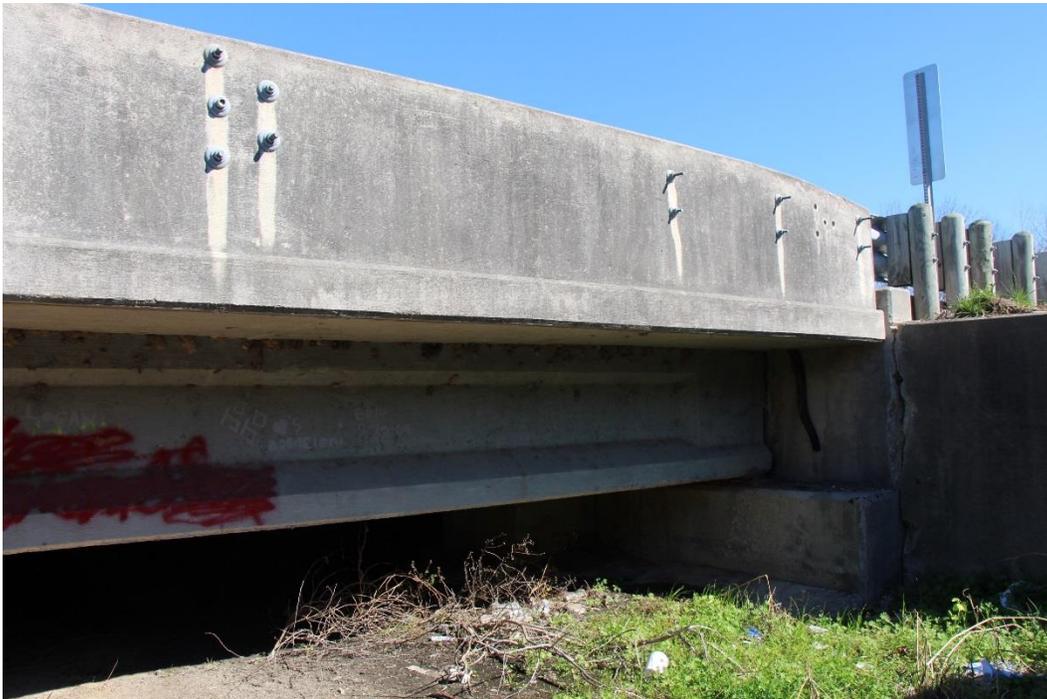
Condition Photo 27: Typical graffiti on the south exterior concrete beam, span 77.

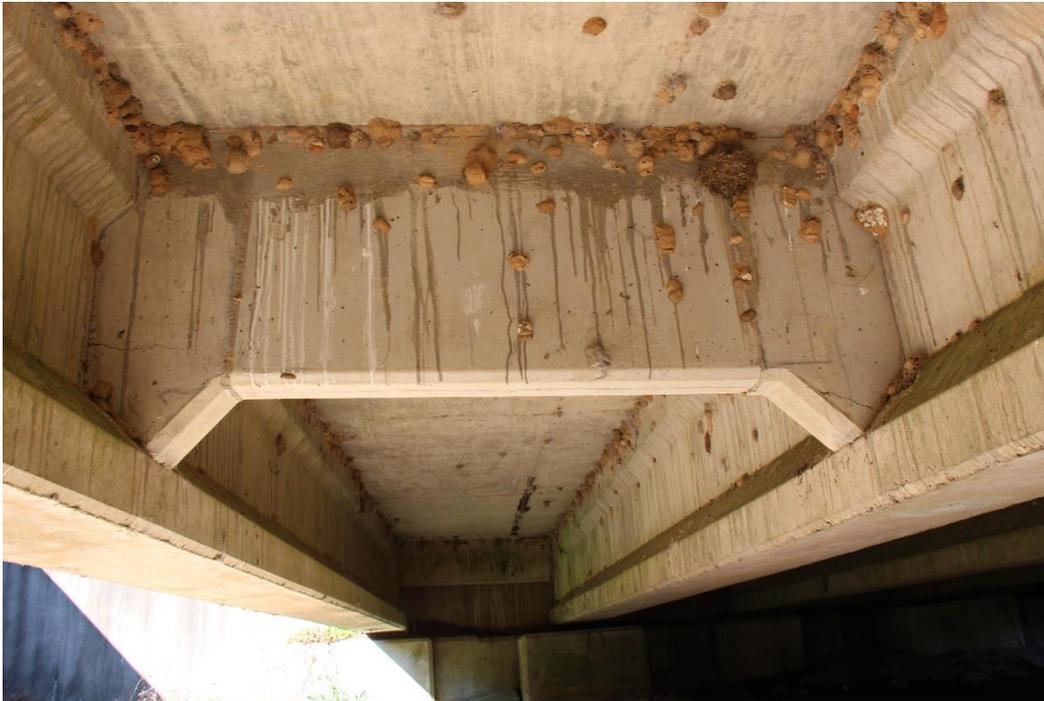
Condition Photo 28: Cracked concrete diaphragm between concrete beams, typical.

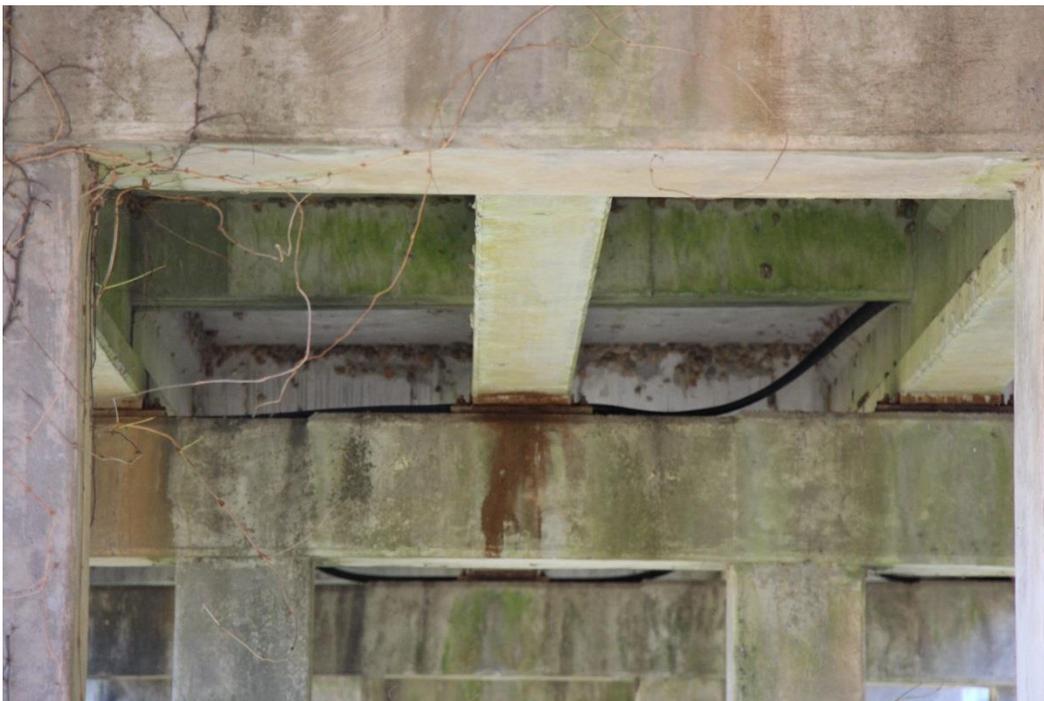
Condition Photo 29: Typical expansion joint failure.

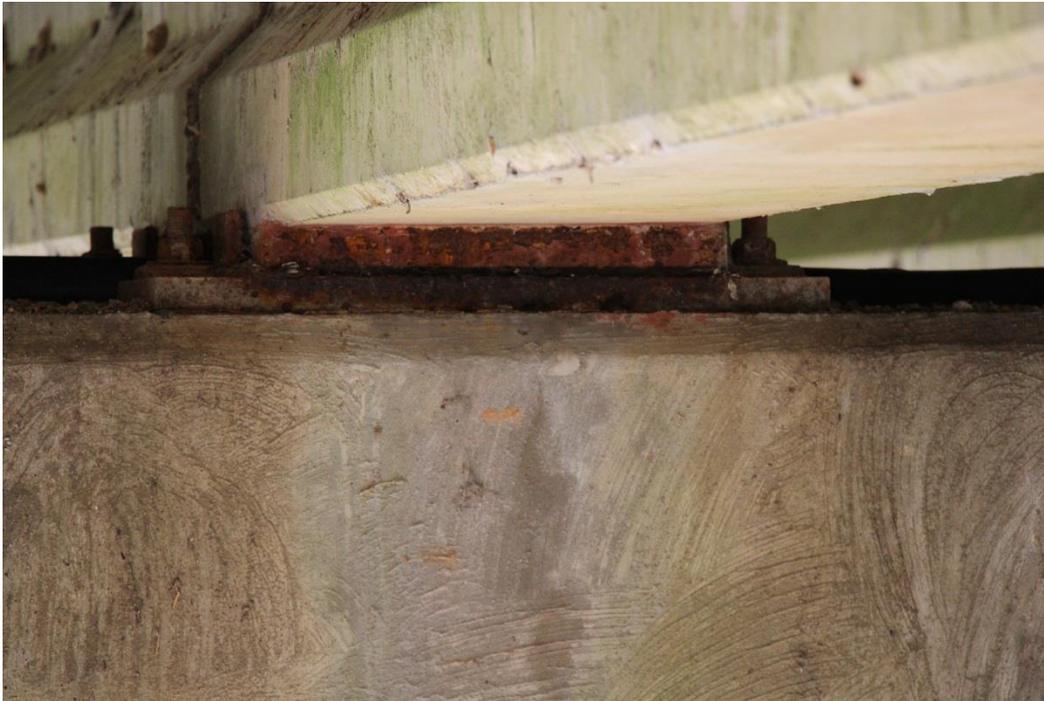
Condition Photo 30: Rusted steel bearing assembly, typical.

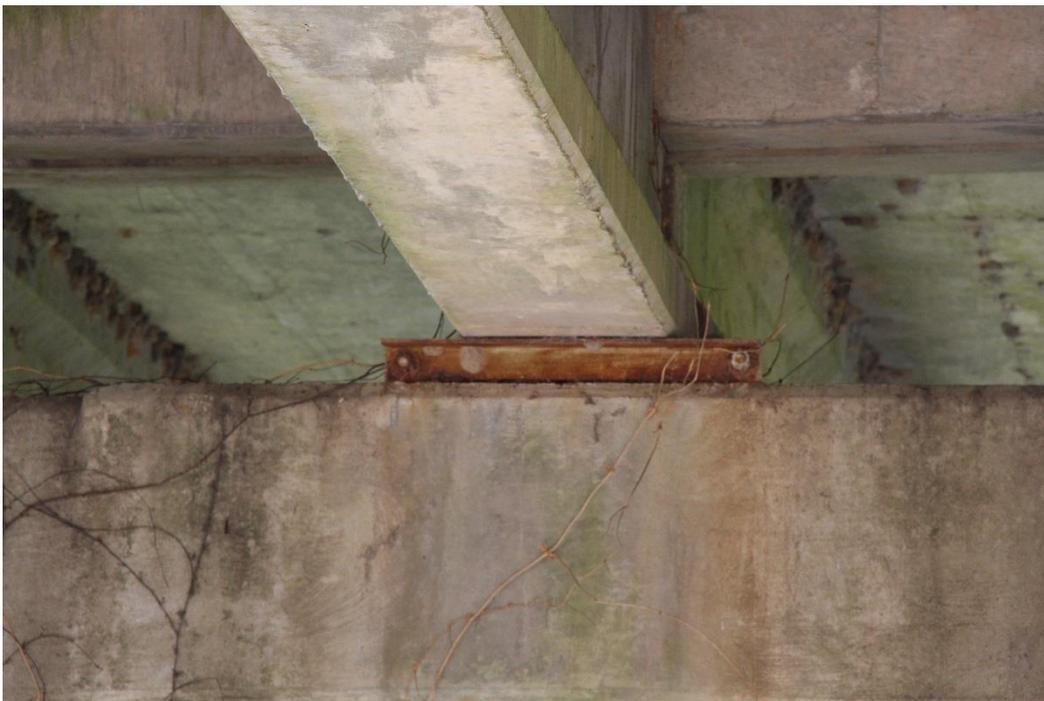
Condition Photo 31: Typical corroded bearing restriction device.

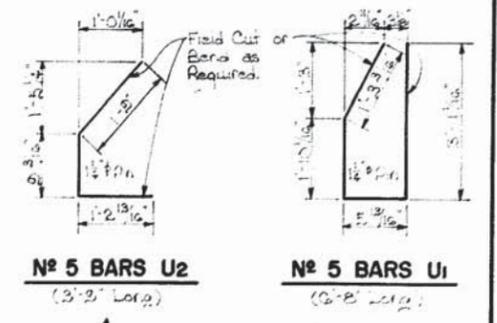
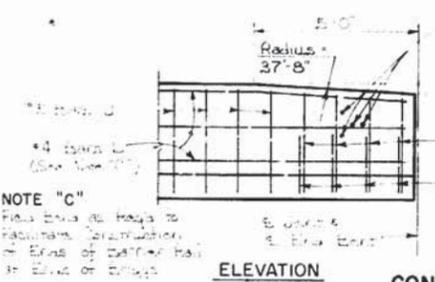
NOTE "C":
Flas Bars as Keys to Facilitate Construction of Ends of Railing at Ends of Bridge.
