Historic Bridge Management Plan for the Bayou Tigre Bridge

Recall Number: 010130

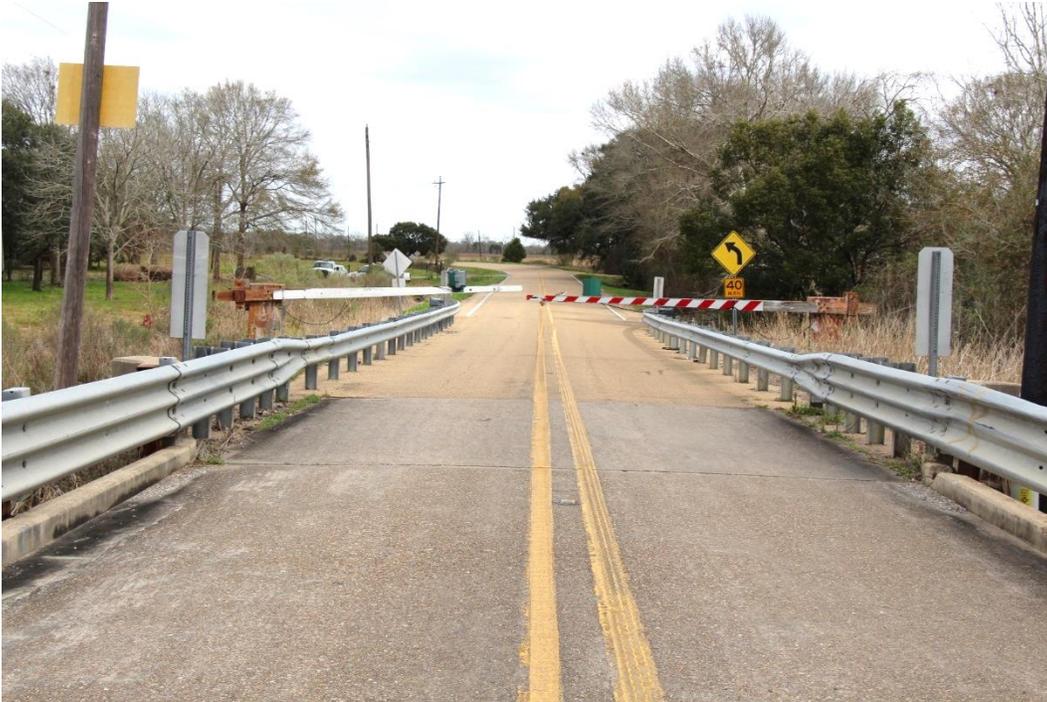
Condition Photo 1: North approach span looking north. Note metal guardrail, approach slab, and traffic gates.

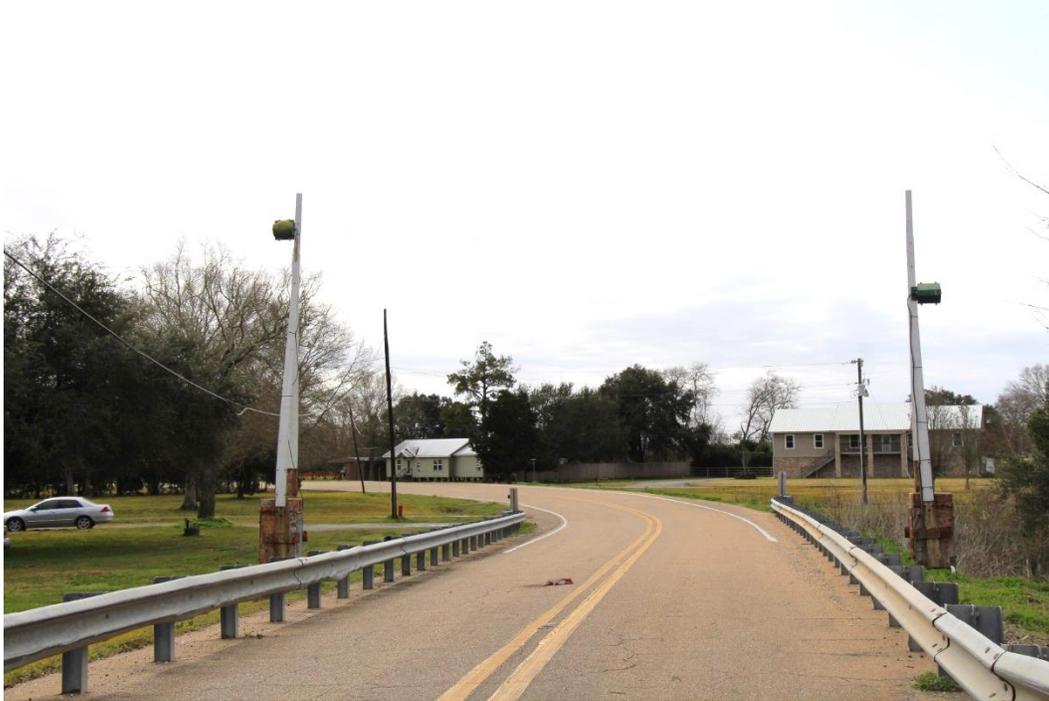
Condition Photo 2: South approach roadway looking south; note guardrail and traffic gates.

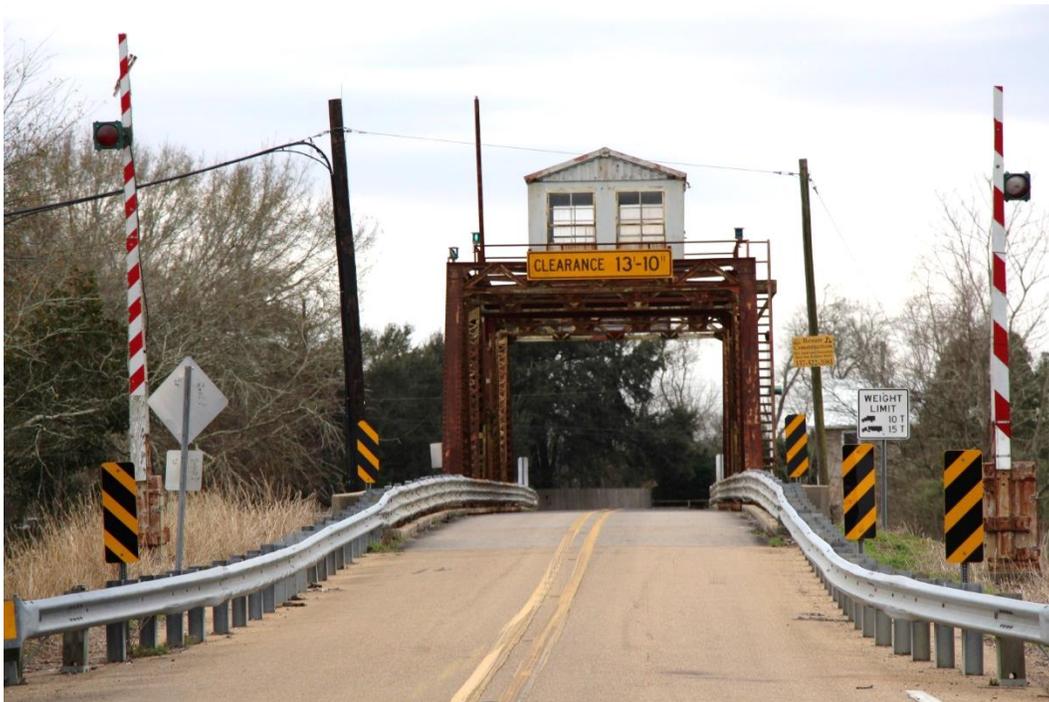
Condition Photo 3: North roadway approach looking south toward the bridge. Note warning features and general view approaching the swing span.

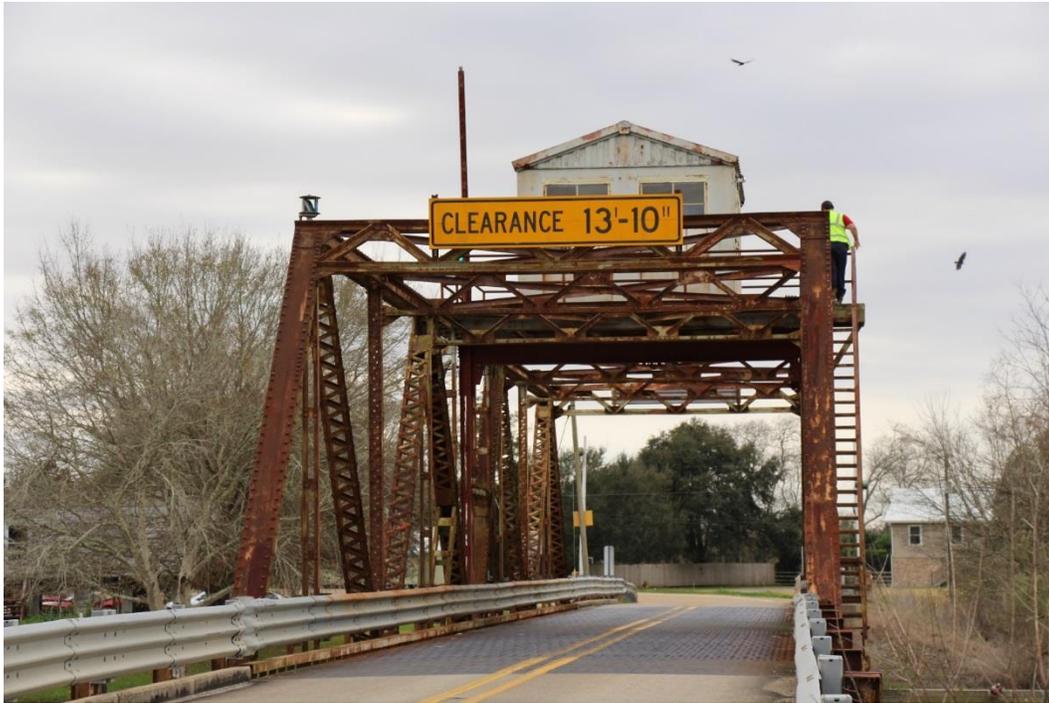
Condition Photo 4: Main span truss paint failure.

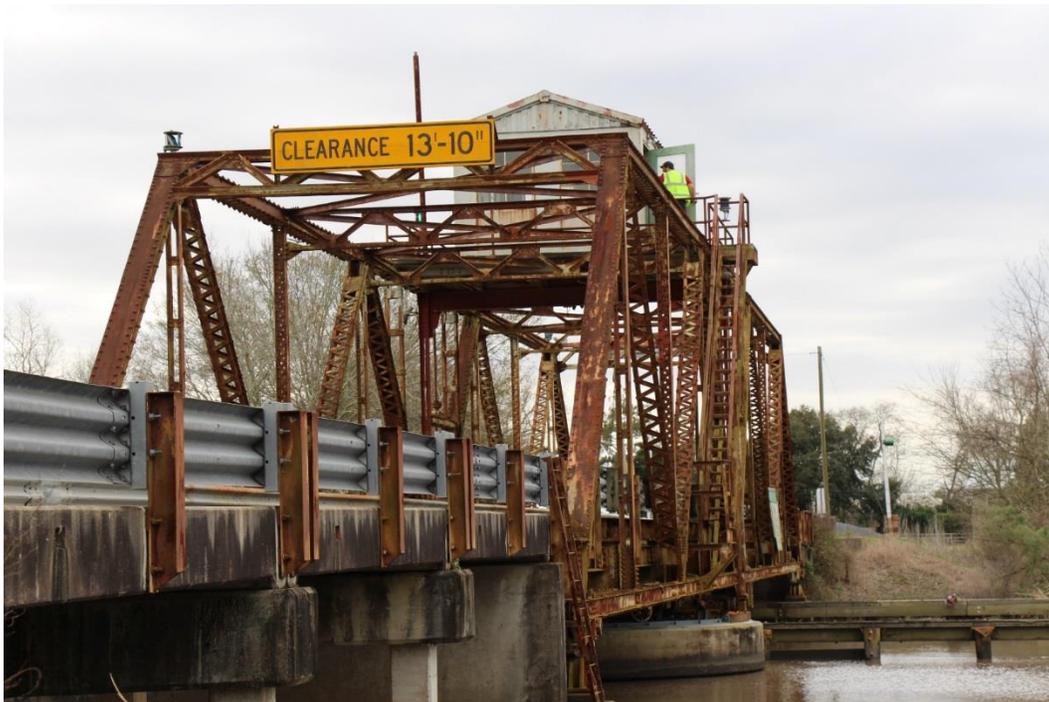
Condition Photo 5: Elevation view of the north concrete approach spans and main span truss, exhibiting concrete staining and paint failure.

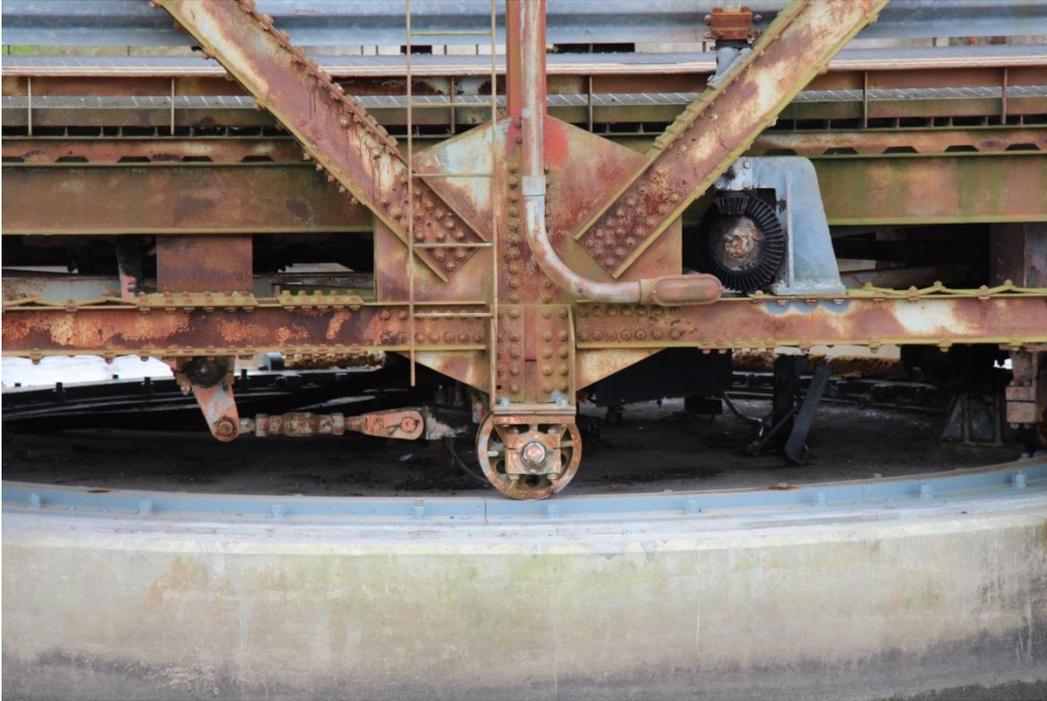
Condition Photo 6: Close-up of the rollers and steel ring track at the center pivot pier (Pier 2) under the truss span.

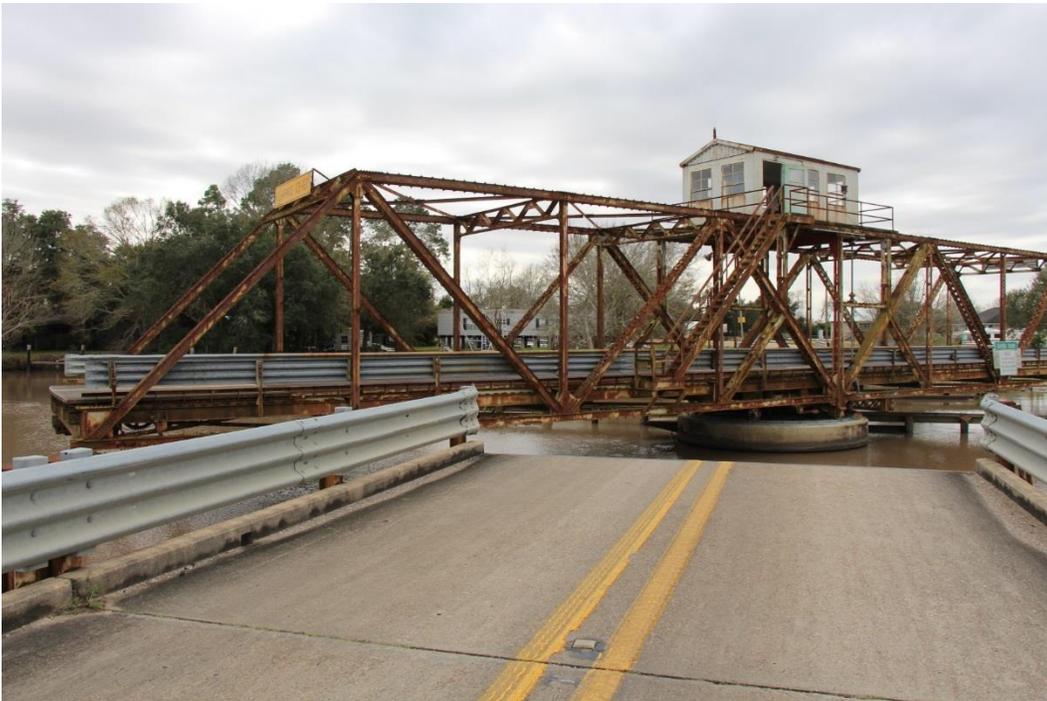
Condition Photo 7: Opening of the swing truss span.

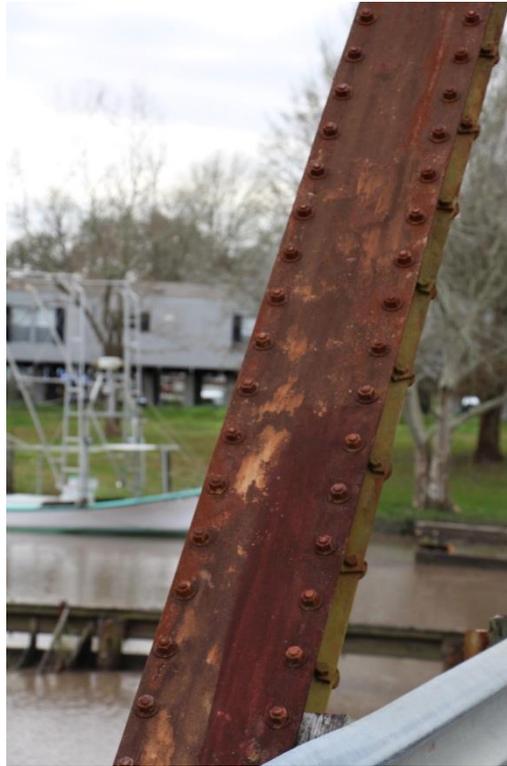
Condition Photo 8: Diagonal member of the main span truss paint failure.

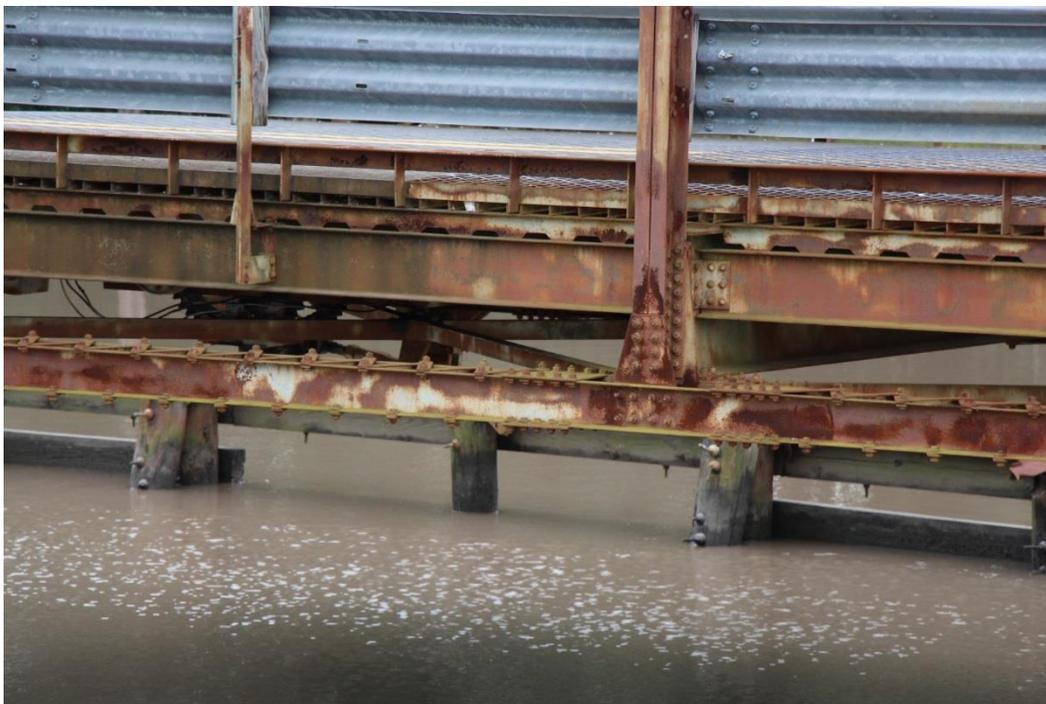
Condition Photo 9: Lower chord paint failure of the main truss span.

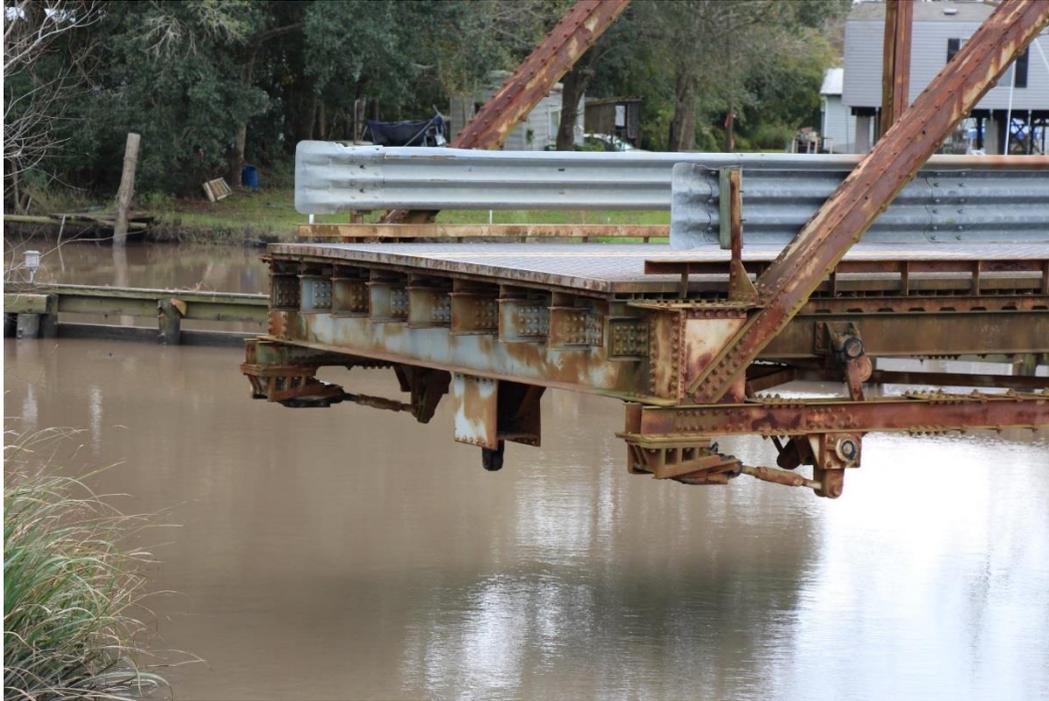
Condition Photo 10: End of the main truss span showing paint failure as well as the condition of the live load bearings and locks.

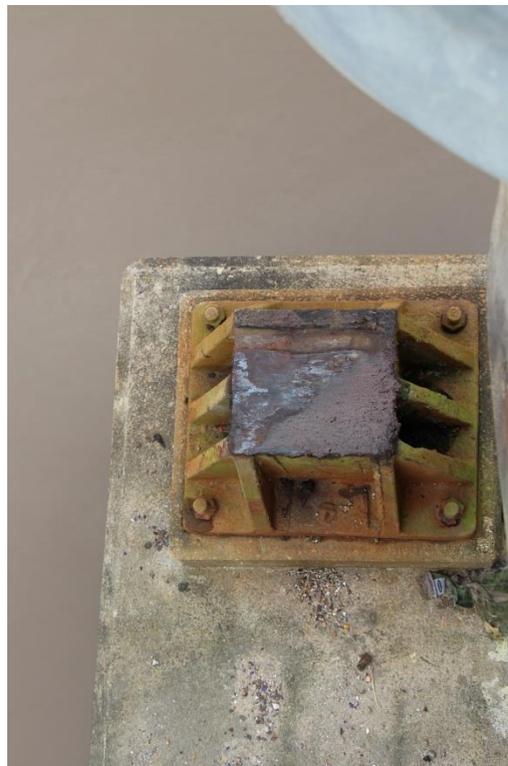
Condition Photo 11: Steel live load bearing for the main truss span.

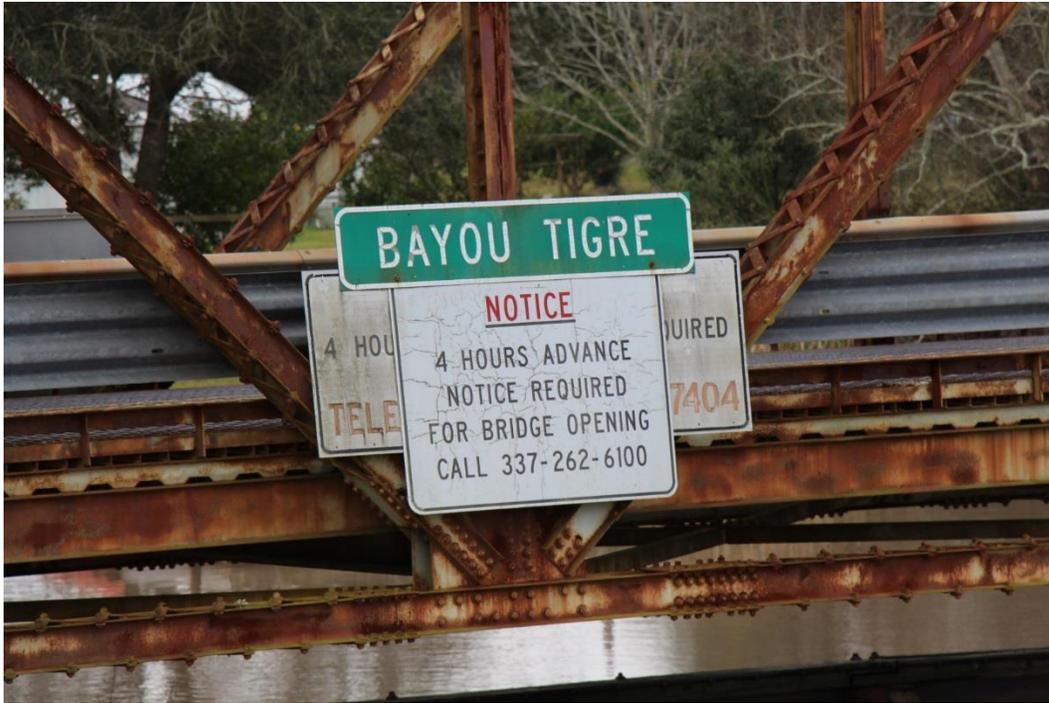
Condition Photo 12: Signage attached to a vertical member of the truss.

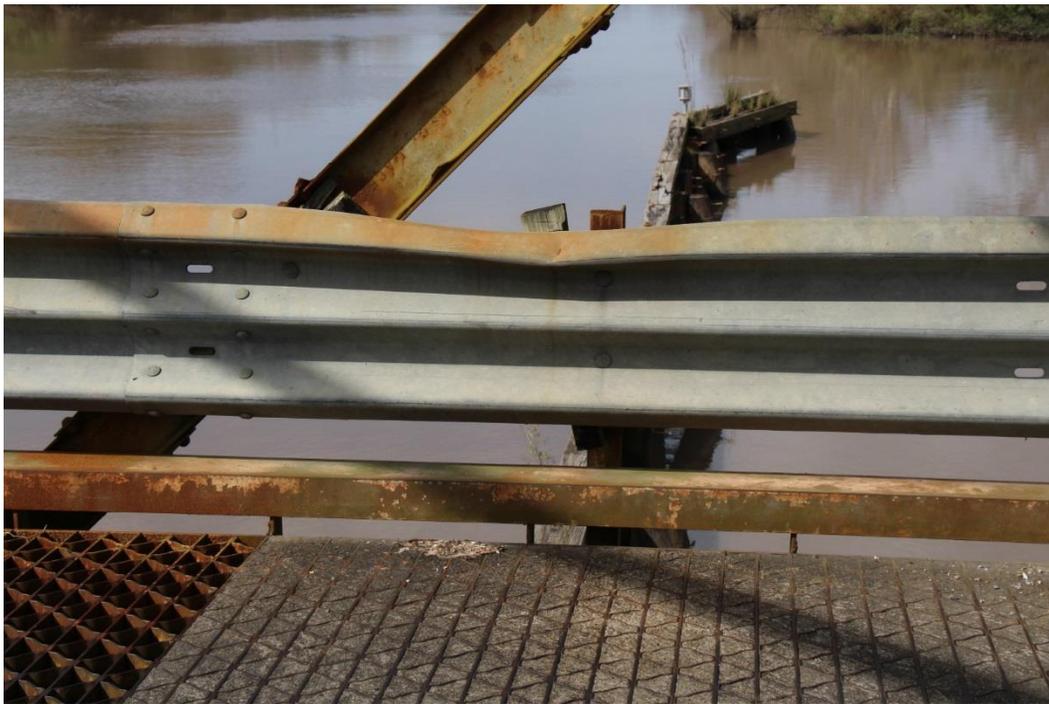
Condition Photo 13: Damaged guardrail on the main span.

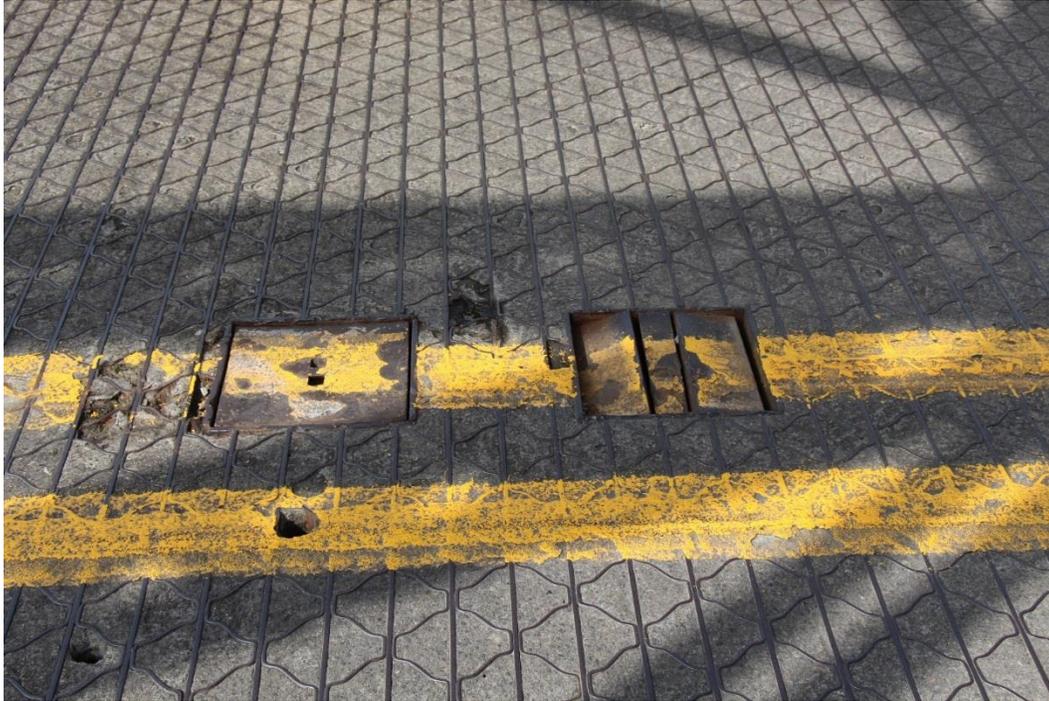
Condition Photo 14: Concrete filled metal grid deck wear and spalling on truss span.

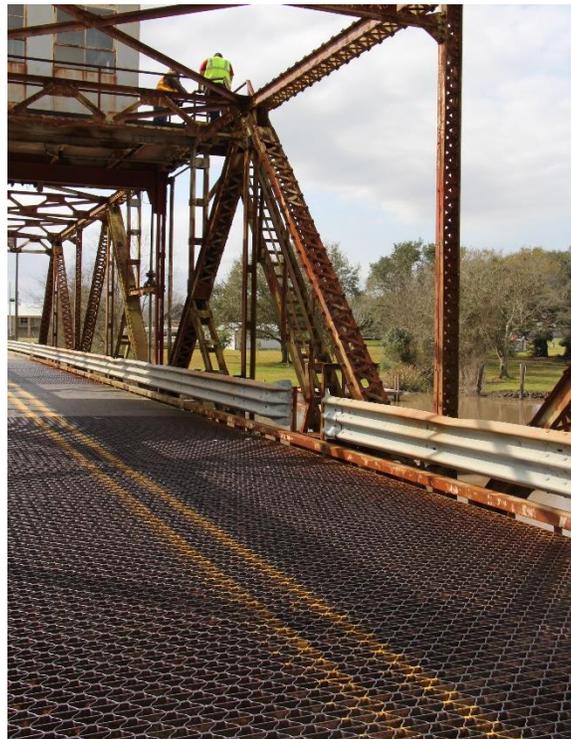
Condition Photo 15: Condition of metal grid deck on the swing span.

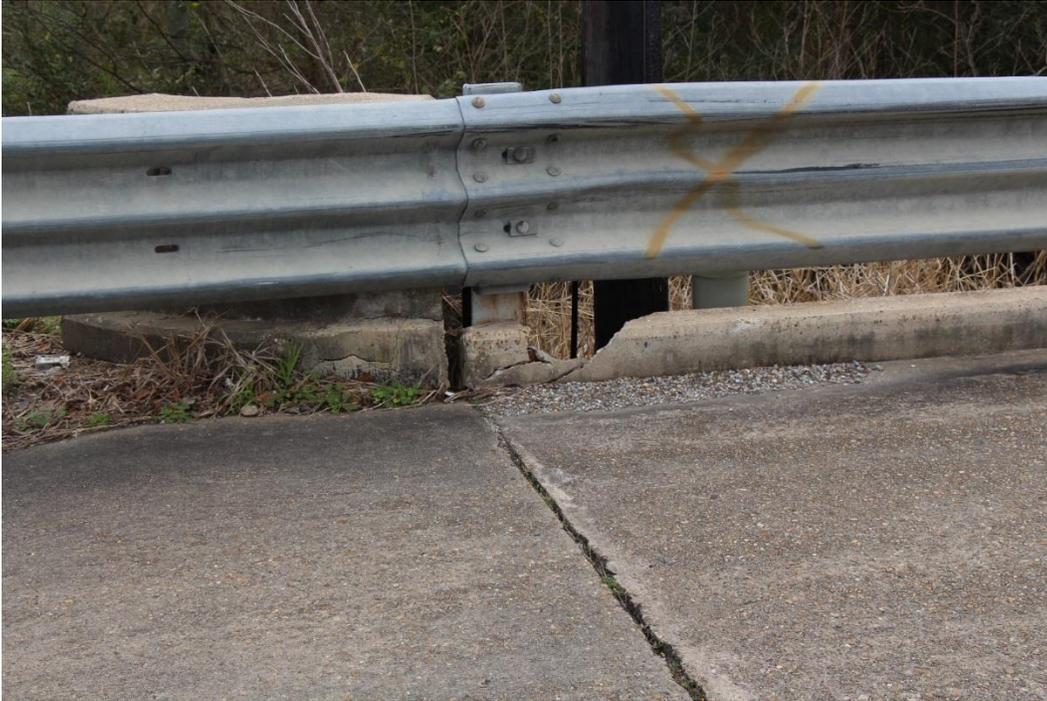
Condition Photo 16: Spalled concrete curb and debris north approach at the joint for the approach slab and bridge approach spans.

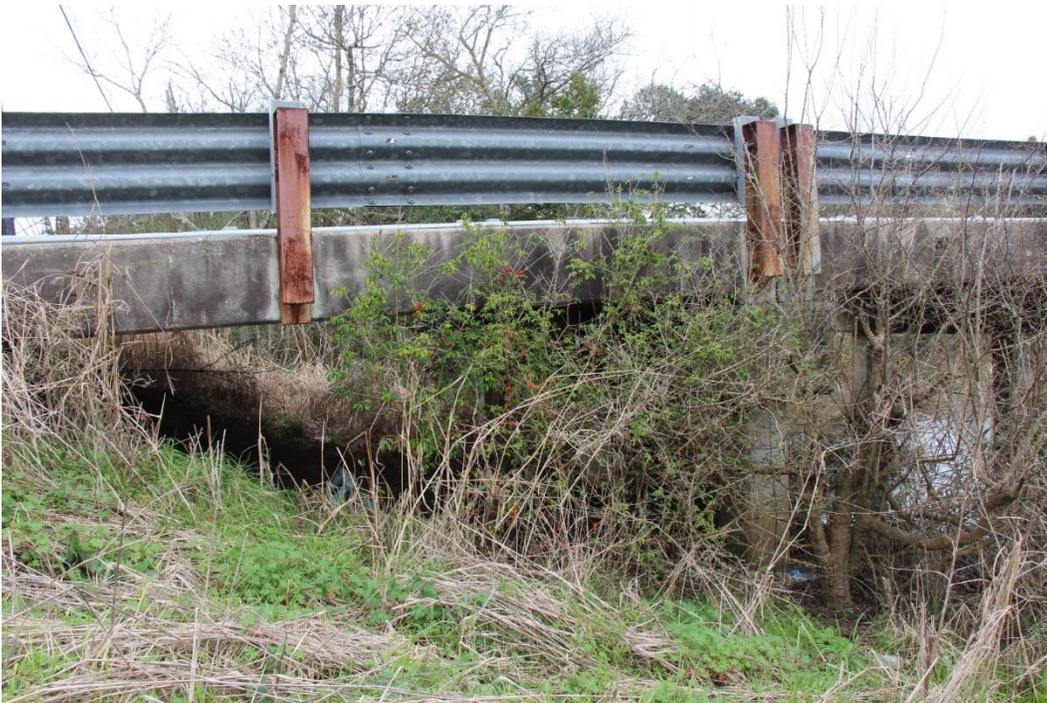
Condition Photo 17: Vegetation growth at the north approach bents; similar condition at south approach bents.

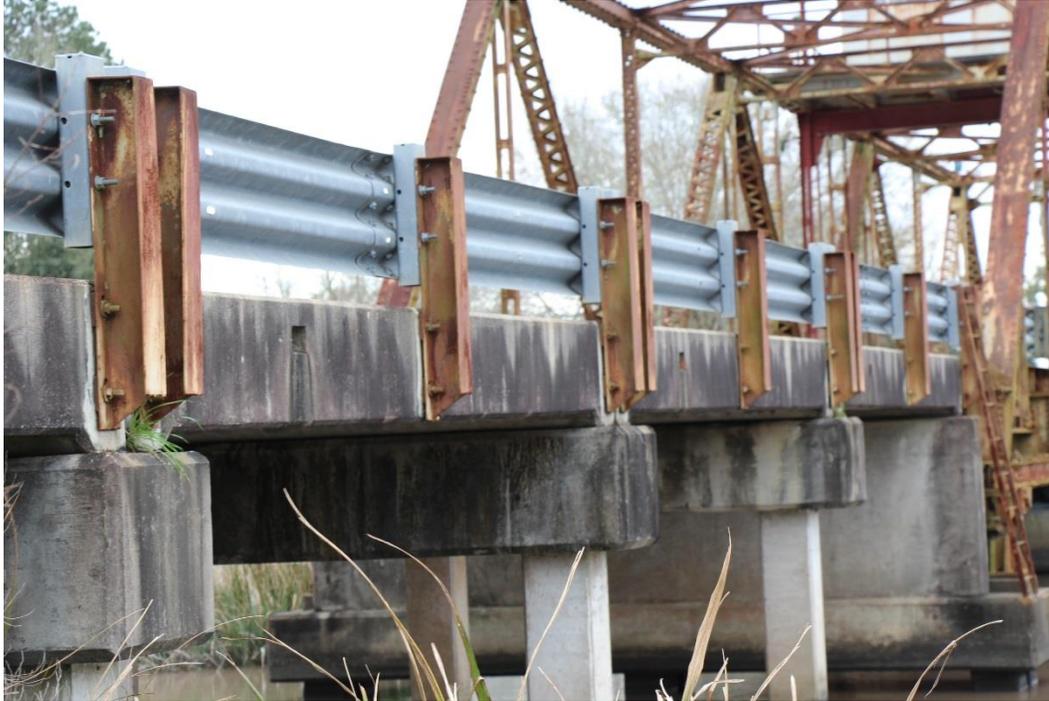
Condition Photo 18: Water staining and vegetation growth on approach Bents 3-5 and Pier 1

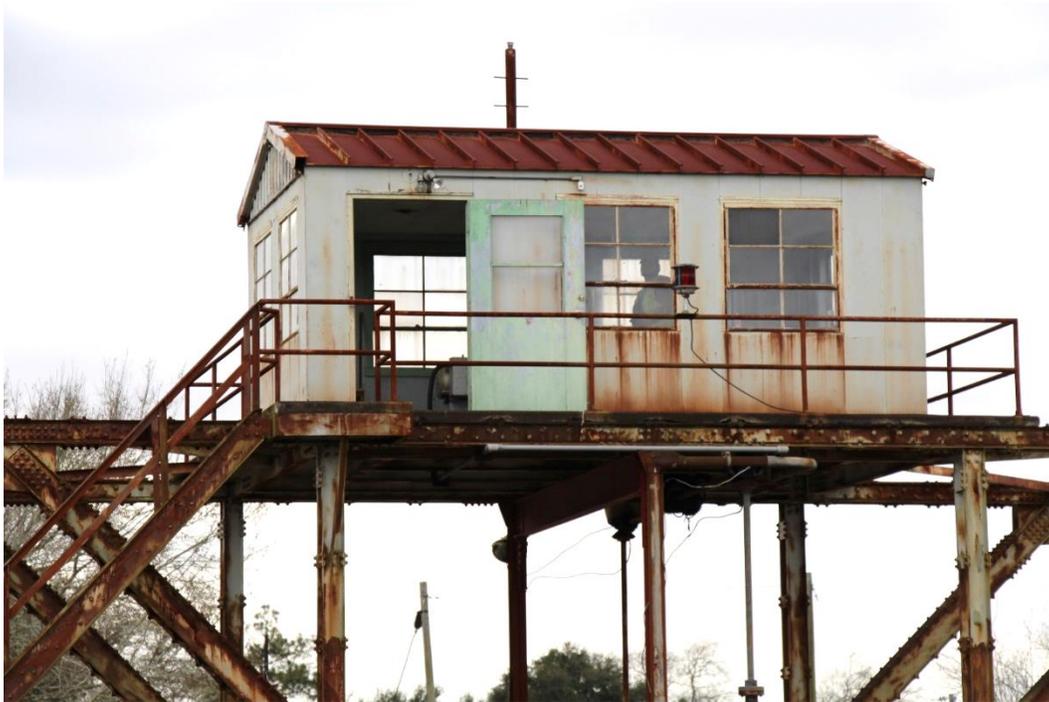
Condition Photo 19: Operator's house centered on top of the main truss span.

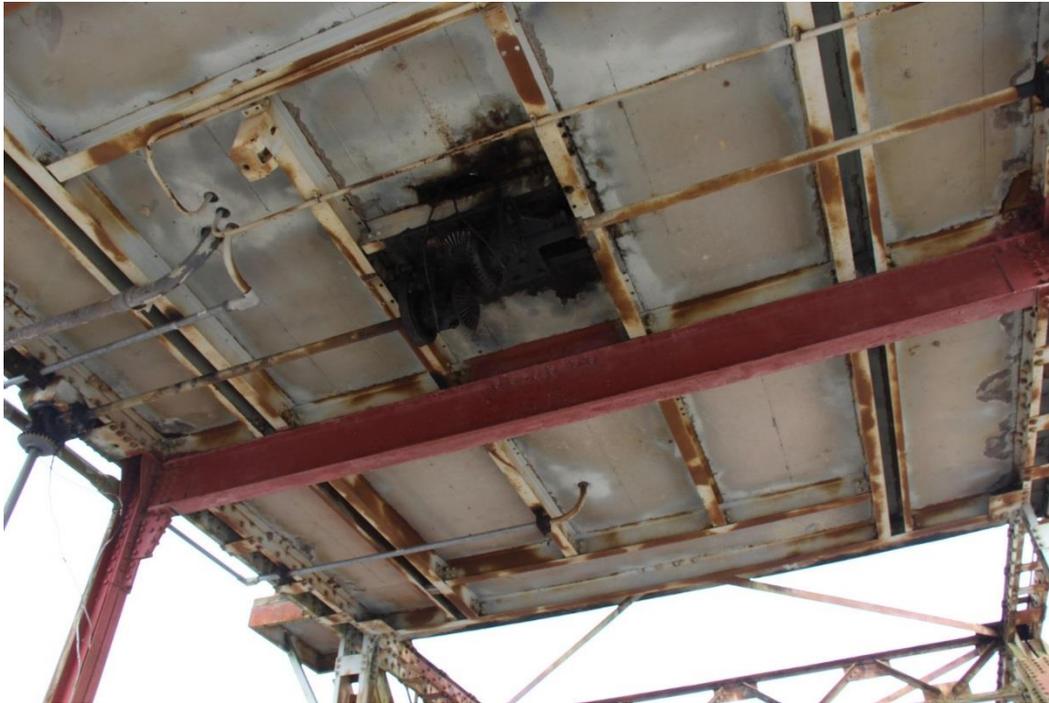
Condition Photo 20: Gears and shafts for the swing span under the operator house at the center on top of the truss; note the newer steel beam and column which replaced in-kind deteriorated original steel members.

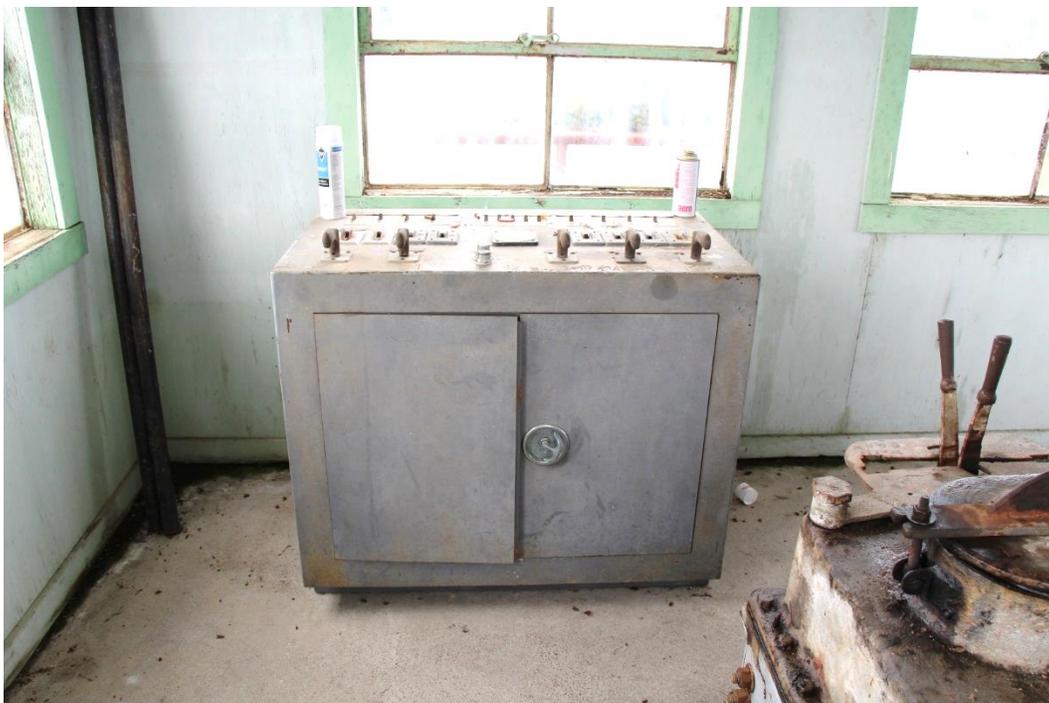
Condition Photo 21: Control console in the operator's house.

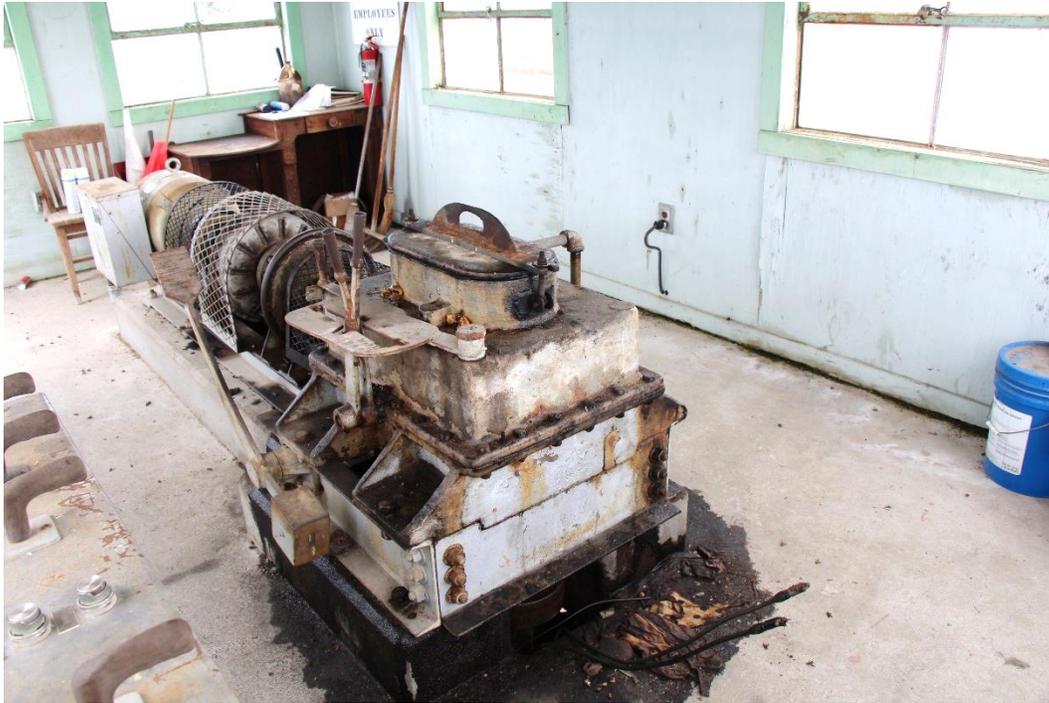
Condition Photo 22: Motor and machinery in the operator's house.

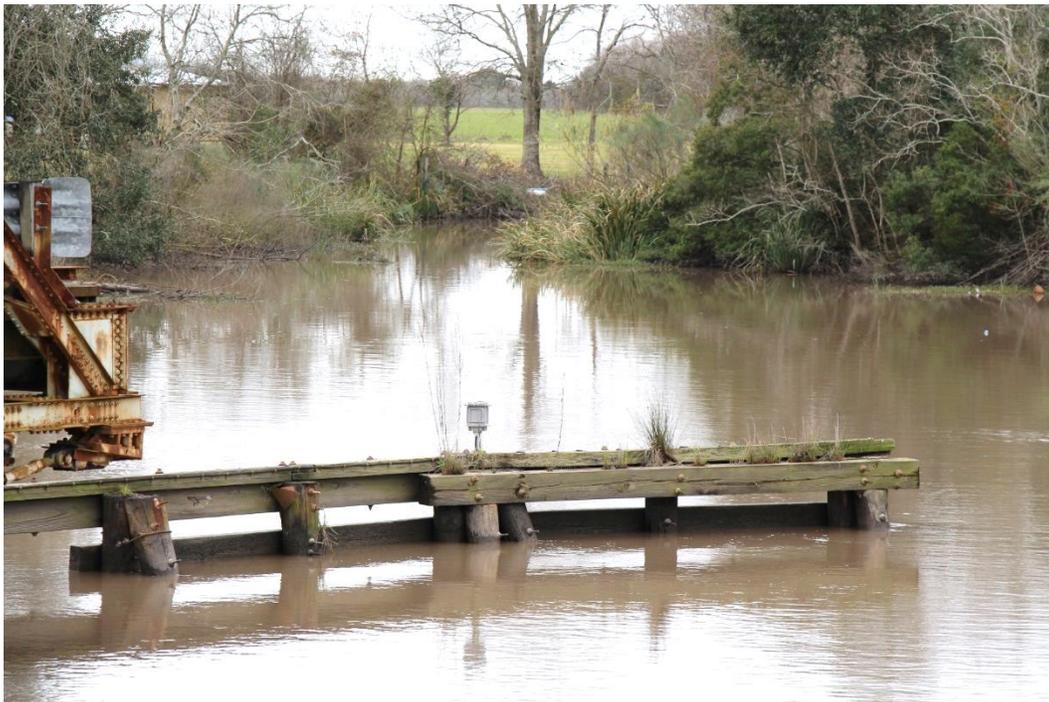
Condition Photo 23: Timber fender system vegetation growth.

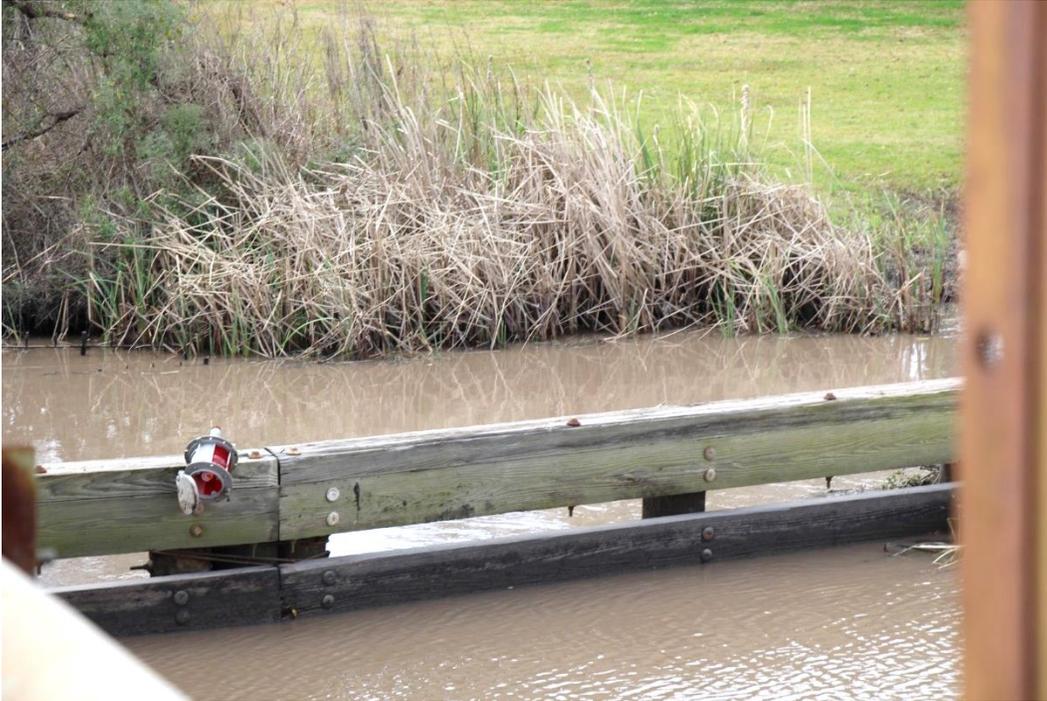
Condition Photo 24: Broken navigation light on the timber fender system.

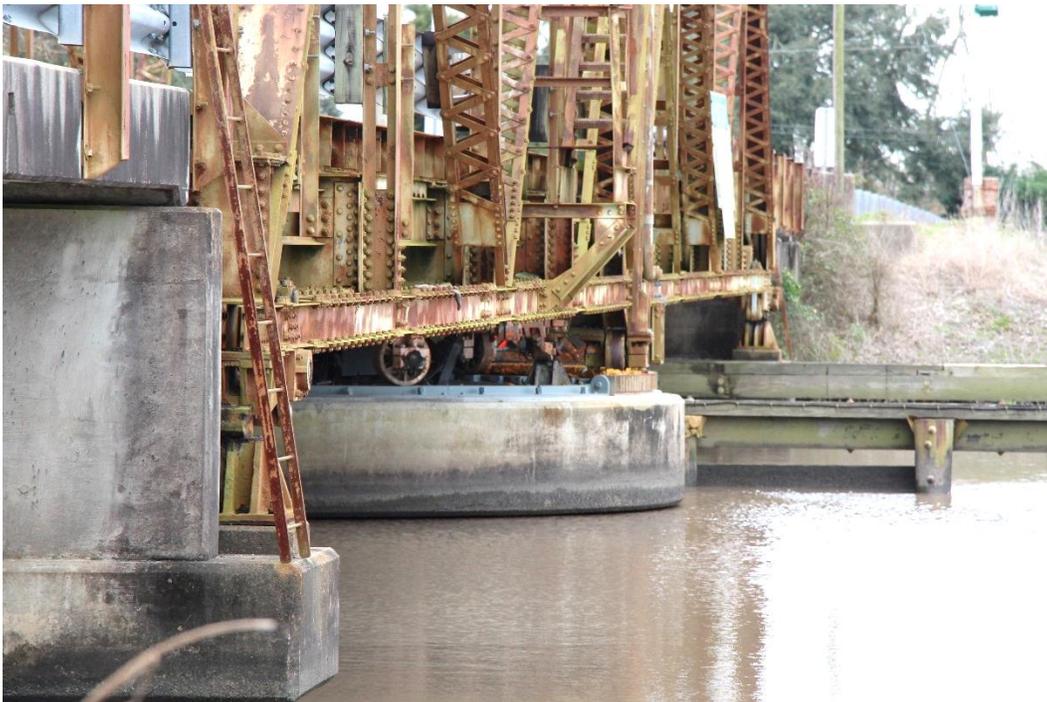
Condition Photo 25: Swing and approach span piers and condition of the swing span.

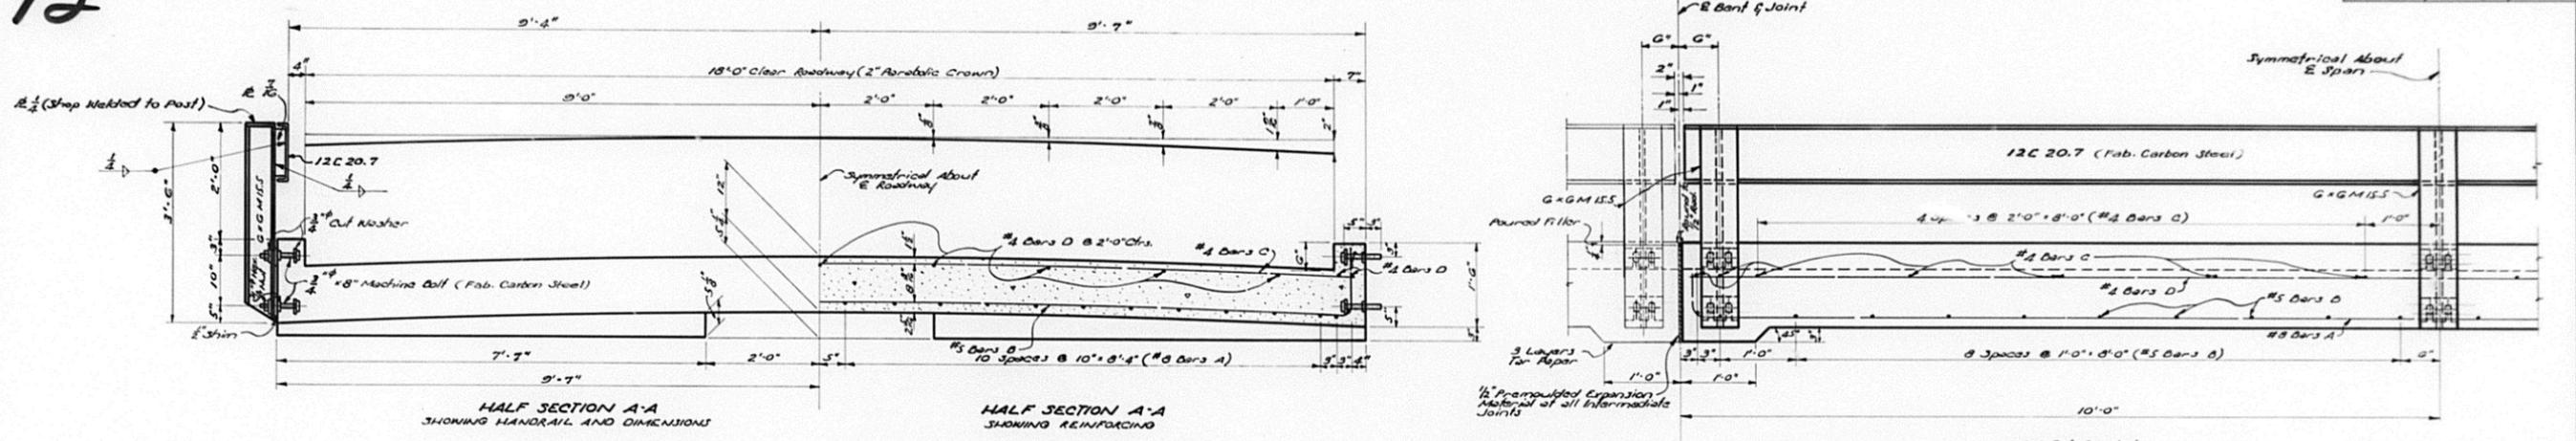
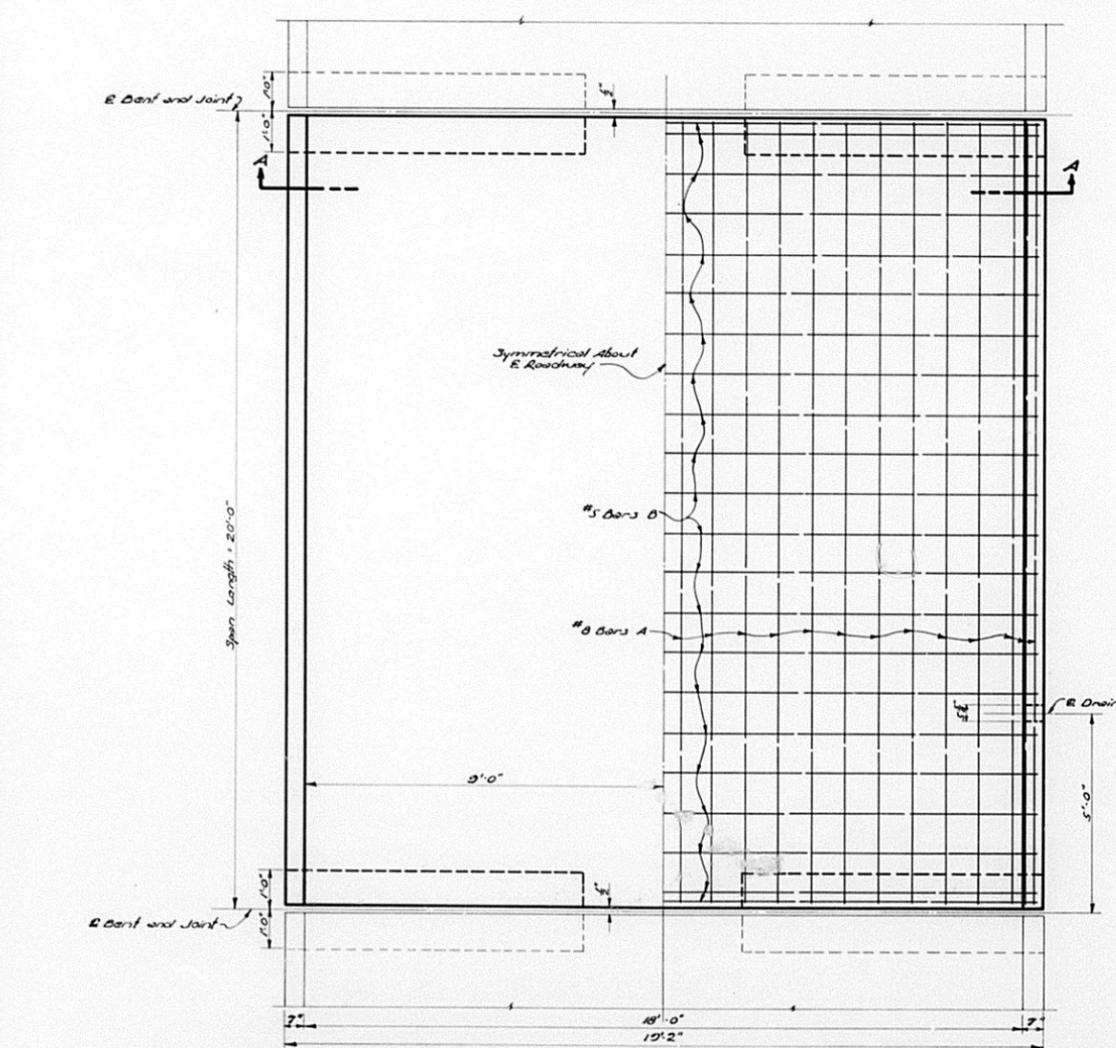
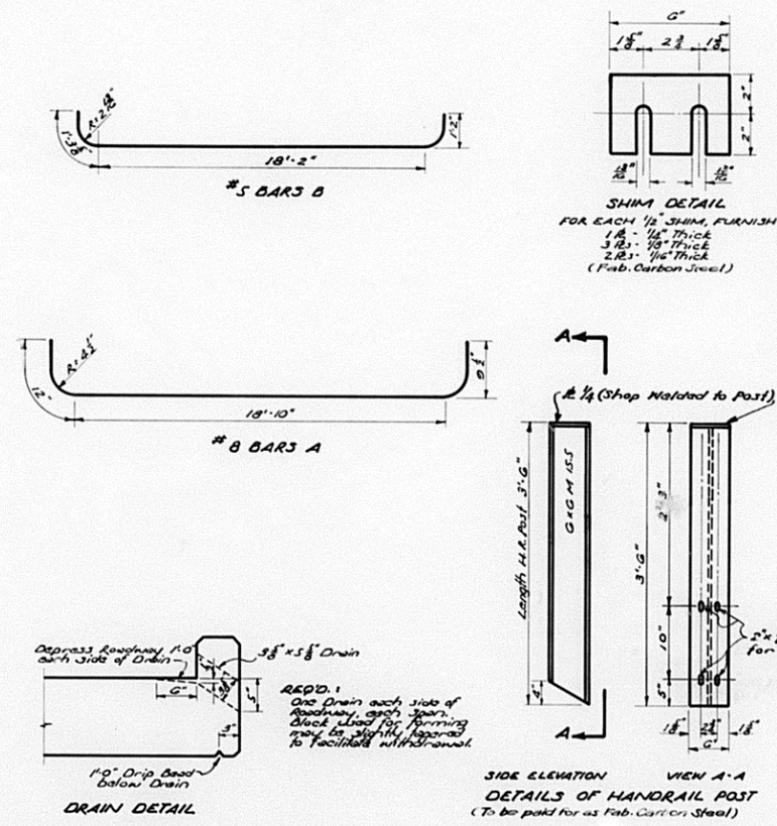
BILL OF MATERIALS (ONE SPAN)					
BAR	SIZE	N ^o	UNIT LENGTH	TOTAL LENGTH	LOCATION
A	#8	26	20'-10"	521'-8"	Bottom of Slab
TOTAL #8 BARS = 521'-8" = 12,460 LBS.					
B	#5	22	20'-9"	456'-6"	Bottom of Slab
TOTAL #5 BARS = 456'-6" = 4,790 LBS.					
C	#4	14	18'-8"	261'-2"	Top of Slab
D	#4	15	15'-8"	235'-0"	Top of Slab
TOTAL #4 BARS = 536'-2" = 372 LBS.					
QUANTITIES (ONE SPAN)					
TOTAL DEFORMED REINF. STEEL =				22,944	LBS.
TOTAL CLASS "A" CONCRETE =				15.06	CU. YDS.
FAB. CARBON STEEL				1254	LBS.

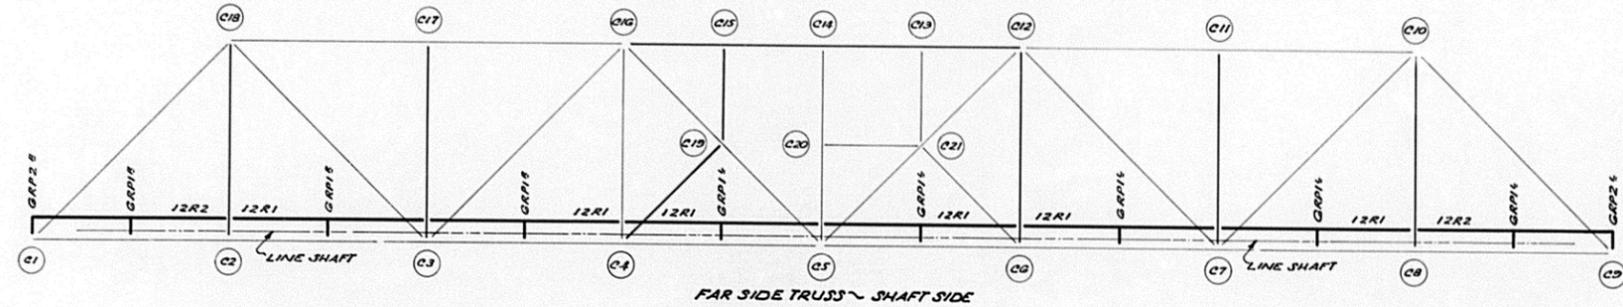
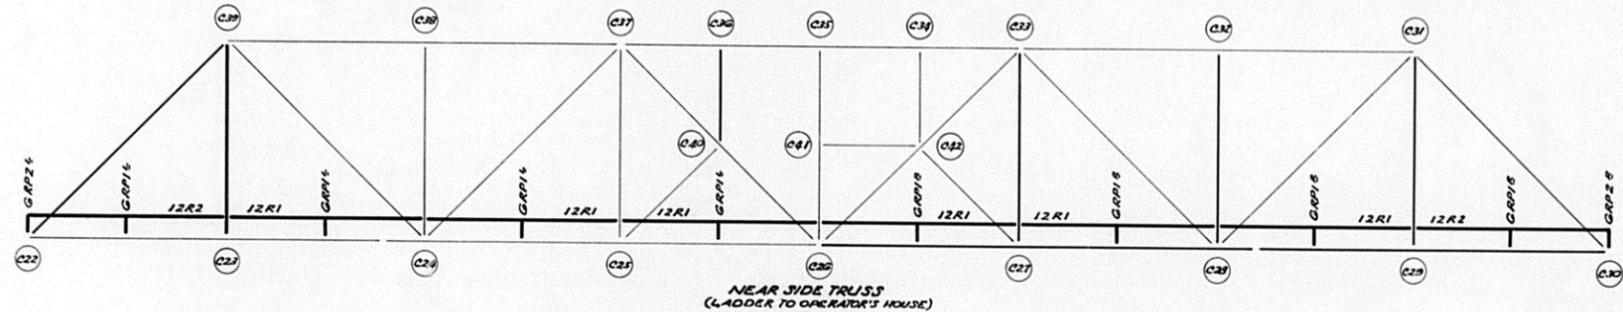
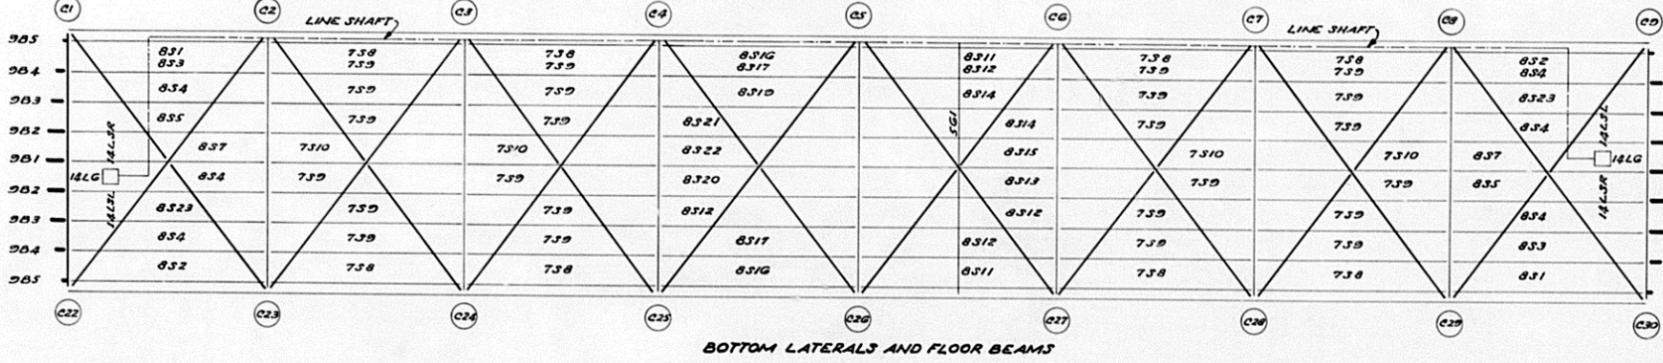
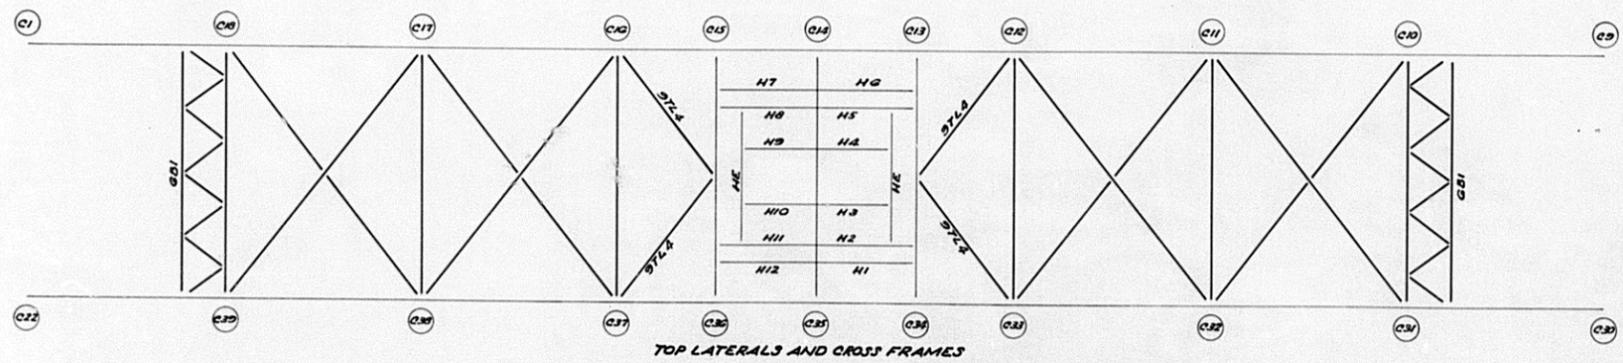
LEGEND
 — GOOD
 - - - BENT
 = = = TO BE REPLACED
