Historic Bridge Management Plan for the Bayou Tigre Bridge

Recall Number: 010130

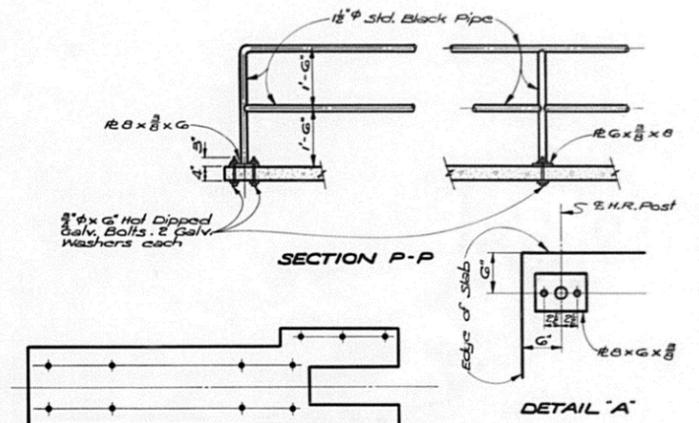
ANCHOR BOLT PLAN FOR MACHINERY BASE
(EXACT LOCATION TO BE MADE FROM APPROVED MACHINERY DRAWING)

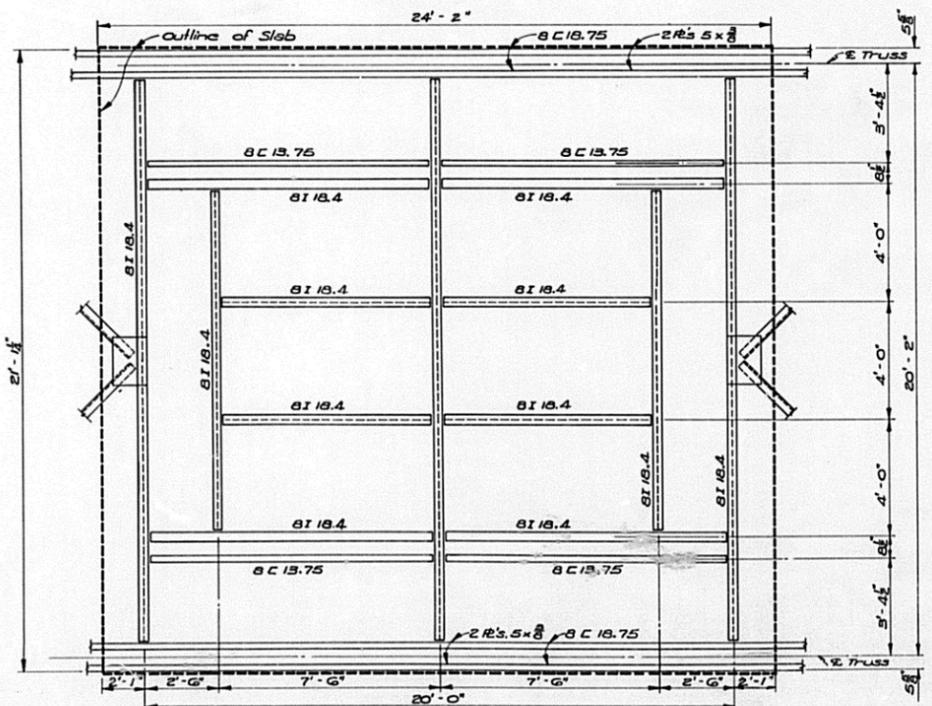
FOUNDATION PLAN
SHOWING SUB STRUCTURE

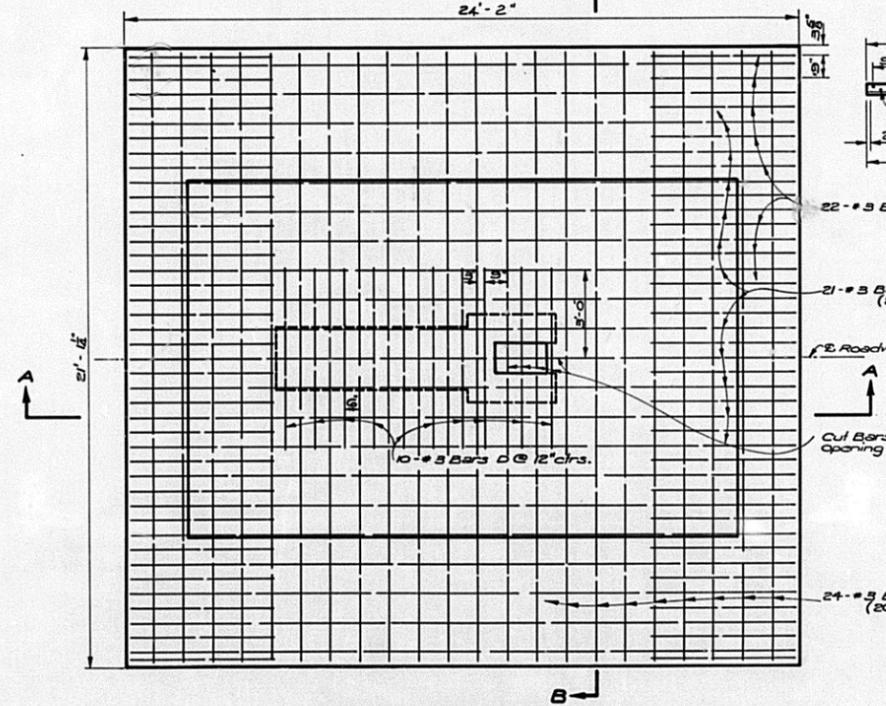
FOUNDATION PLAN
SHOWING REINFORCING STEEL
