Historic Bridge Management Plan for the Calcasieu River (Moss Bluff) Bridge

Recall Number: 031736

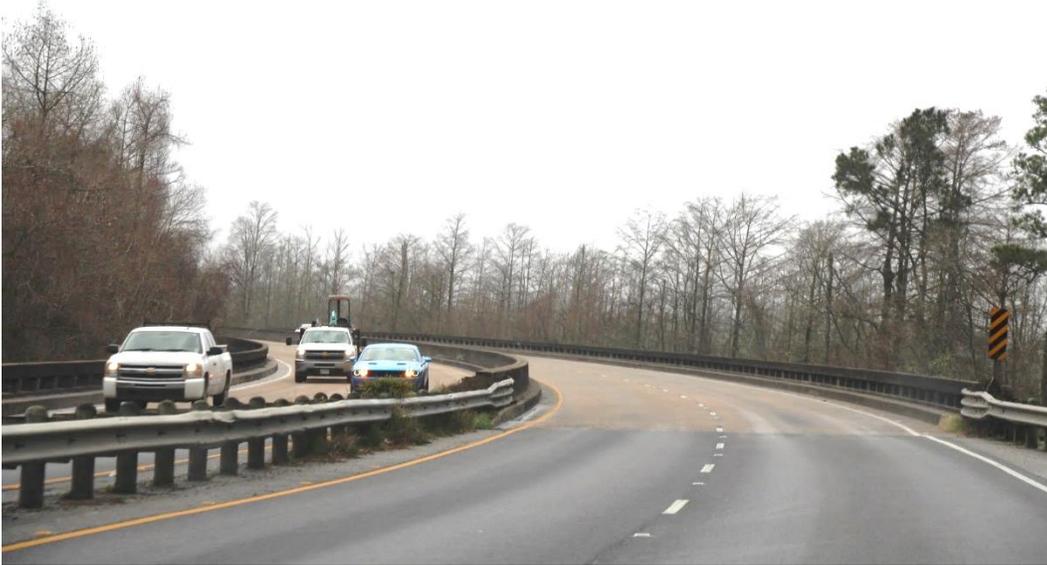
Condition Photo 1: Southbound approach, looking south at north end of bridge.

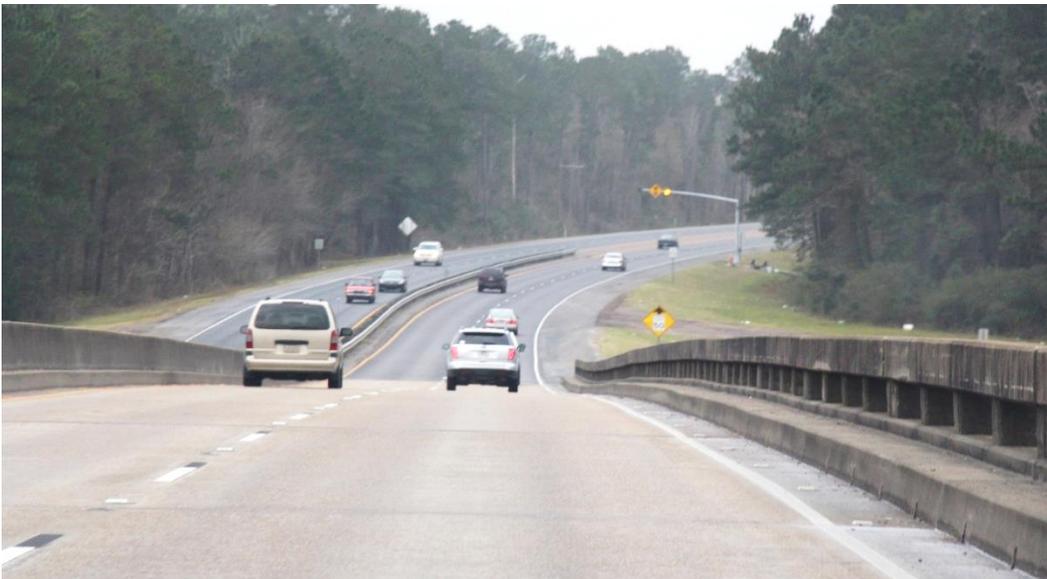
Condition Photo 2: Southbound travel lanes, looking south at south end of bridge.

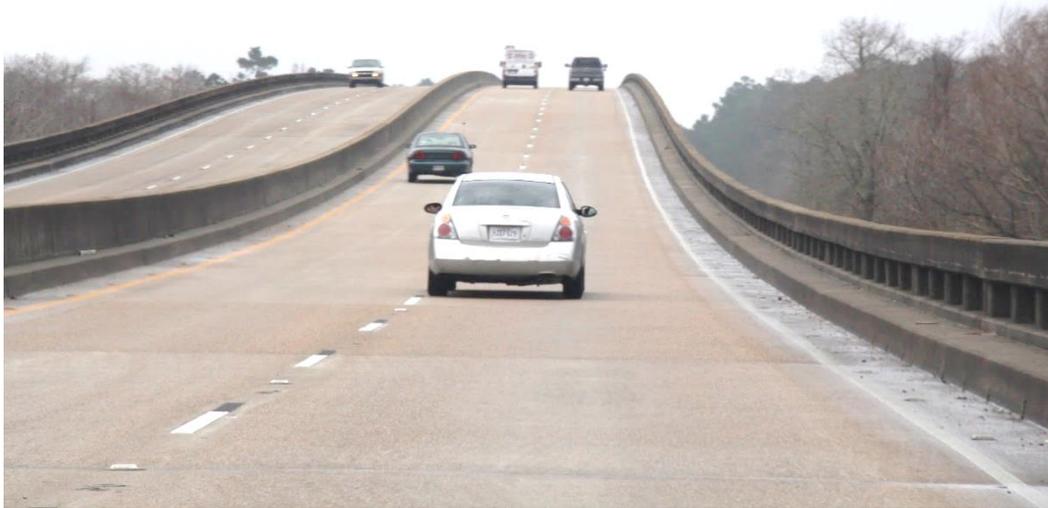
Condition Photo 3: Approach spans concrete deck slabs, looking north.

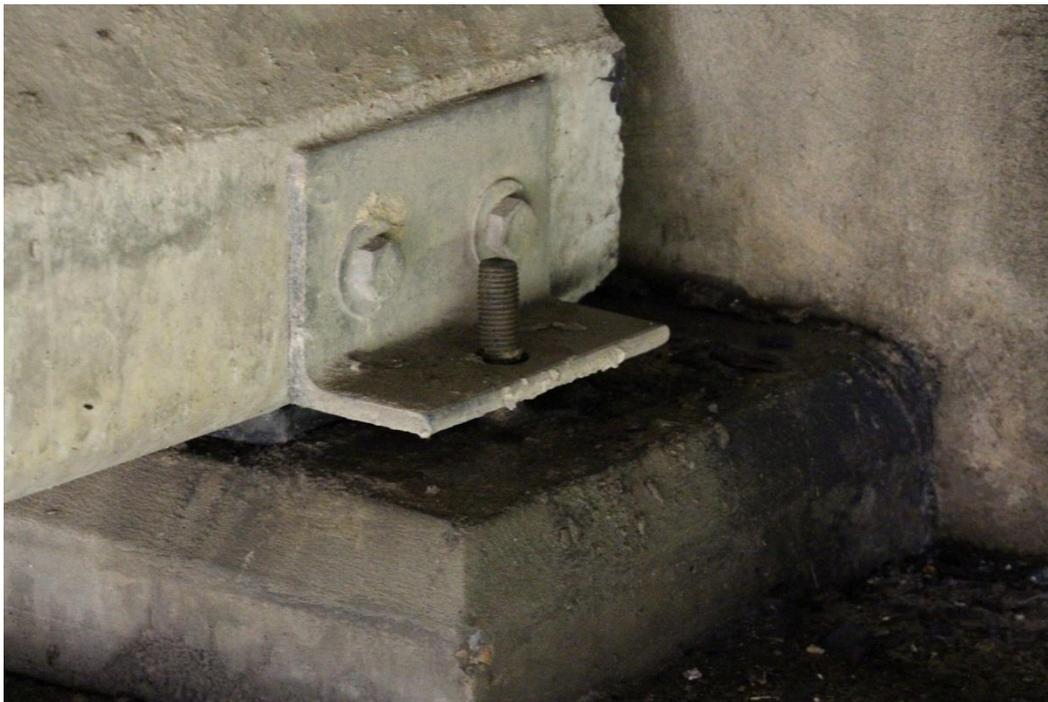
Condition Photo 4: Missing bolt at the concrete beam tie down at end bent 1, beam 7.

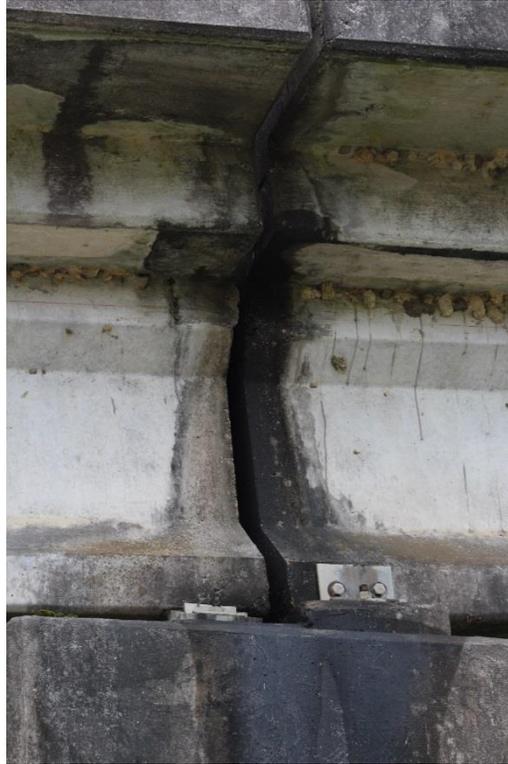
Condition Photo 5: Dirt dauber nests and water staining at the concrete approach bent caps.

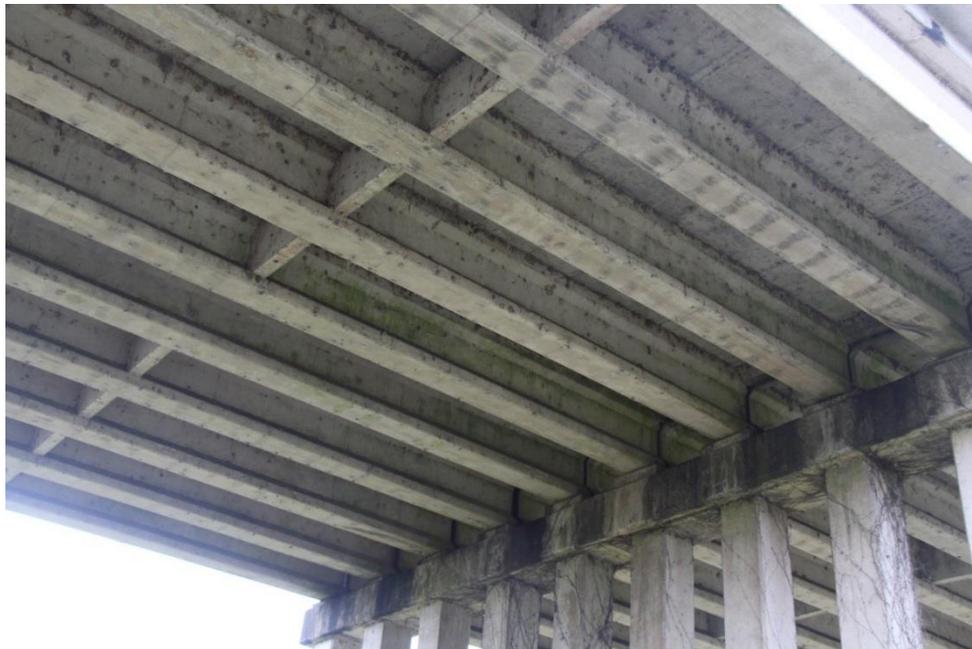
Condition Photo 6: Dirt dauber nests and efflorescence on the underside of the precast prestressed concrete beam approach spans.

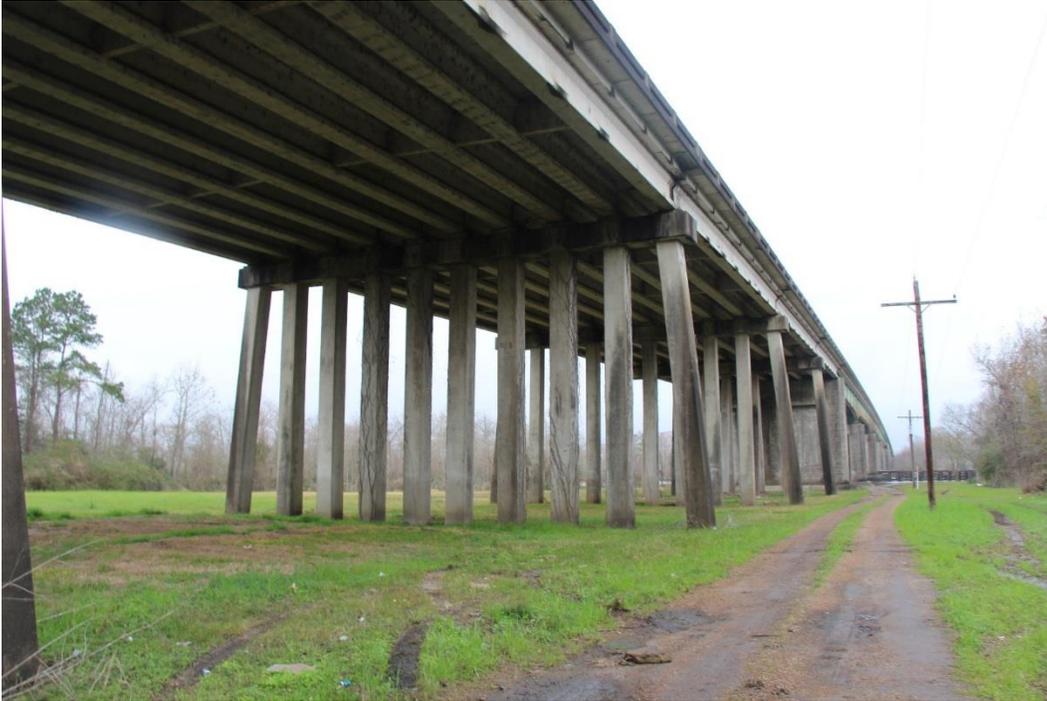
Condition Photo 7: Elevation view of concrete bents of the approach spans.

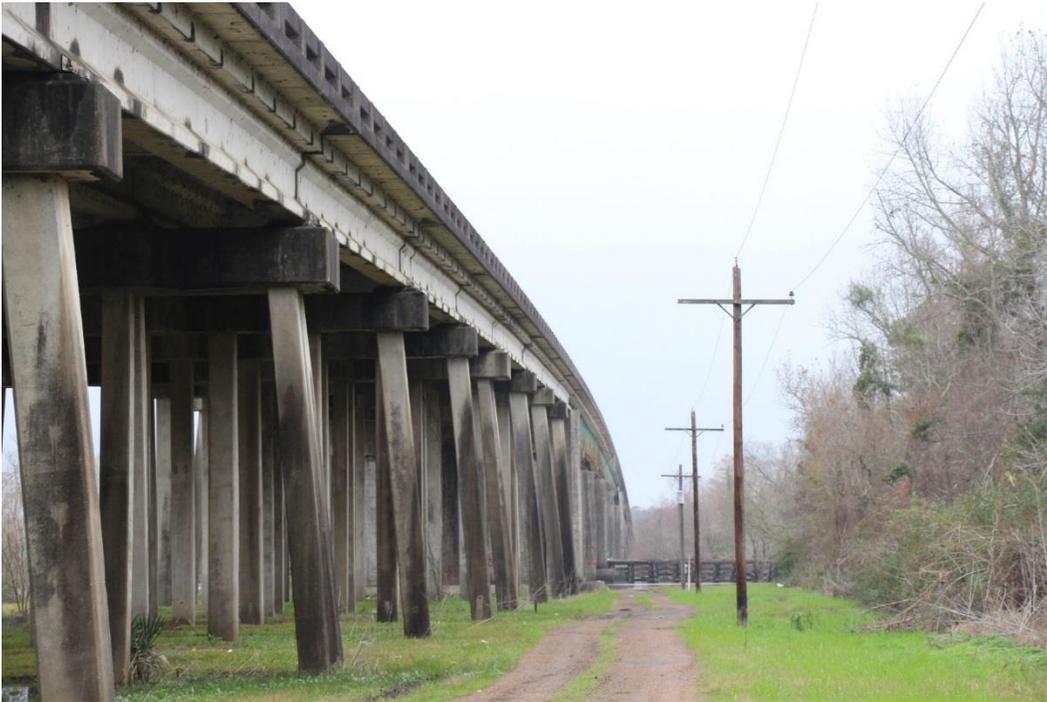
Condition Photo 8: Water staining on the approach span concrete pile bents.

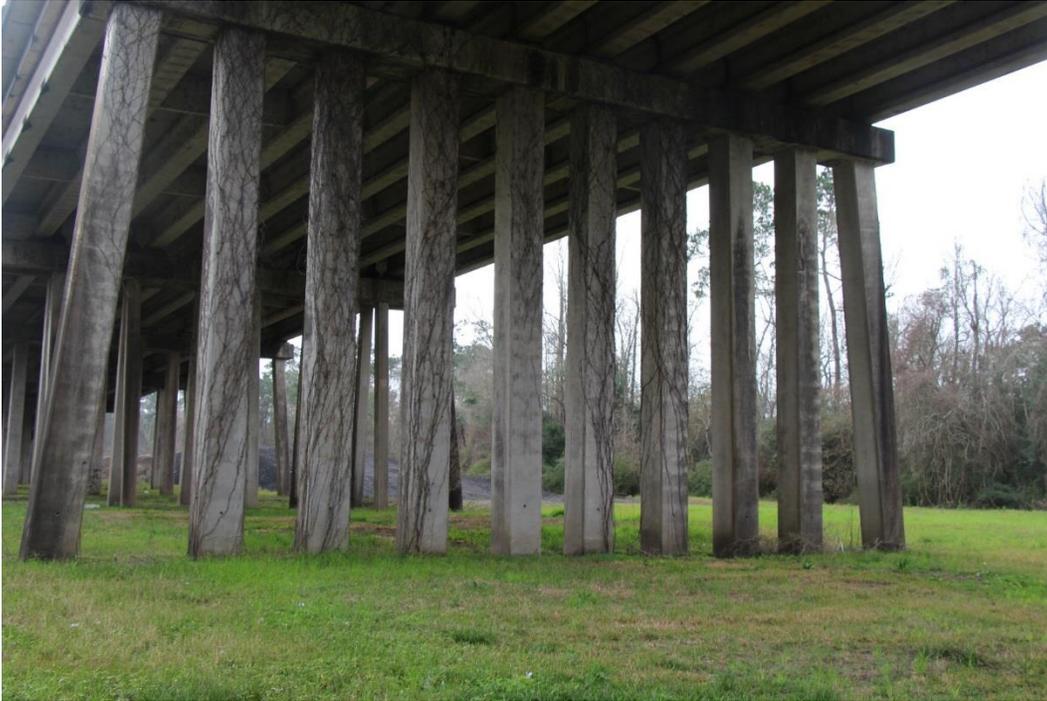
Condition Photo 9: Vines and vegetation growing on the concrete bent pile columns.

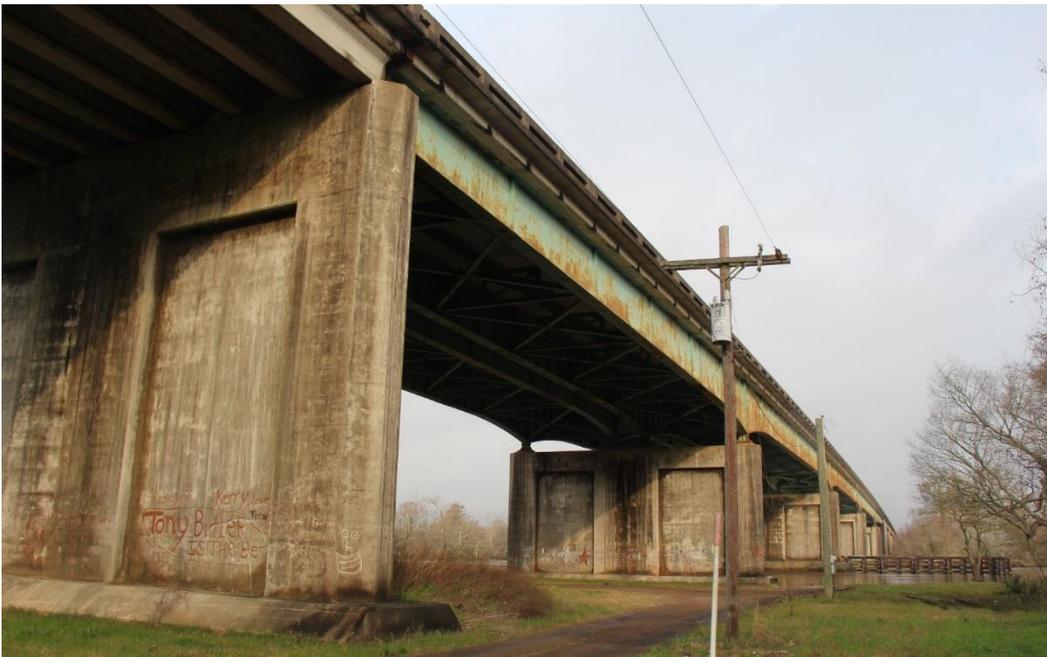
Condition Photo 10: Elevation view of the main span (five steel plate girder spans), showing piers 1 and 2, and showing failure of paint system in steel girder spans.

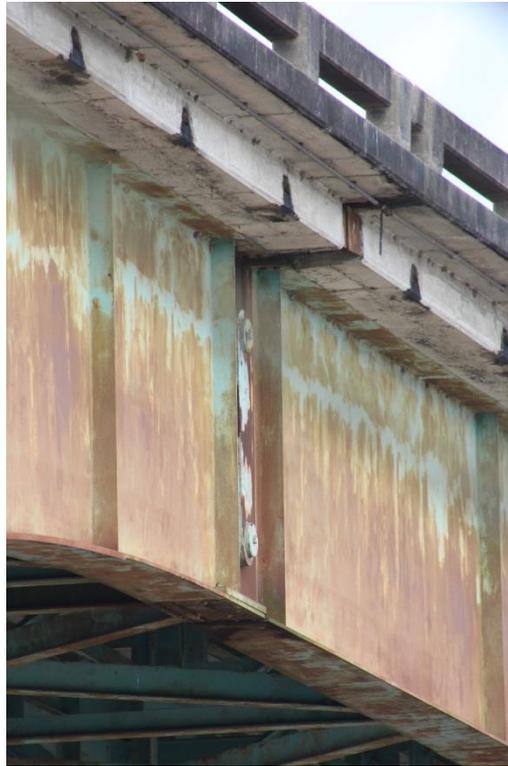
Condition Photo 11: Paint failure of the main span steel girder pin and hanger assembly, typical of all pin and hanger assemblies; also shows failure of paint system on steel girders.

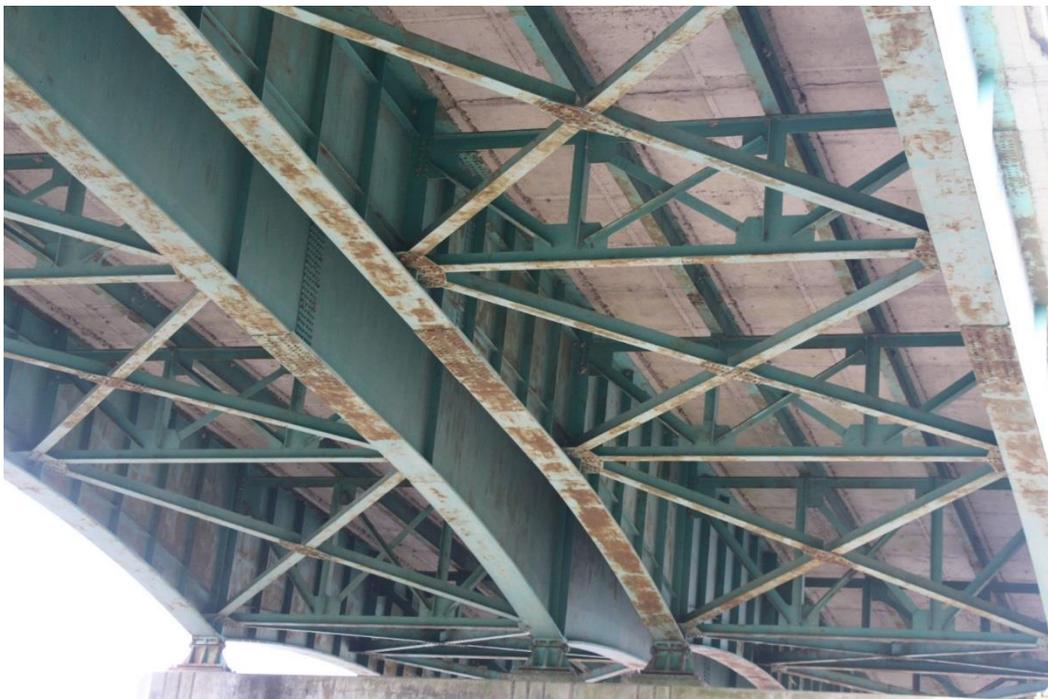
Condition Photo 12: Underside of main spans, steel plate girder paint failure.

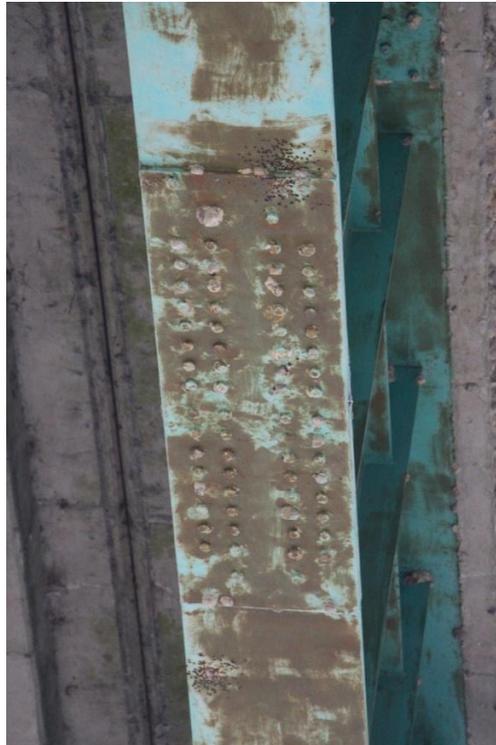
Condition Photo 13: Main span, steel plate girder field splice paint failure, typical at all splices.

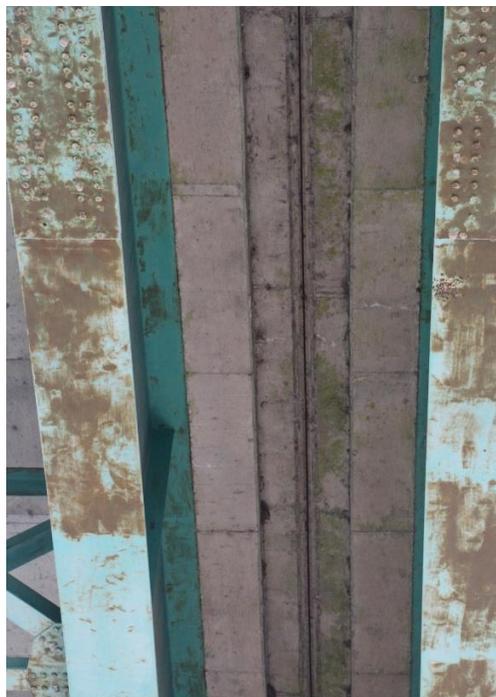
Condition Photo 14: Underside of joint between the northbound and southbound roadways exhibiting efflorescence and staining on the concrete deck underside.

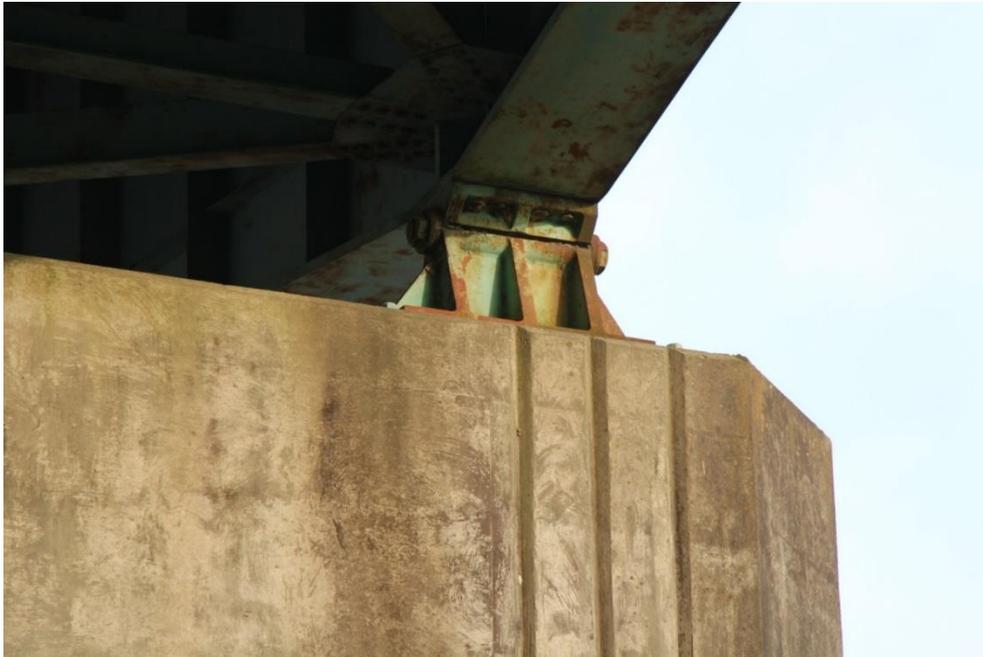
Condition Photo 15: Paint failure at the steel bearings of the main span, typical for all bearings.

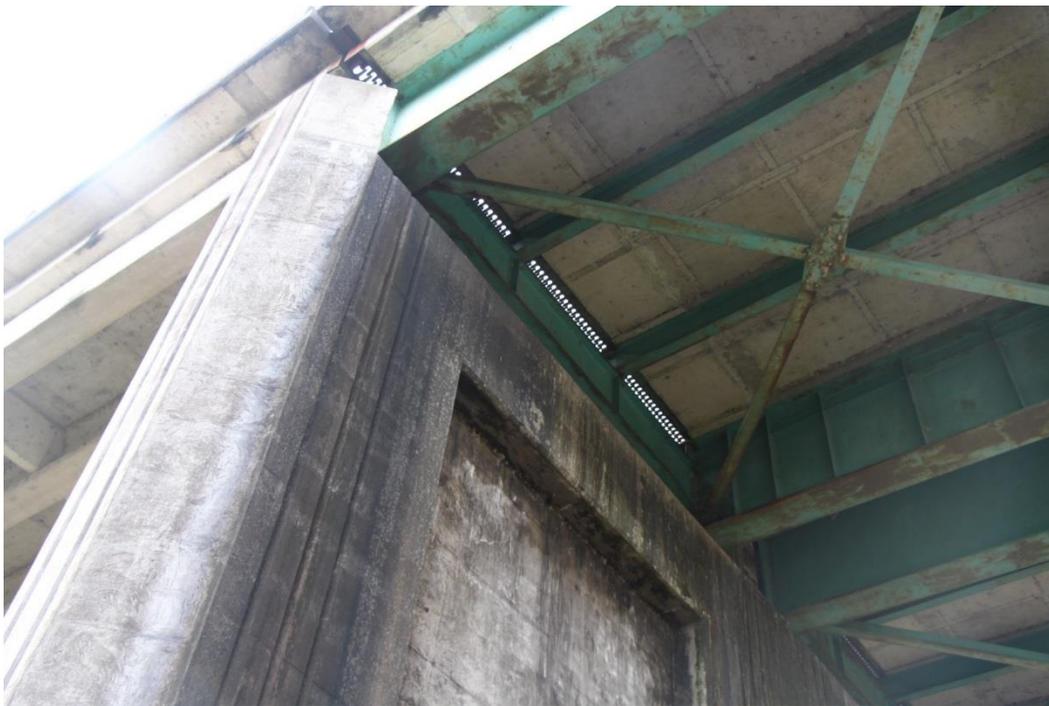
Condition Photo 16: Underside of finger-type expansion joint at the transition from the approach spans to the main span.

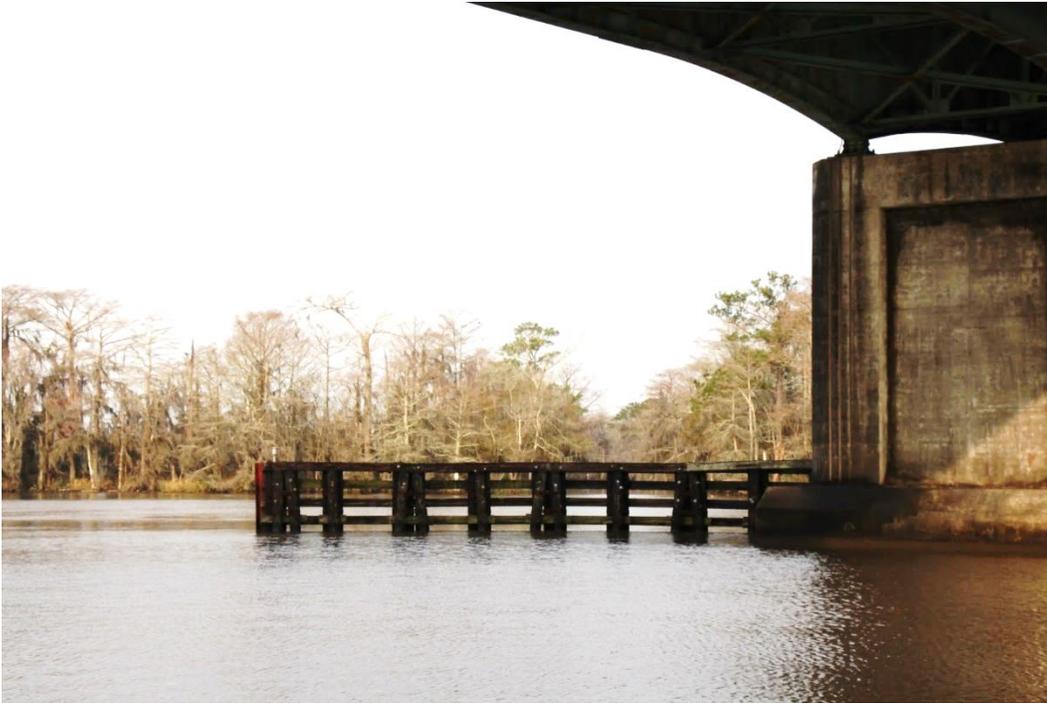
Condition Photo 17: West timber fender system.

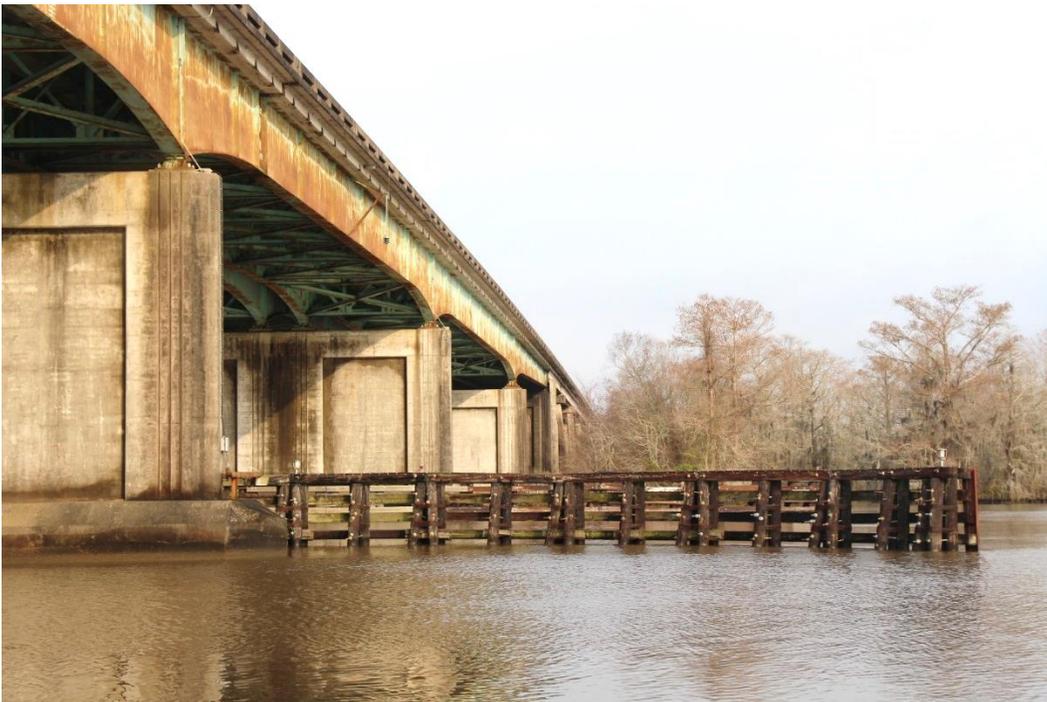
Condition Photo 18: East timber fender system.
