# Pre-1946 Timber Review

## Louisiana Statewide Historic Bridge Inventory

## Louisiana Department of Transportation and Development

January 2016

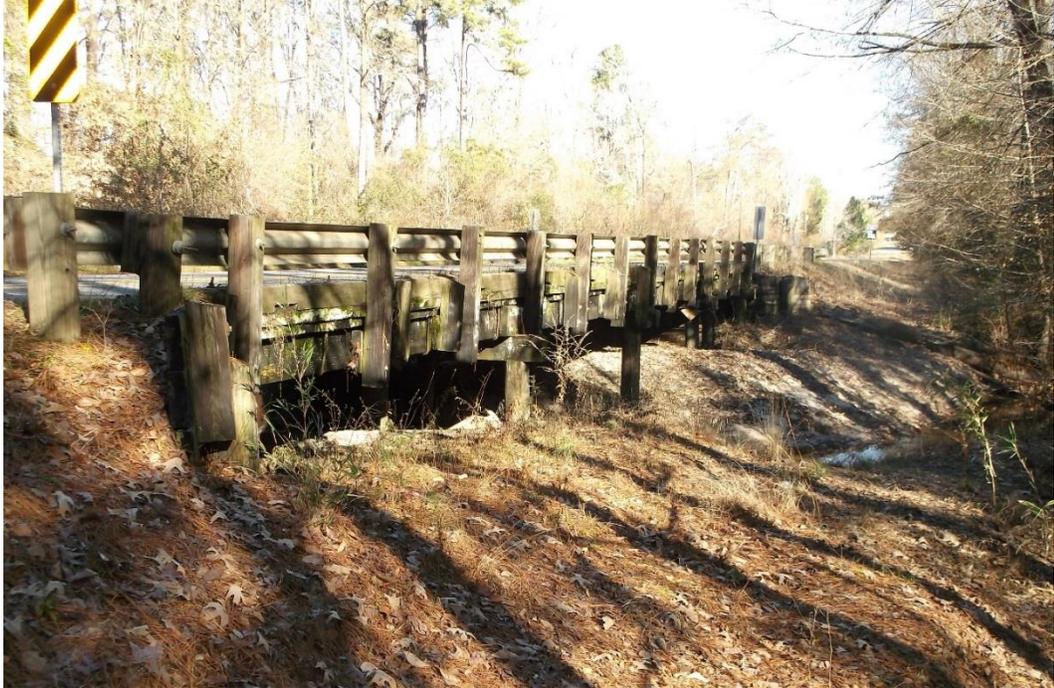
Figure 1. Bridge 038290 in Natchitoches Parish, built in 1926. The bridge has four main spans and an overall length of 78 feet. See Figure 2 for another view.

The earliest extant timber bridge in the state is Bridge 038290, built in 1926 (see Figures 1 and 2 in Appendix A). The bridge is a four-span, treated, timber trestle structure with an overall span length of 78 feet. The longest individual span is the typical 19 feet. This bridge has a replacement steel guard rail and alterations to the substructure, including the encasement of three piles in concrete, the addition of four helper piles (an additional pile driven in to add support next to an existing pile), and the strengthening of the timber cap at bent 2 with an additional timber beam bolted to the cap. Bridge 038290 is noted in the project microfilm file of the LADOTD as standard plan B-20-60; however, there is no further record at LADOTD of this standard plan. The specific use of this standard plan or another in the construction of Bridge 038290 cannot be documented. Bridge 038290 is very similar in form and construction as other extant timber bridges.

Although this is the oldest extant timber bridge in the state, it was constructed nine years after the development of standard plans for this type and after the type was well established in the state. Therefore, it does not reflect the pre-standardization period of timber bridge construction, nor does it represent the earliest use of the timber trestle bridge type in Louisiana since there would have been examples constructed before the development of standard plans in 1917. Therefore, Bridge 038290 does not demonstrate significance under *Criterion C*.

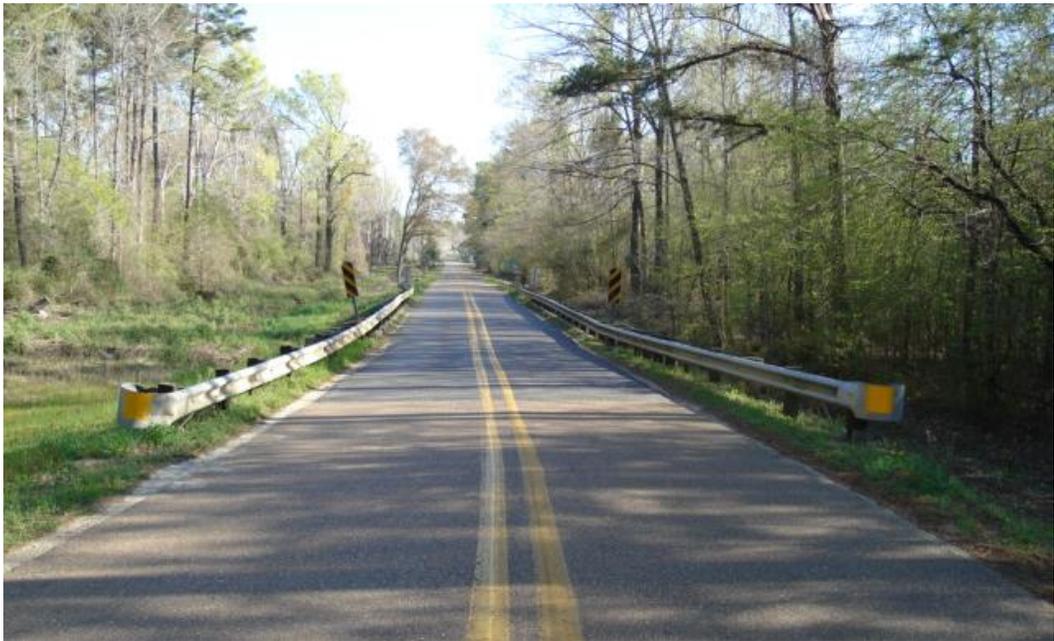
Figure 2. Bridge 038290, deck view. See Figure 1 for another view.

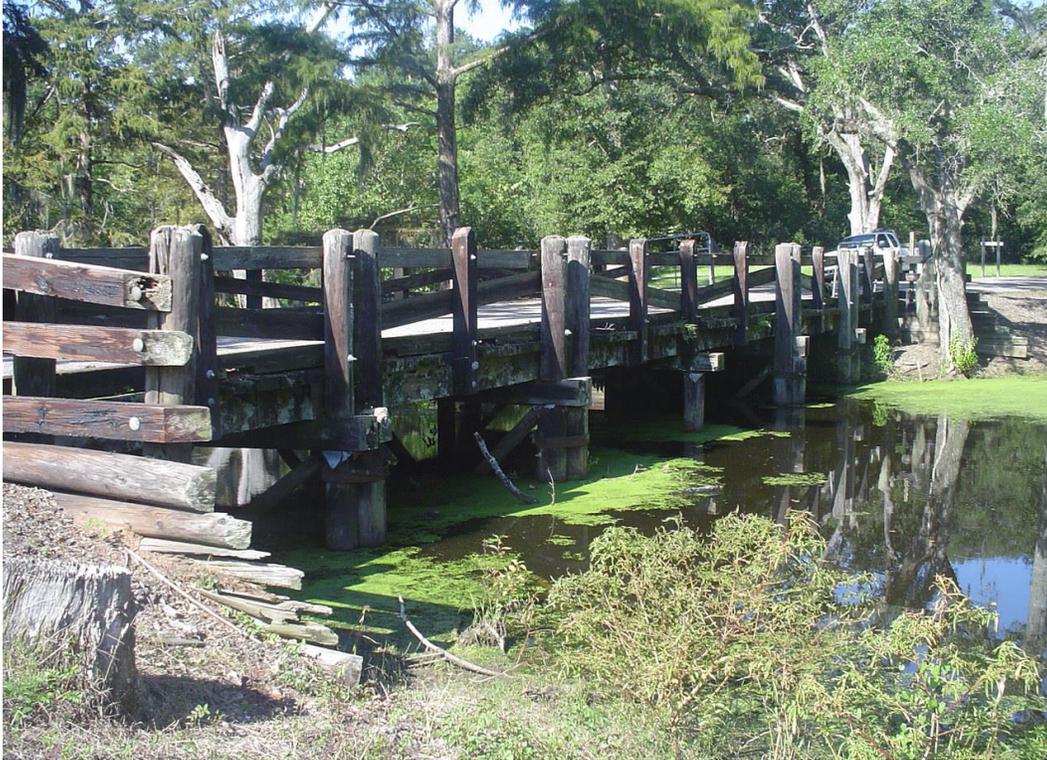
*Figure 3. Bridge 008900 in St. Martin Parish, 1938. This bridge has five main spans, with the longest individual span—29 feet—within the study pool. Overall length is 86 feet.*

The majority of pre-1946 timber trestle bridges have an individual maximum span length of 19 feet. Two bridges in the study pool have an individual span length over 19 feet: one at 29 feet (Bridge 008900, see Figure 3) and one at 20 feet (Bridge 600518, see Figures 15 and 16). Span lengths up to 29 feet are seen in the standard plans; therefore, an individual span length over 19 feet was not found to be a distinctive design feature or subtype of this bridge type and does not allow a bridge to demonstrate significance under *Criterion C*.

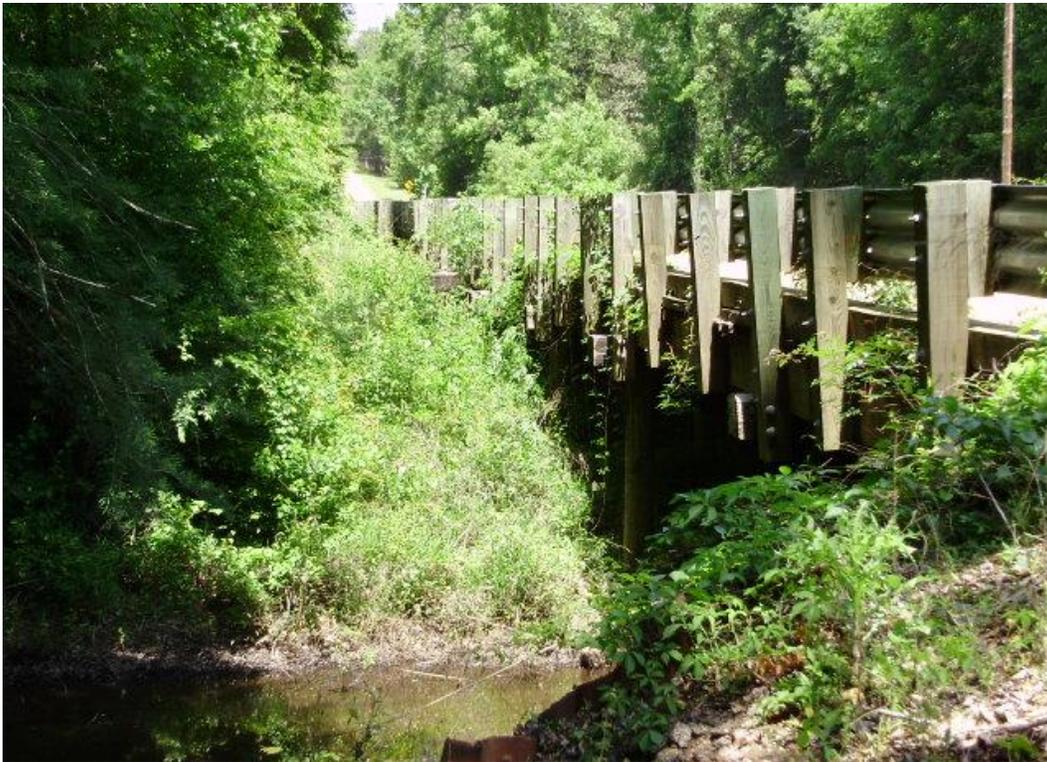
*Figure 4. Bridge 037640 in Grant Parish, 1931. This is the longest example in the study pool – 24 spans comprising 457 feet. See Figure 5 for another view.*

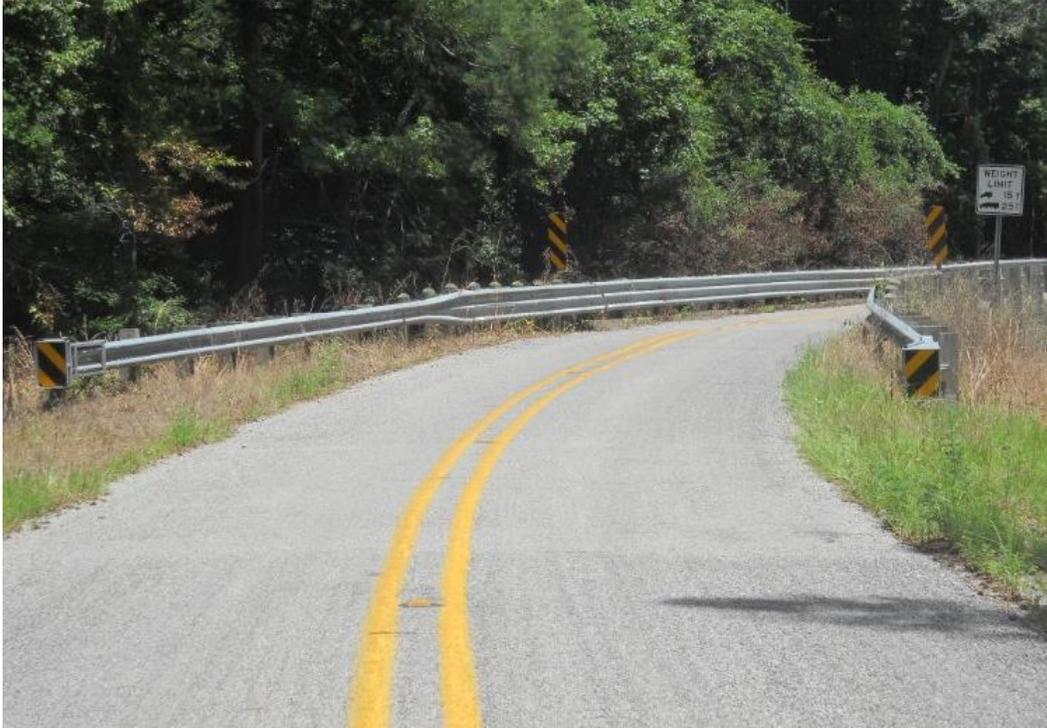
*Figure 5. Deck view of Bridge 037640 in Grant Parish, 1931. This is the longest example in the study pool – 24 spans comprising 457 feet. See Figure 4 for another view.*

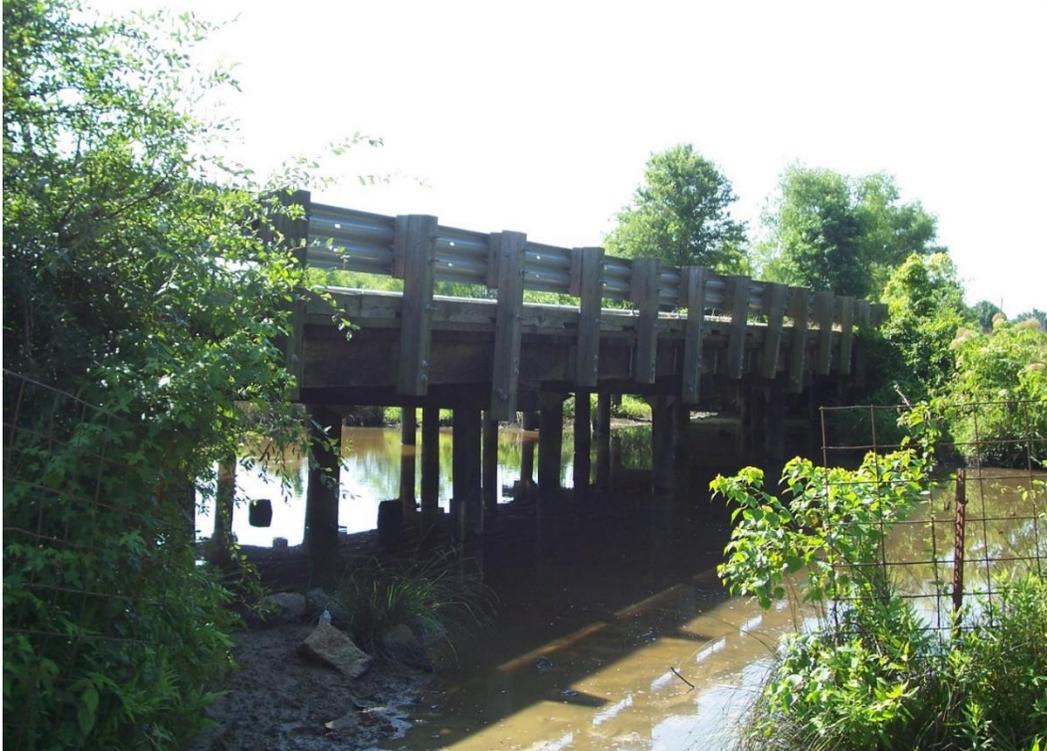
*Figure 6. Bridge 027910 in Union Parish, built in 1936. Example of five or more spans – six main spans (maximum individual span length of 19 feet) comprising an overall length of 115 feet.*

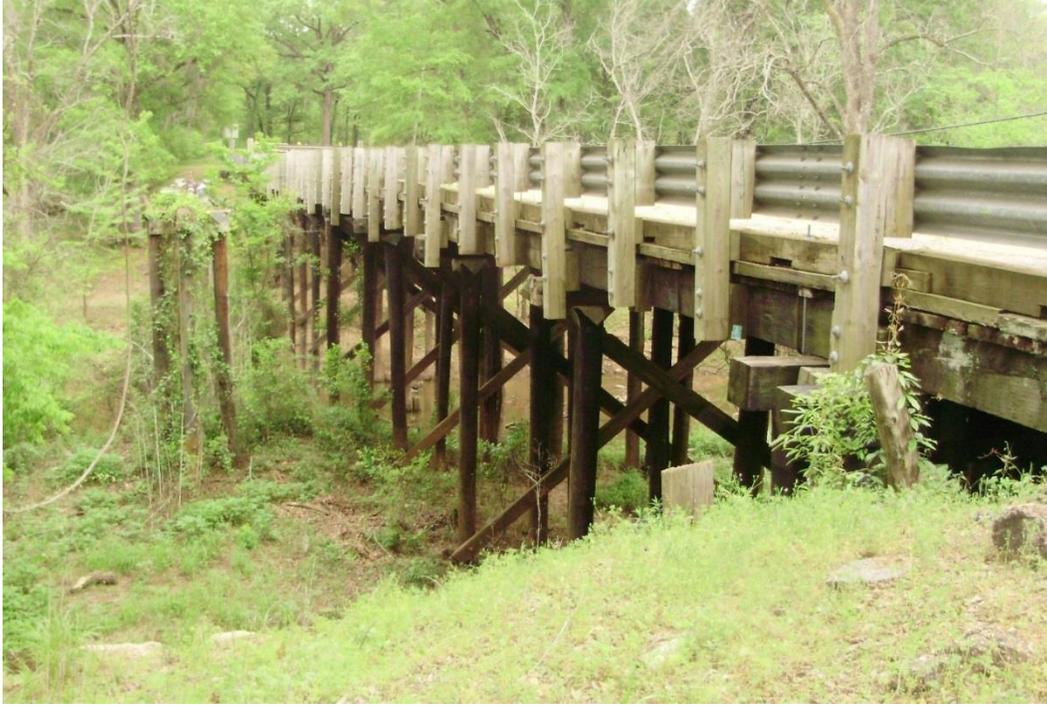
*Figure 7. Bridge 800030 in Grant Parish, built in 1931. Example with five or more spans – 12 main spans (maximum individual span length of 19 feet) comprising an overall length of 223 feet.*

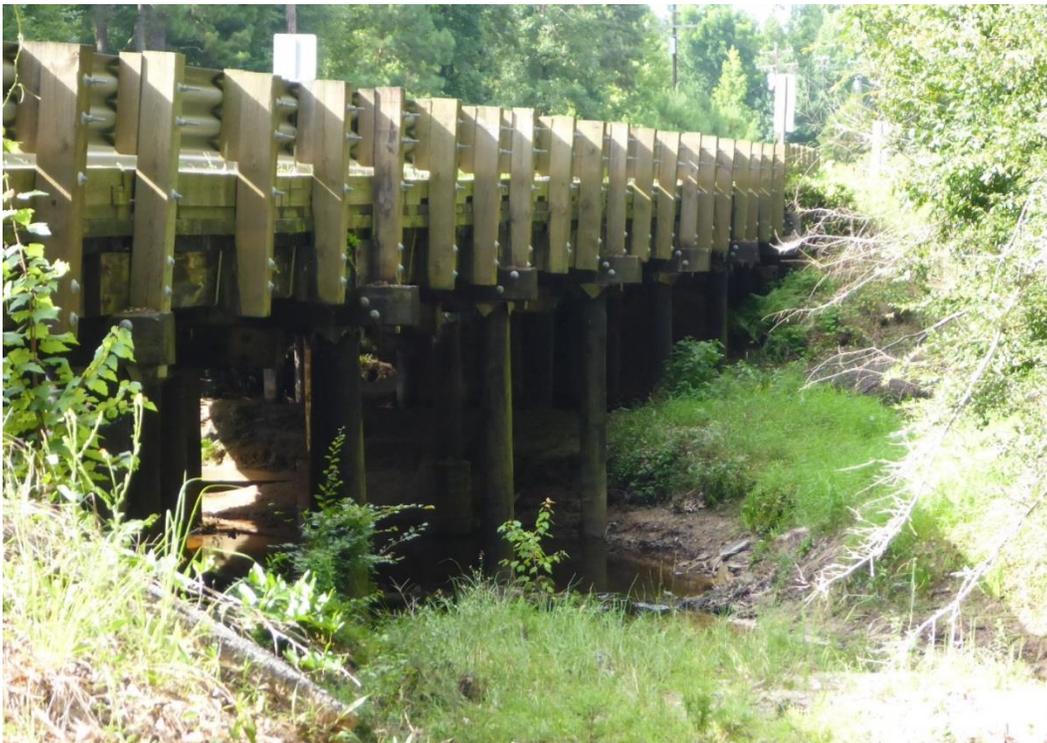
*Figure 8. Bridge 044540 in Vernon Parish, 1944. Example with five or more spans – seven spans comprising an overall length of 135 feet. See Figure 9 for another view.*

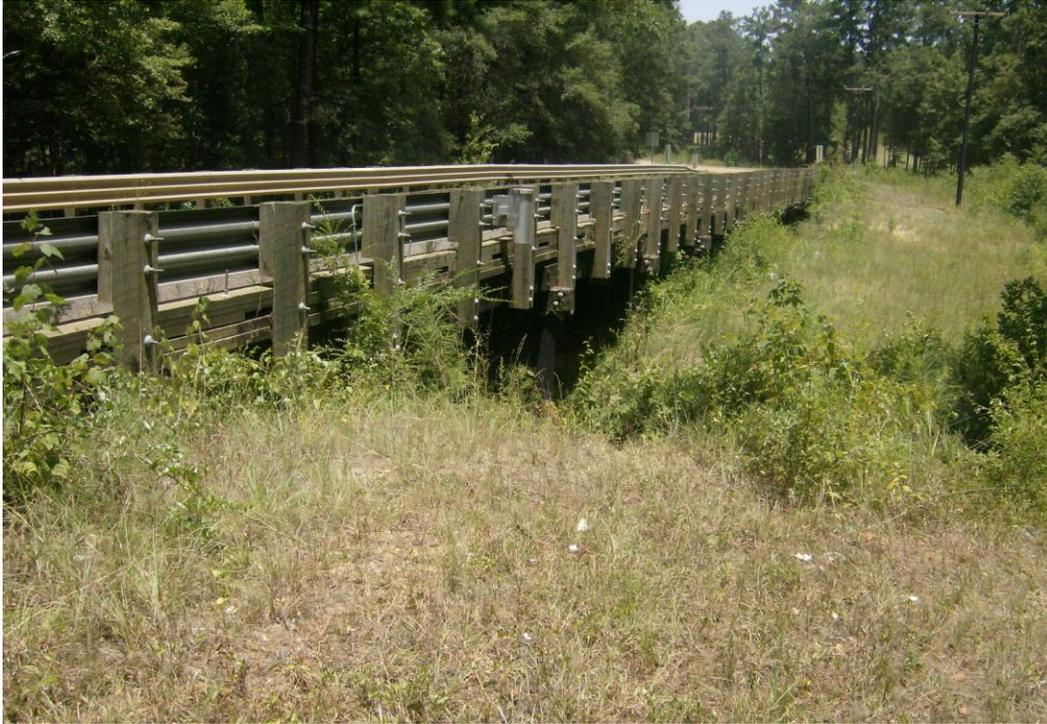
*Figure 9. Bridge 044550 in Vernon Parish, 1944. Example with five or more spans – 10 spans comprising an overall length of 191 feet. See Figure 8 for another view.*

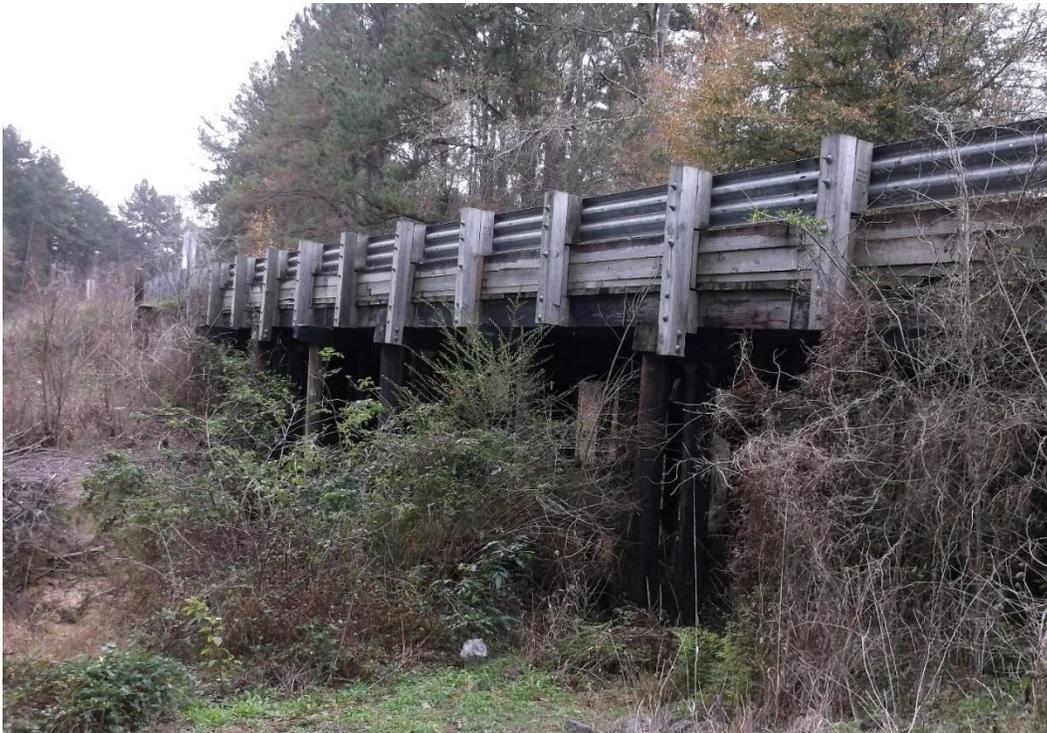
*Figure 10. Bridge 041090 in Rapides Parish, 1940. Example five or more spans – 16 spans comprising 78 feet.*

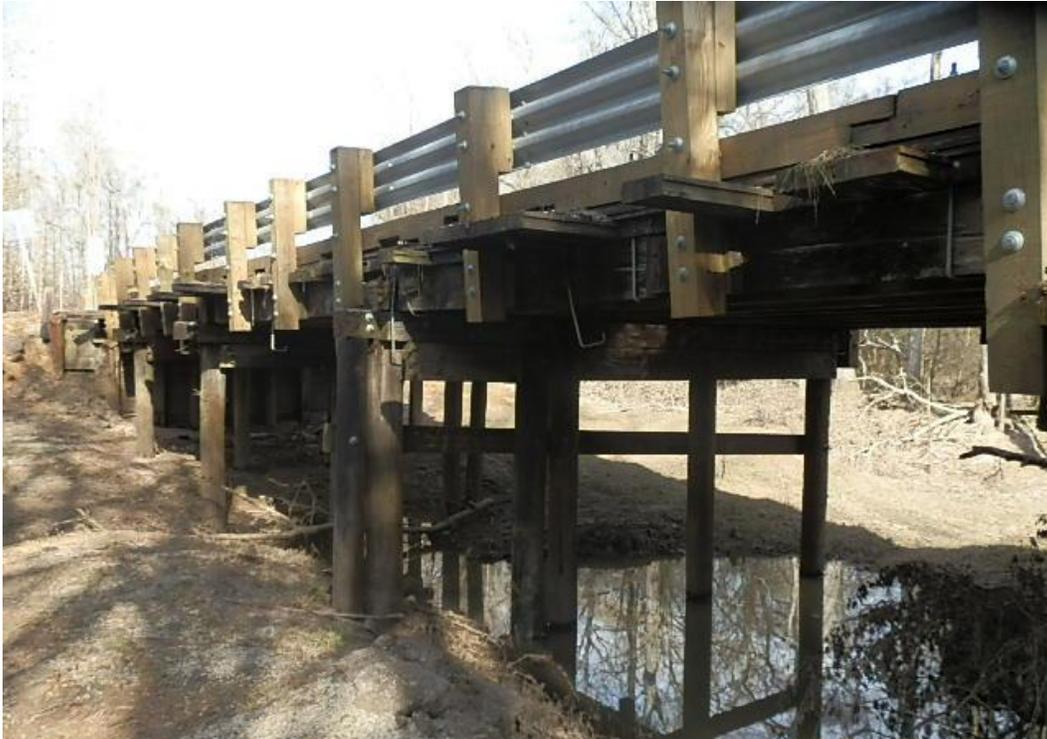
*Figure 11. Bridge 047070 in Caldwell Parish, 1931. Example with five or more spans – five spans totaling 97 feet.*

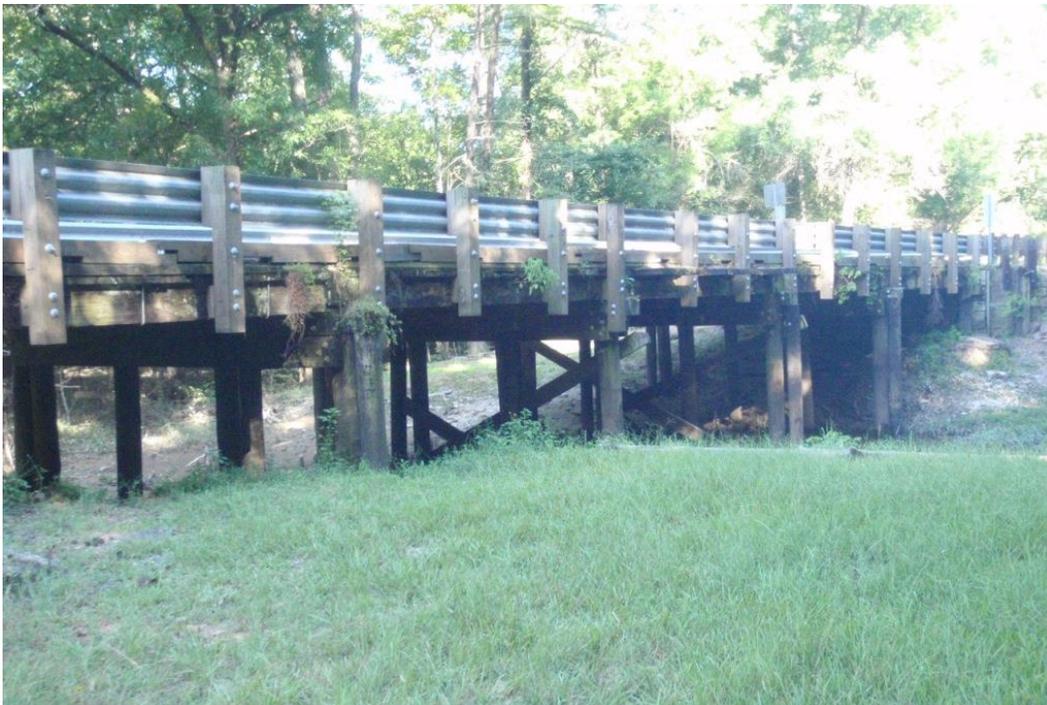
*Figure 12. Bridge 047050 in Caldwell Parish, 1931. Example with five or more spans – five spans comprising an overall length of 97 feet.*

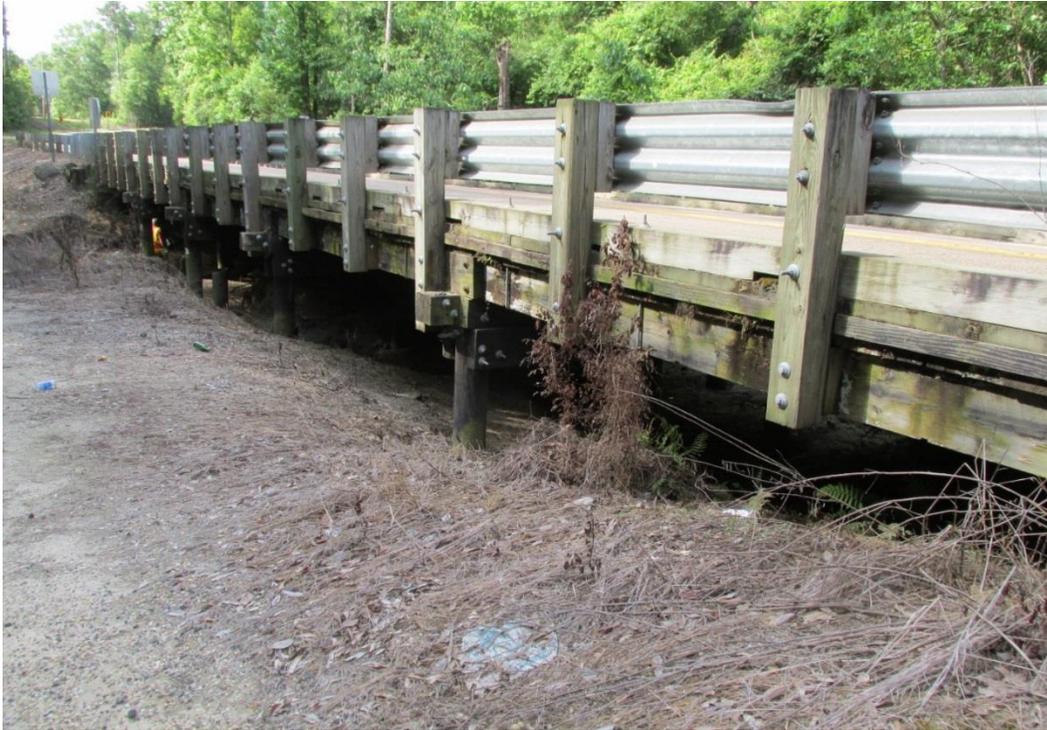
Figure 13. Bridge 065000 in Washington Parish, 1942. Example with five or more spans – five spans comprising an overall length of 97 feet.

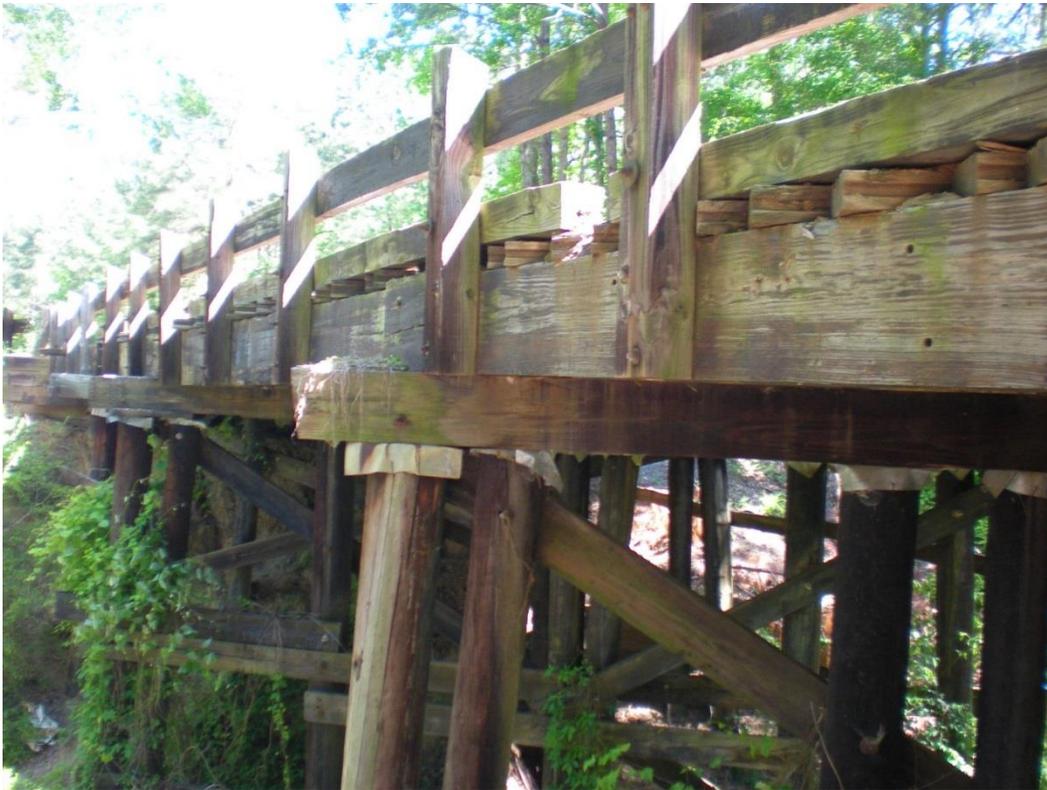
Figure 14. Bridge 400413 in Ouachita Parish, 1942. Example with five or more spans – five spans comprising an overall length of 80 feet.

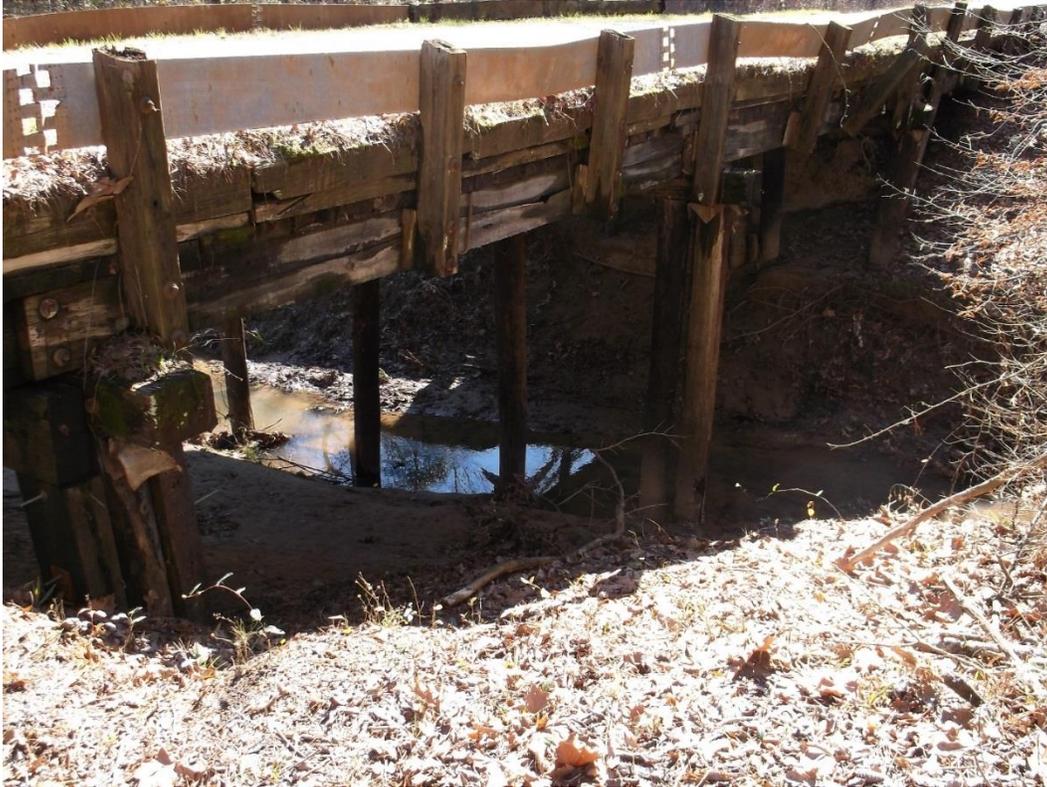
Figure 15. Bridge 600518 in Sabine Parish, 1940. Example of an individual span over 19 feet – four spans comprising an overall length of 77 feet. Longest individual span is 20 feet. See Figure 16 for another view.

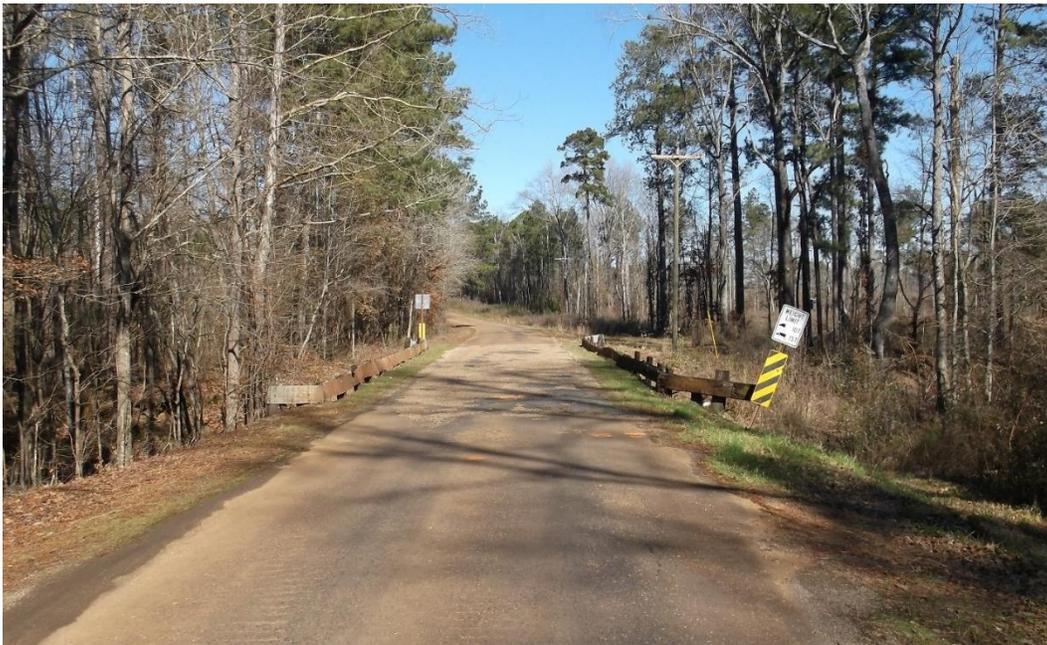
Figure 16. Bridge 600518 in Sabine Parish, 1940. Example of an individual span over 19 feet – four spans comprising an overall length of 77 feet. Longest individual span is 20 feet. See Figure 15 for another view.
