RE: Asbestos Survey Report
State Project Number: H.003453
Project Name: Lafayette Connector
510 NW Evangeline Thruway, Lafayette, LA

The following letter report summarizes the findings of the Asbestos Survey completed by Leaaf Environmental, LLC (Leaaf). The survey was conducted on the Sanctuary and Fellowship Hall building located on the vacant church property (parcel # ADV-66-P1) at 510 NW Evangeline Thruway, Lafayette, LA. Refer to Appendix A for an illustration of the location of the property.

Project Name: Sanctuary & Fellowship Hall Parcel ADV-66-P1

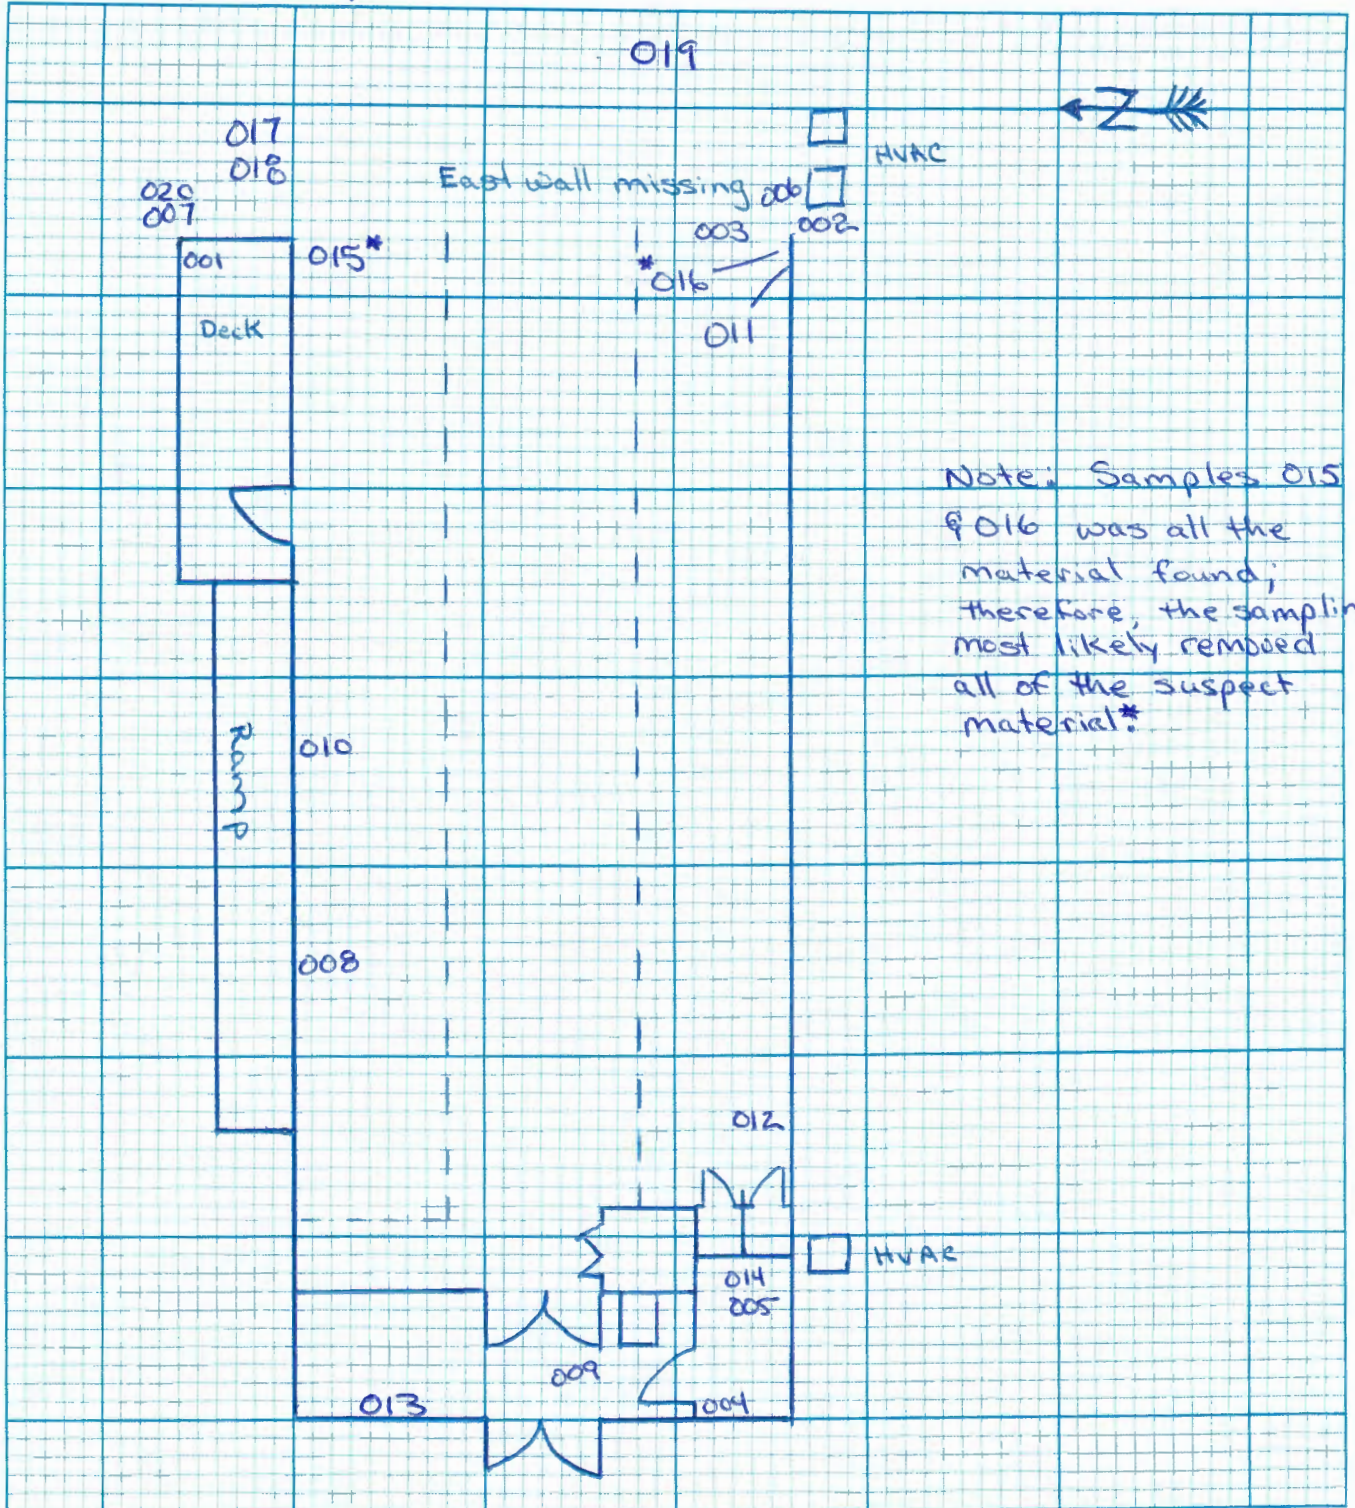
Sample Map

Note: Samples 015 & 016 was all the material found; therefore, the sampling most likely removed all of the suspect material*.

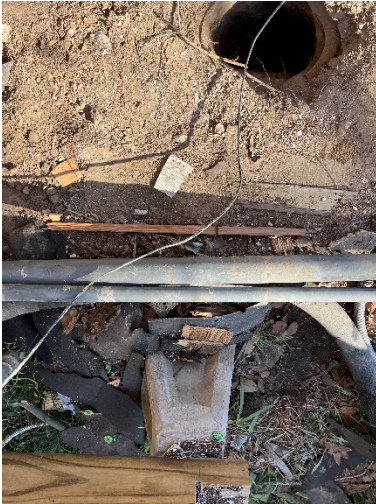
Photo of Asbestos Containing Material

Photo of area where transite debris
was sampled.

Sample Layers	Asbestos Content
Gray Transit with Paint	20% Chrysotile
Sample Composite Homogeneity:	Good

The LDEQ defines asbestos-containing materials as having an asbestos content of 1% or greater. Based on the PLM analytical results, asbestos above the regulatory limit is present in the following building materials sampled: gray transite debris (20% chrysotile asbestos). The demolition contractor and/or their subcontractor will need to fill the appropriate forms with the LDEQ in accordance with the Louisiana Administrative Code, Title 33, Part III.
