RE: Asbestos Survey Report
State Project Number: H.004100
Project Name: I-10: LA 415 to Essen on I-10 & I-12
1234 E Washington St, Baton Rouge, Louisiana 70802

The following letter report summarizes the findings of the Asbestos Survey completed by Leaaf Environmental, LLC (Leaaf) on April 27, 2022, by Louisiana Department of Environmental Quality (LDEQ) Asbestos Inspectors Gary Brooks (CERT # AI102434) and Sadie Jill Hunt (CERT # JI215979). The survey was conducted on the property located at 1234 E Washington St, Baton Rouge, Louisiana 70802. Refer to Appendix A for an illustration of the location of the property.

Asbestos Inspection
 1234 E. Washington St.
 Baton Rouge, LA 70802
 April 27, 2022

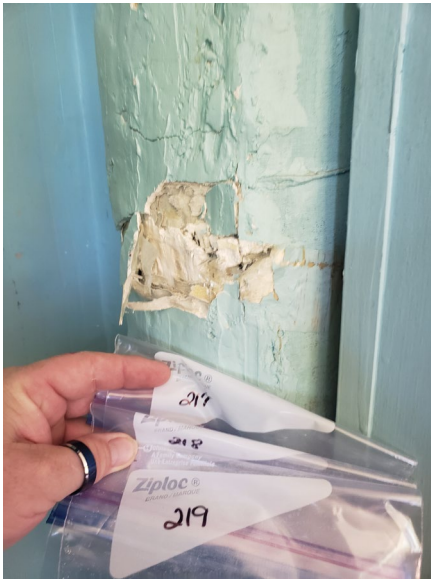
Asbestos-Containing Materials	Estimated Quantities
Gray Pipe Insulation (6" diameter)	approximately 10 ft

Gray Pipe Insulation 6" Diameter
