CONCRETE BRIDGE - FIRE DAMAGE EVALUATION – by Don Sorgenfri

Inspection and Repair of a Fire Damaged Prestressed Girder Bridge

RICHARD STODDARD, Washington State DOT, Olympia, WA

DAMAGE INSPECTION REPORT 12/12/02

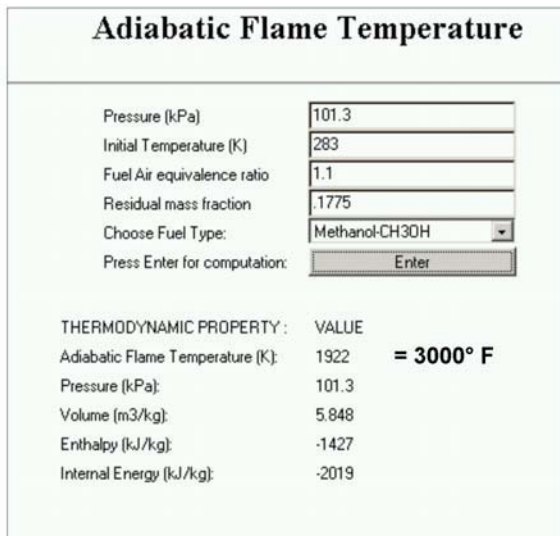
Figure 1 – Methanol Flame Temperature

The flame temperatures of the fire were estimated to be approximately 3000° F. This estimate was calculated with the use of an On-Line software program provided by Dr. Allan T. Kirkpatrick, a professor of Mechanical Engineering at Colorado State University, (Figure 1).

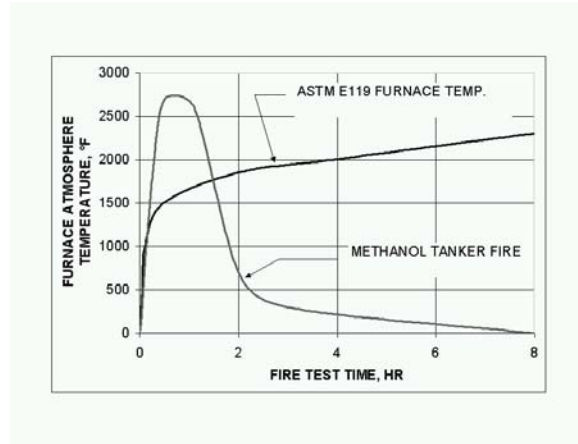
Figure 2. Temperature vs Time

Calculations were made to estimate the heat energy released by the methanol fire. A comparison of the intensity of this fire to ASTM E119 fire tests was helpful in determining the probable heat penetration and concrete damage within the girders. PCI publication MNL-124-77, *Design for Fire Resistance of Precast Prestressed Concrete*², provides the temperature and heat energy applied during the ASTM fire tests as well as graphs for establishing isotherms within concrete beams. Furnace temperatures for the ASTM fire test reach a maximum of 2300° F after eight (8) hours of exposure. It is likely that the methanol tanker fire projected temperatures of 2700° F to the bottom of the girders after only one-half (1/2) hour and temperatures fell below 1000° F after two (2) hours. Figure 2 compares the ATSM furnace temperatures to a possible heat time history for the methanol tanker fire. Differences can be seen in temperature and duration. The tanker fire was hotter but temperatures subsided more quickly than prescribed for the ASTM test.

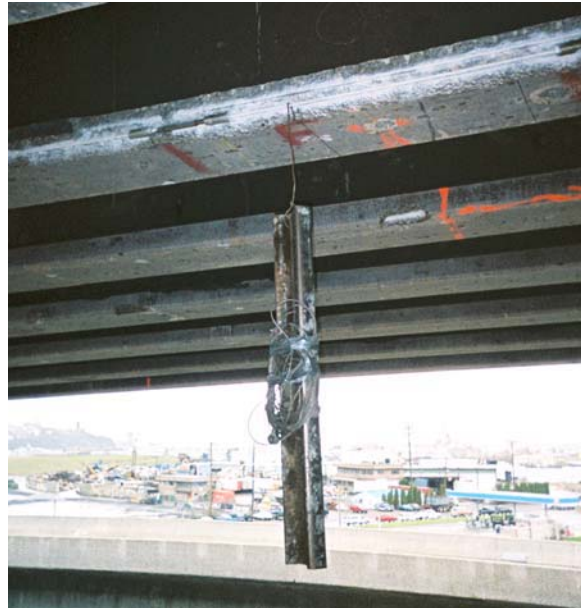
Photo 6. Deflection Test Dead Weight

Prior to removing samples of prestressing strands for material testing, a simple deflection test was performed to calculate the prestressing force remaining in the exposed strands. The deflection tests were conducted on exposed strands with exposed lengths varying from 8 feet to 14 feet. The tests were conducted before the strands were cut and after the cable replacement splices were tensioned. Cable deflections were induced by hanging a 4 foot piece of rail provided by the BNSF Railroad. The rail and the attachment cable provided a dead weight of 173.3 pounds.

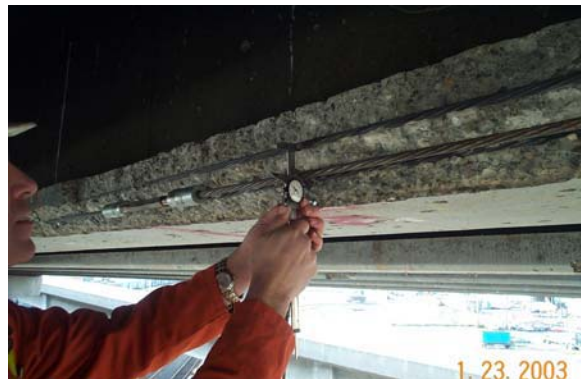
Photo 7. Deflection Test Measurement

The cable deflections were measured multiple times by two inspectors using a dial reading caliper with an accuracy of 0.001 inches. The readings were averaged to provide a deflection for the tension calculation. The exposed span length for the deflection test was measured between the points at which the strands re-entered the concrete.

The deflection tests were performed 40 feet above the ground and there was concern about the accuracy of the measurements. The actual location of vertical support points for the exposed strands could extend into the concrete, the displacement measurements could be affected by random placement of the calipers, and the overall accuracy could also be affected by error in the dead weight. Based on these concerns, it was concluded that the span length measurements were accurate to within 2 inches, the dead weight was accurate to within 0.1 pound, and the deflection measurements were accurate to within 0.001 inches. Combining all of these possible measurements errors produces a 3% change in the calculated tension. Additional errors may be present in this method but it is believed that the field test had a

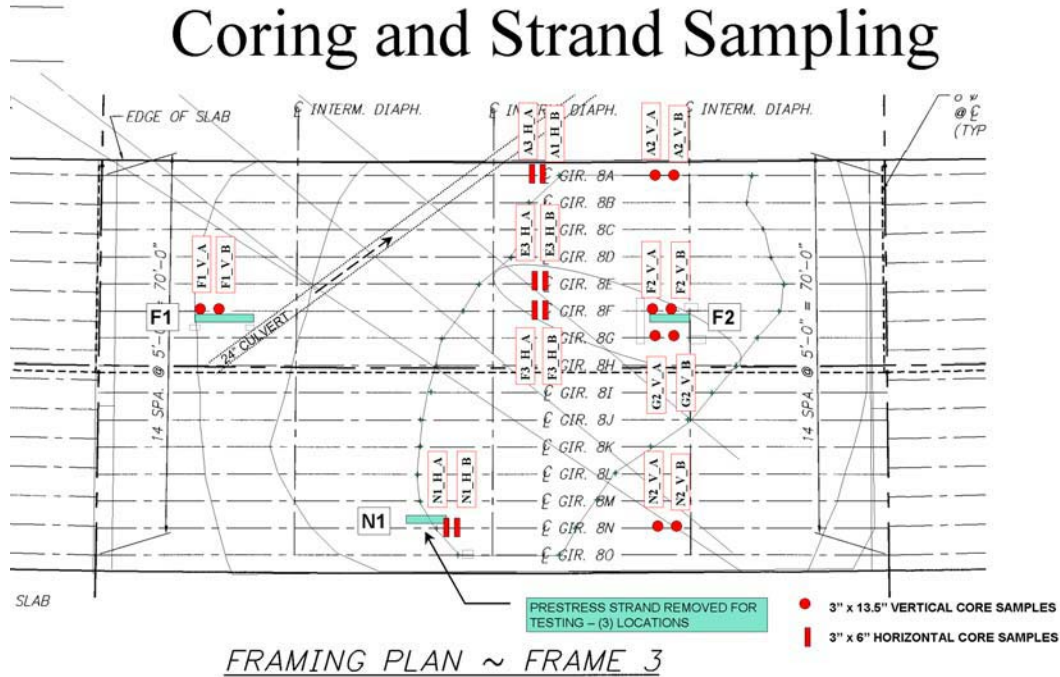
Figure 8. Concrete Core Sample and Prestress Stand Sample Locations

Three samples of the prestressing strands in Span 8 were removed for lab testing to determine their material properties, Figure 8. Two samples of strand number 2 were removed from Girder 8F. Sample F1 was located near Pier 8 at the boundary of the Soot colored region well away from the hot zone, (Figure 3). The concrete in this region displayed very little damage from the fire. Sample F2 was located directly above the tanker fire in the Extreme-White color region, (Figure 3). Concrete in this region crumbled when tapped with a hand held rock hammer and could be crushed with finger pressure. One sample from Girder 8N, labeled N1, was taken at the eastern edge of the Ash-White color region, (Figure 3). Concrete in this region spalled when struck with a hand held rock hammer resulting in 6 inch long chunks that were difficult to break with hand pressure. The material and strength tests were performed by Smith-Emery Laboratories in Los Angeles, California. The report⁶ concluded that the material and strength properties of the strands samples met the requirements for 0.5 inch diameter uncoated seven wire prestress strands as described in ASTM A 416-96 and ASTM A370. Test results are shown in Table 2.

Conclusions: The prestressing strands retained the original material properties and design prestress force despite being surrounded by concrete that was significantly degraded by the heat of the fire.

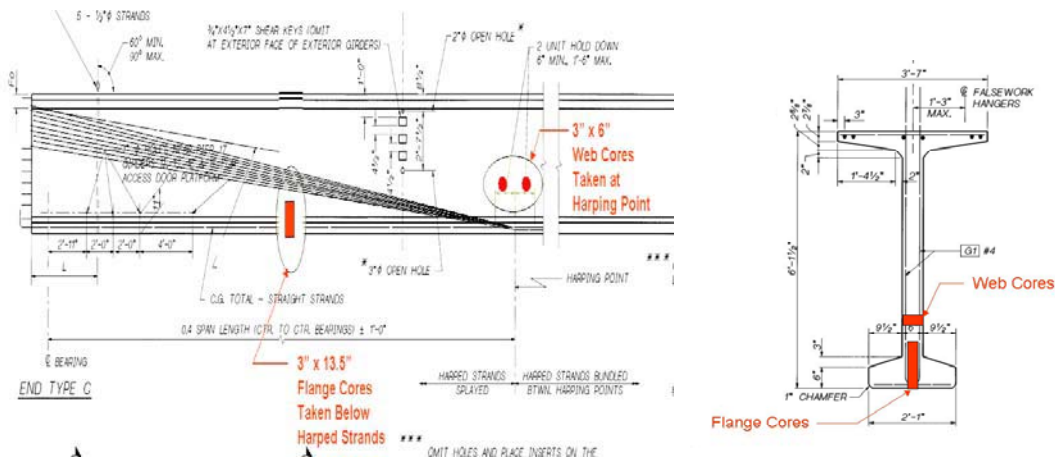
Figure 9. Concrete Coring Located to Avoid Prestressing Strands and Rebar

Concrete core samples were removed from eighteen locations in the webs and bottom flanges of six girders in Span 8. Vertical cores measuring 3 inches in diameter by approximately 13½ inches deep were removed from ten locations in four girders. Eight of the vertical cores were taken from the hot zone in Girders 8A, 8F, 8G, and 8N. Two vertical cores were taken from in the coolest heat zone of Girder 8E, which was near Pier 8. Eight horizontal cores measuring 3 inches in diameter by 6 inches deep were taken in the hot zones near mid-span of Girders 8A, 8E, 8F, and 8N.
