# Louisiana Dam Owners' Workshop

July 2023

Tim Harper, PE  
DOTD Public Works & Water Resources  
Dam Safety Program

# Louisiana Dam Safety Program

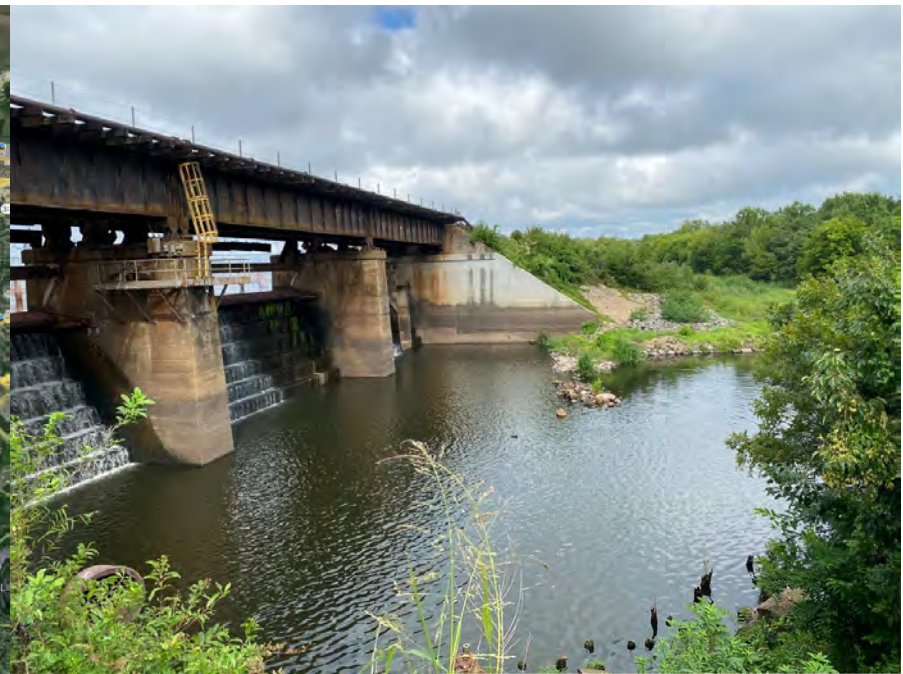
# High Hazard Dam – Cross Lake

8,700 Acres, 50' Tall, Dam Length: 8100'

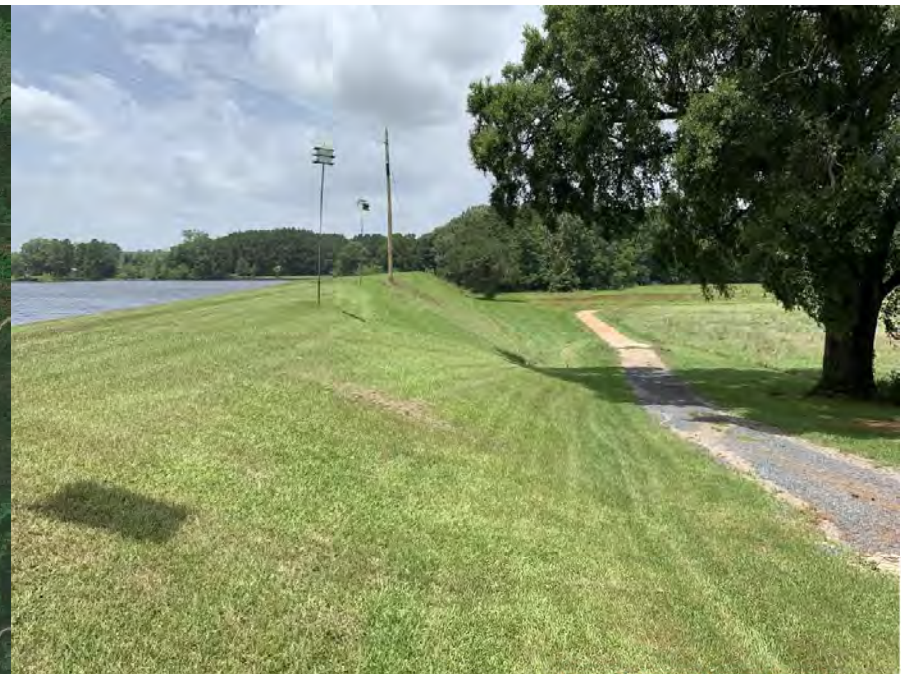
# Significant Hazard Dam - Bayou Dupont No 10 98 Acres, 26' Tall

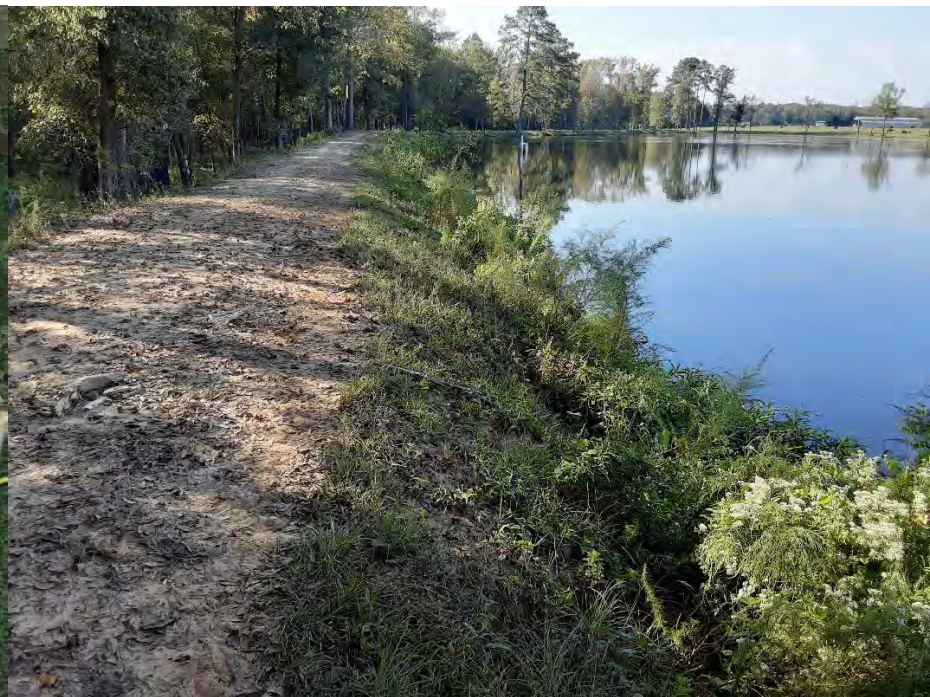
# Low Hazard Dam - Lacy Lake Dam 20' Tall, 13 Acres

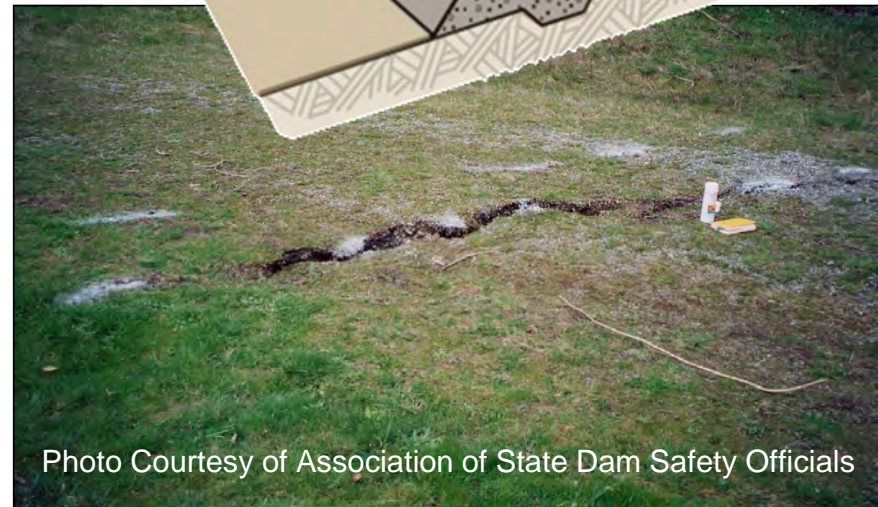
**Transverse  
Cracking**

## Crest Transverse Cracks

- Differential settlement of embankment
- Foundation settlement

- Seepage paths through cracks can lead to internal erosion and failure

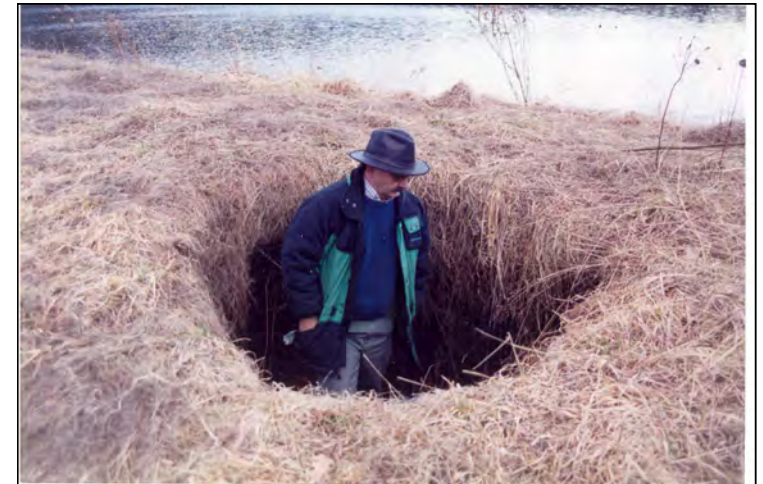
- Collapse of embankment fill into piping hole, animal burrow, or hole associated with breakdown of dispersive soil; settlement over outlet works conduit

- Possible Consequence

- Sinkhole could represent serious piping problem in the embankment leading to failure

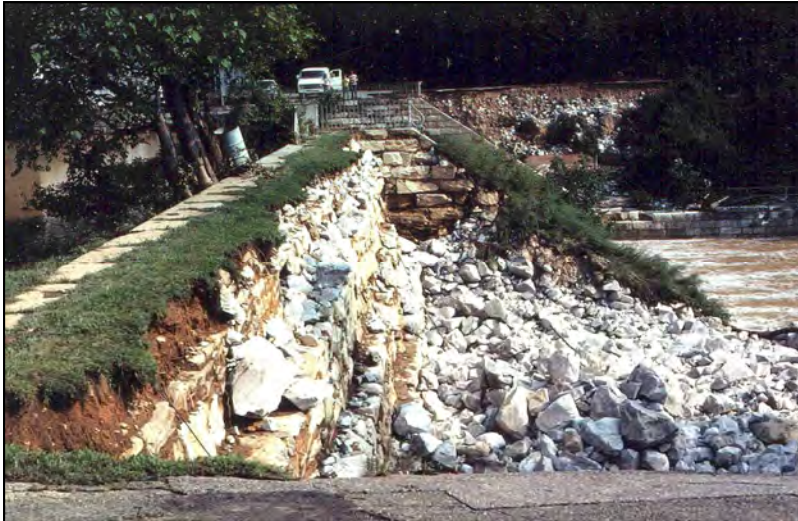
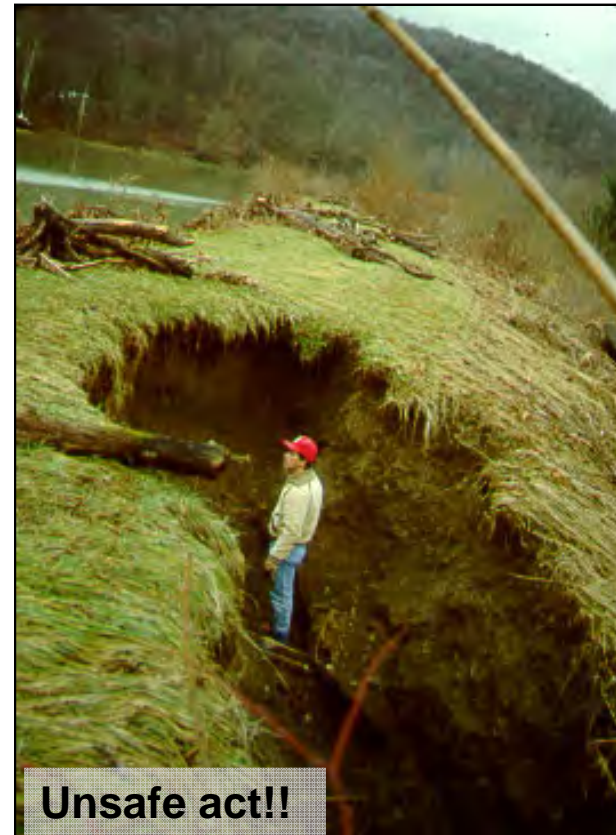
Major erosion and near breach caused by overtopping

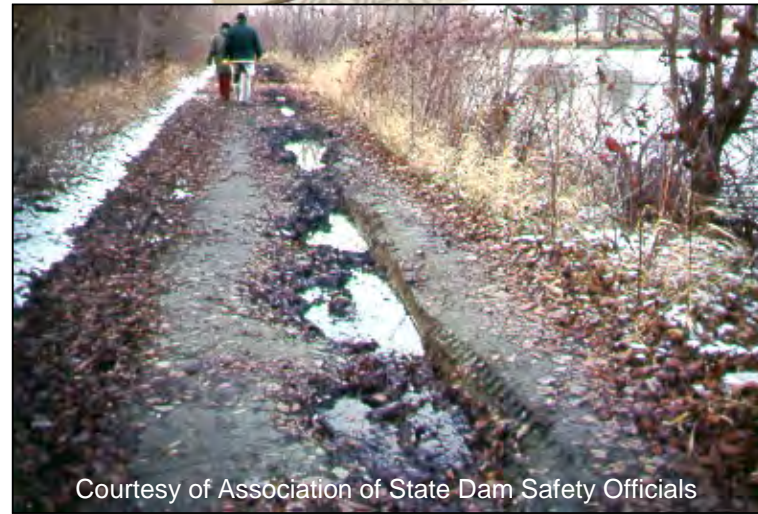
## Crest Ruts

- Ponded water on crest/seepage into embankment
- Loss of freeboard

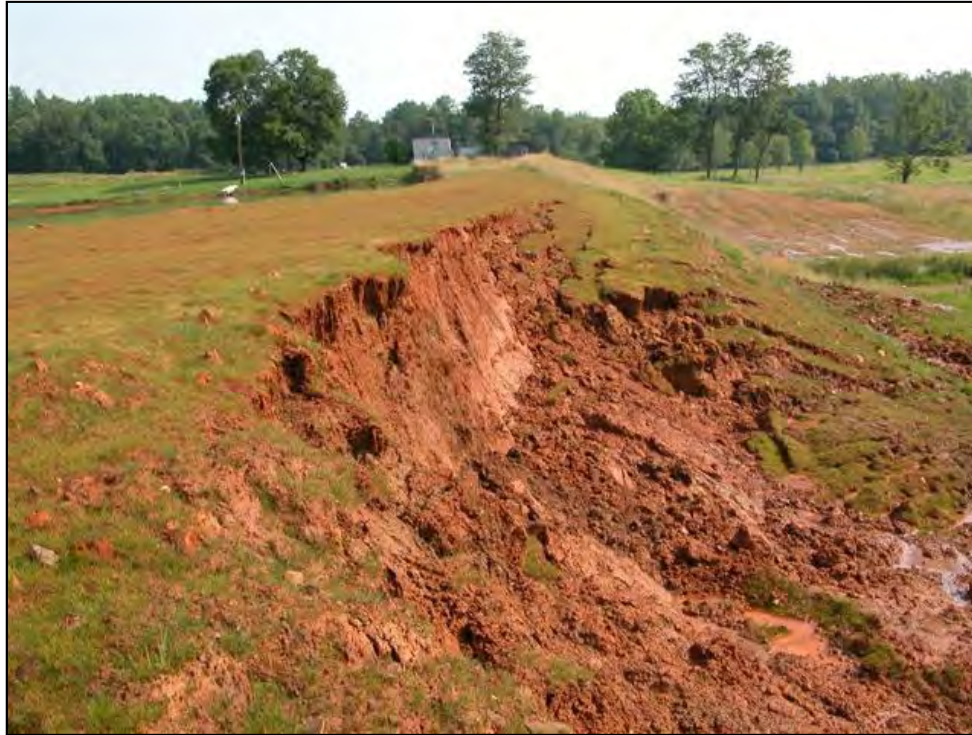
# Downstream Slide - Instability due to Uncontrolled Seepage

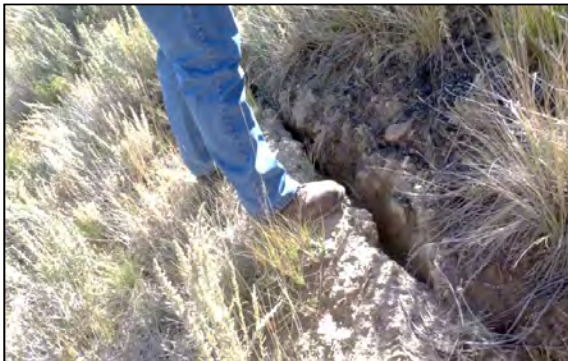
**Longitudinal  
Cracking**

# Downstream Slope Longitudinal Cracking

- Differential settlement of embankment or foundation
- Downstream movement
- Drying cracks

- Can allow surface water to enter, freeze and worsen cracks
- Can lead to slumps/slides
- Can fill with water, reducing stability

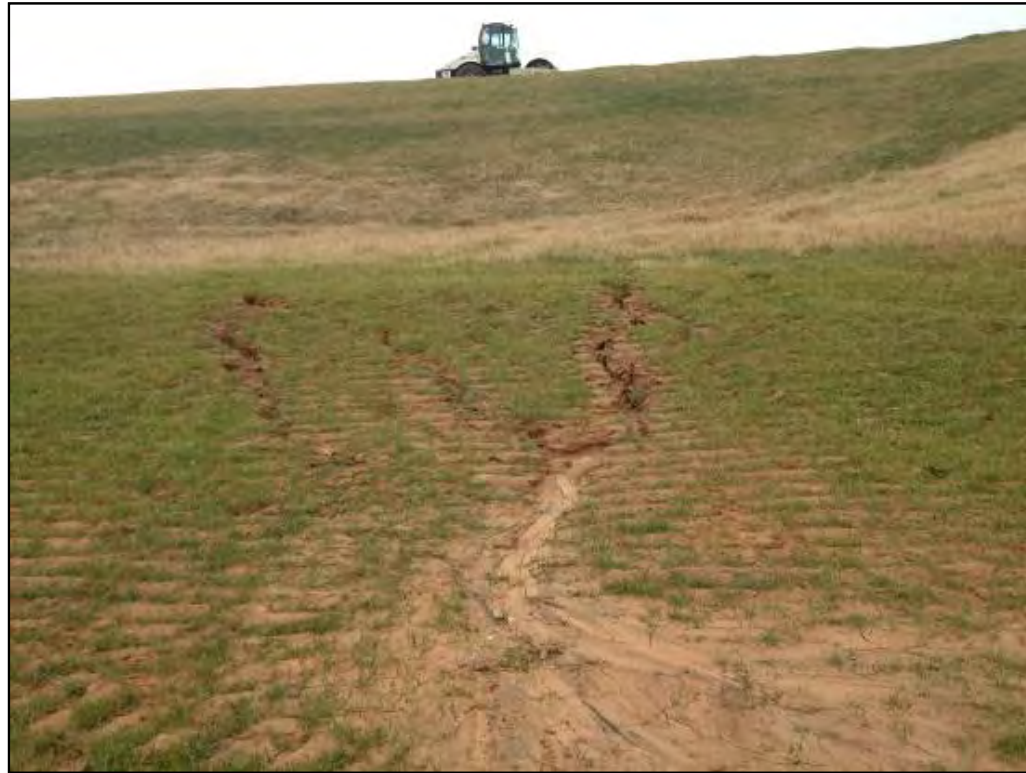
## Downstream Slope – Sparse Vegetation

Likelihood of downstream slope erosion increases if vegetation is sparse.

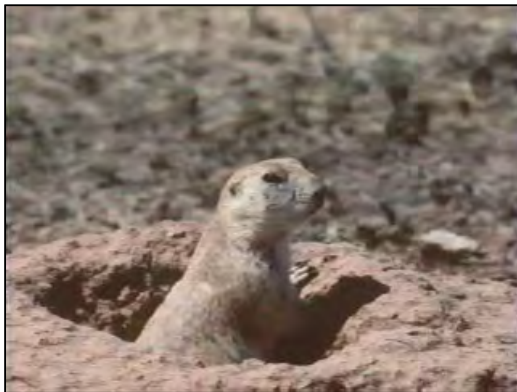
## Downstream Slope – Animal Burrows

- Possible Cause
  - Water attracts wildlife
  - Vegetation attracts wildlife
- Possible Consequence
  - Burrows can become seepage paths
  - Burrows can reduce seepage path distance
  - Burrows can collapse leading to erosion, loss of freeboard and other problems

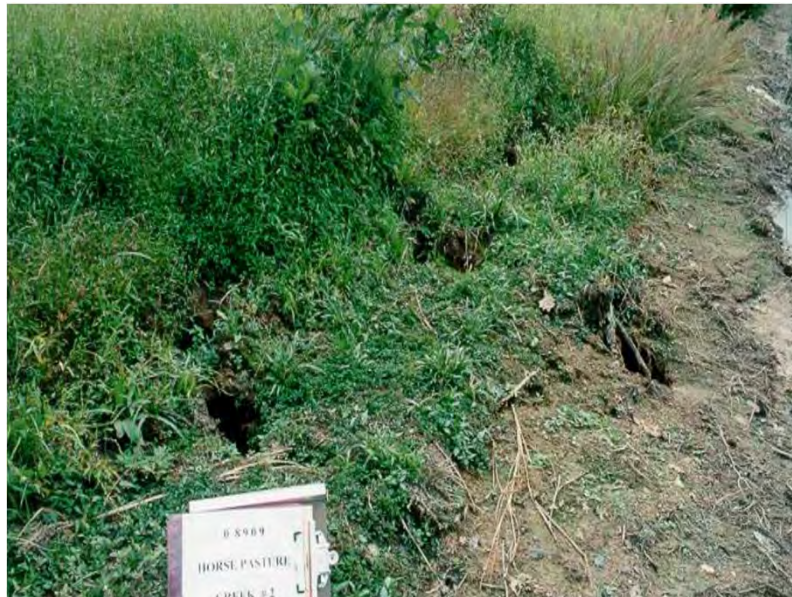
# Animal Activity

Uncontrolled Animal Activity Could Lead  
To Uncontrolled Seepage and Piping Failure

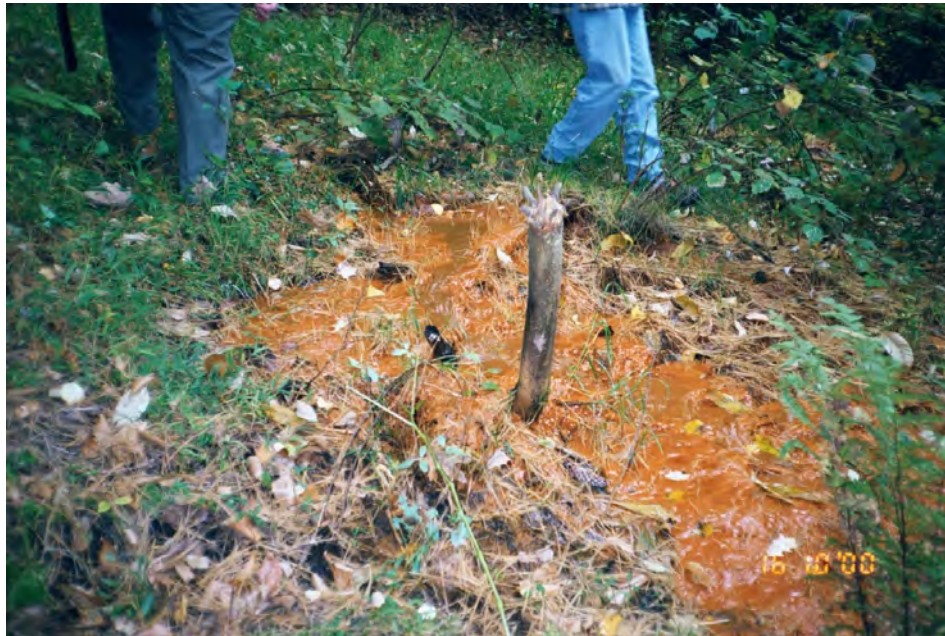
**Plugged Embankment Drains Could Lead To Excessive Seepage and Boils At Toe That Could Lead To Embankment Failure**

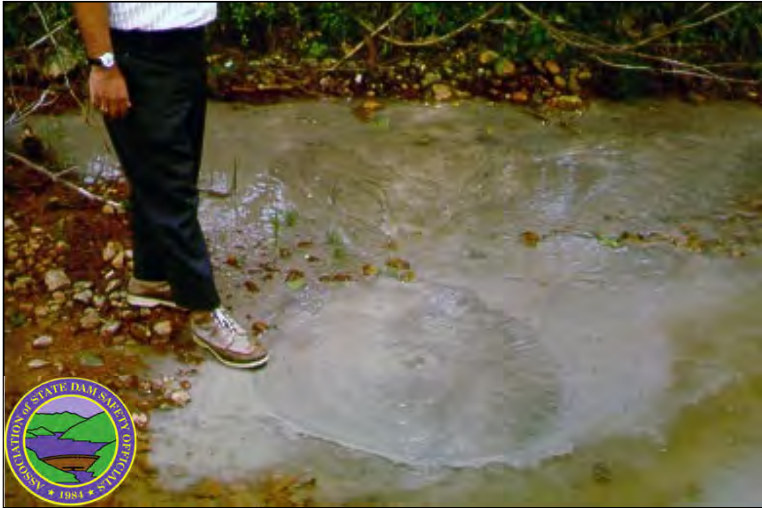
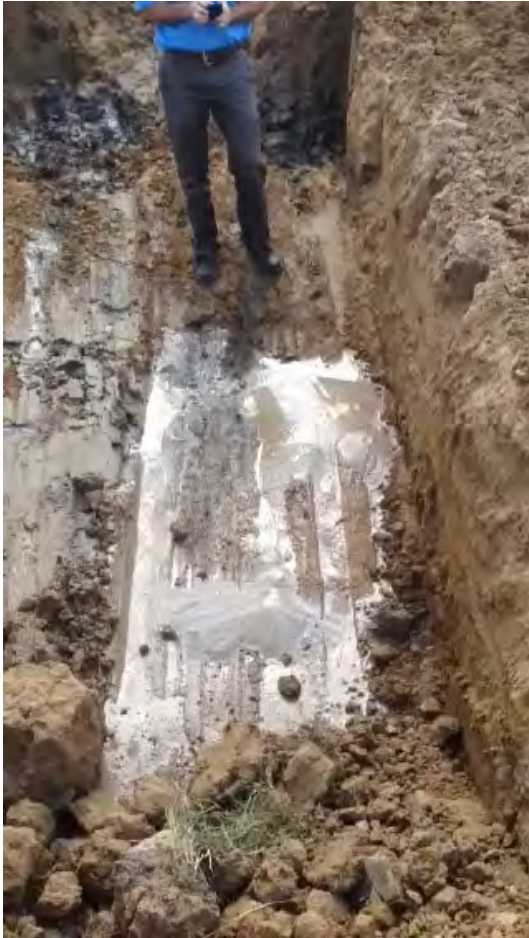
# Sand Boils

- Bubbling up or “boiling action” caused by high seepage exit velocities usually in fine sandy soil
- Sand boils may indicate piping; look for:
  - Cloudy discharge
  - Cone of sand around seepage exit point
- Take immediate action:
  - Record pool level and elevation/location of boil
  - Photograph
  - Record seepage flow
  - **Get professional help to address. Condition may be serious**

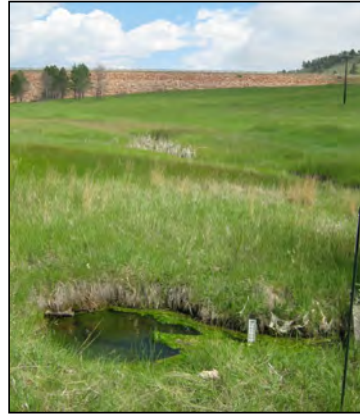
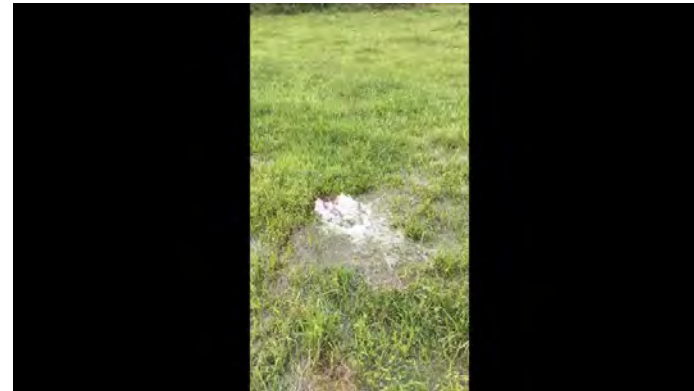
### Downstream Area Seepage

May not be a concern depending on seepage volume, distance from embankment, and whether water is cloudy or clear, but still should be reported

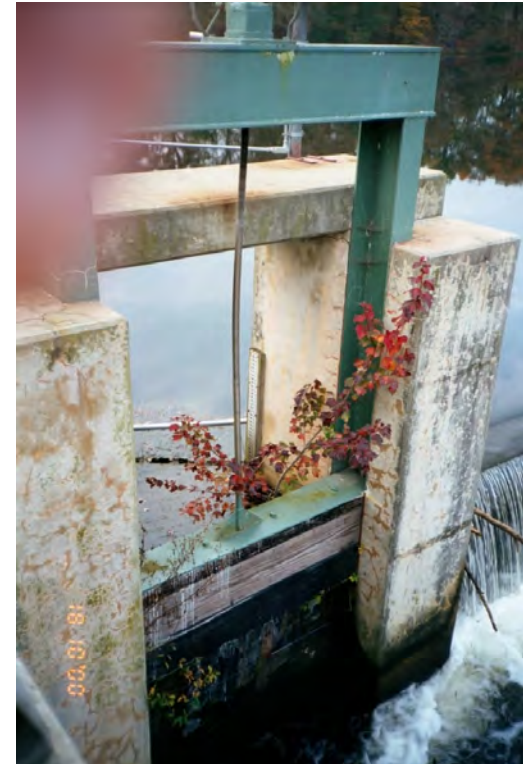
# Inoperable Gates

- Bent Stem
- Trash and Woody Vegetation can make Gate Inoperable

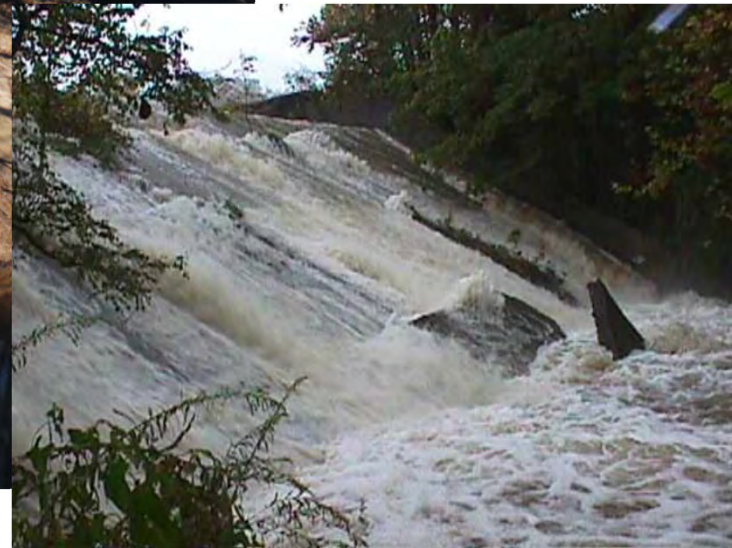
**Deteriorated Concrete  
Spillway Can Lead To  
Failure During Flow**

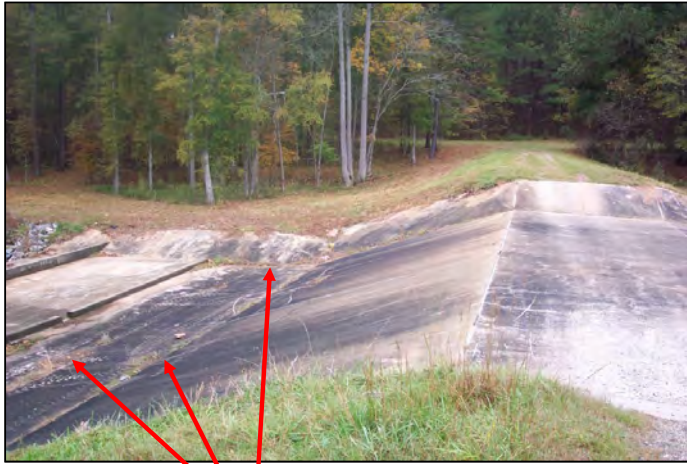
**Open, vegetated joints**

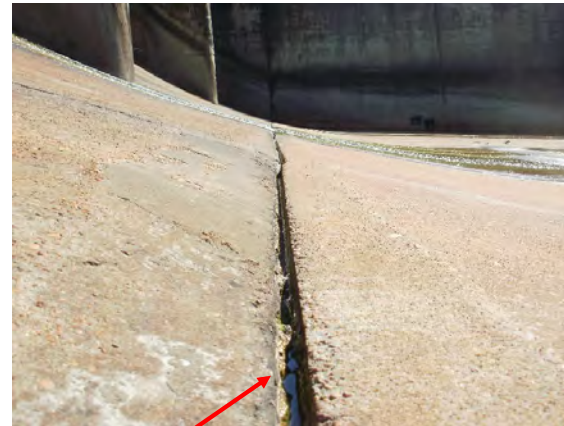
**Open joint, deteriorated /  
missing joint sealant**

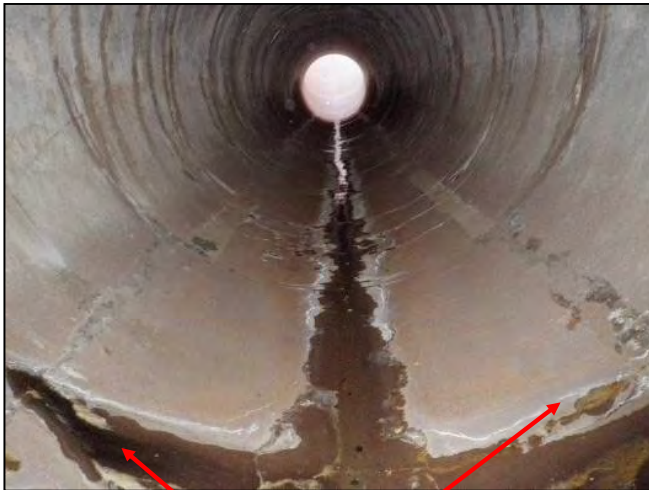
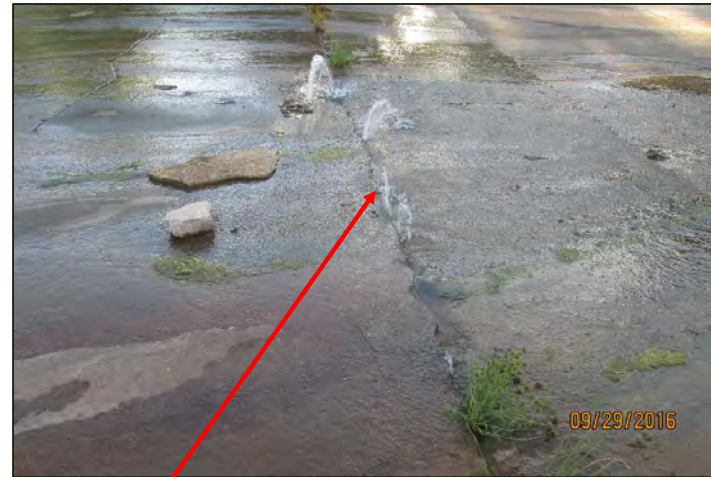
## Conduit and Chute Seepage

**Seepage flowing out of  
spillway joints**

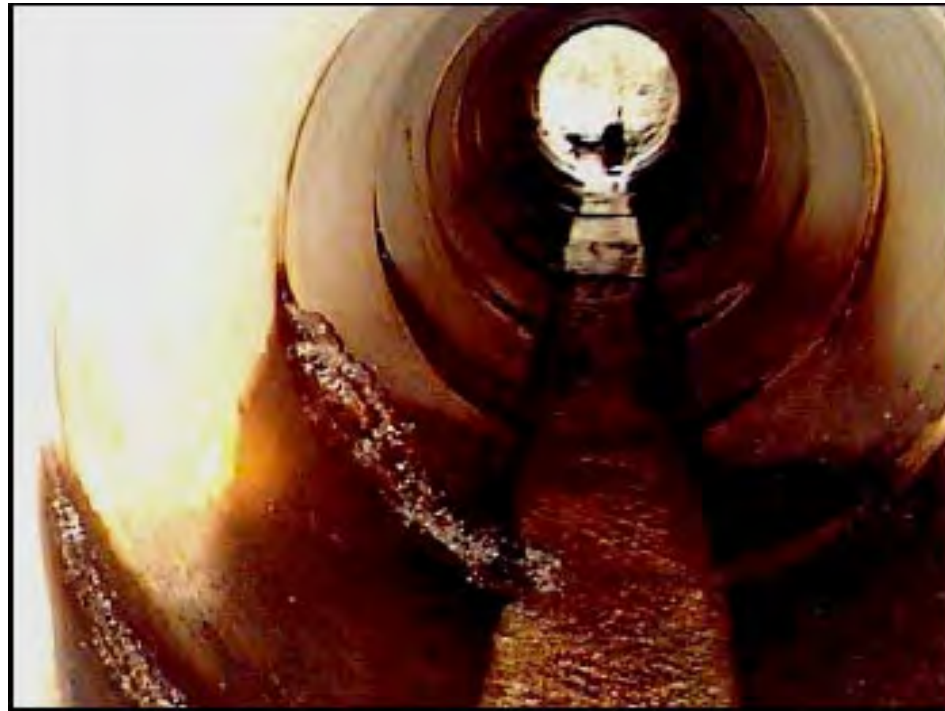
# Conduit Leakage

Seepage Into  
Conduit  
Could  
Lead To  
Piping Failure  
Of  
The  
Embankment

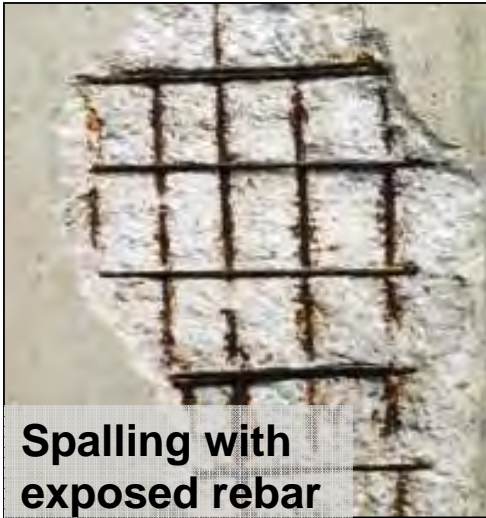
Spalling with exposed rebar

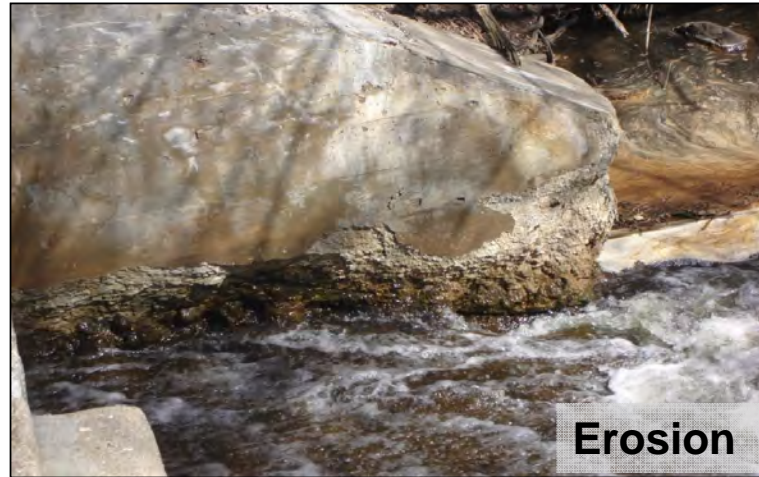
Erosion

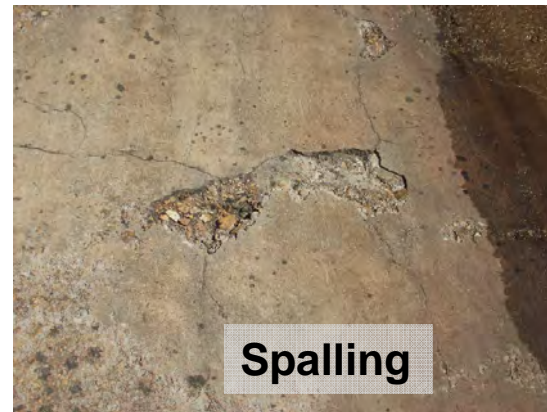
Spalling

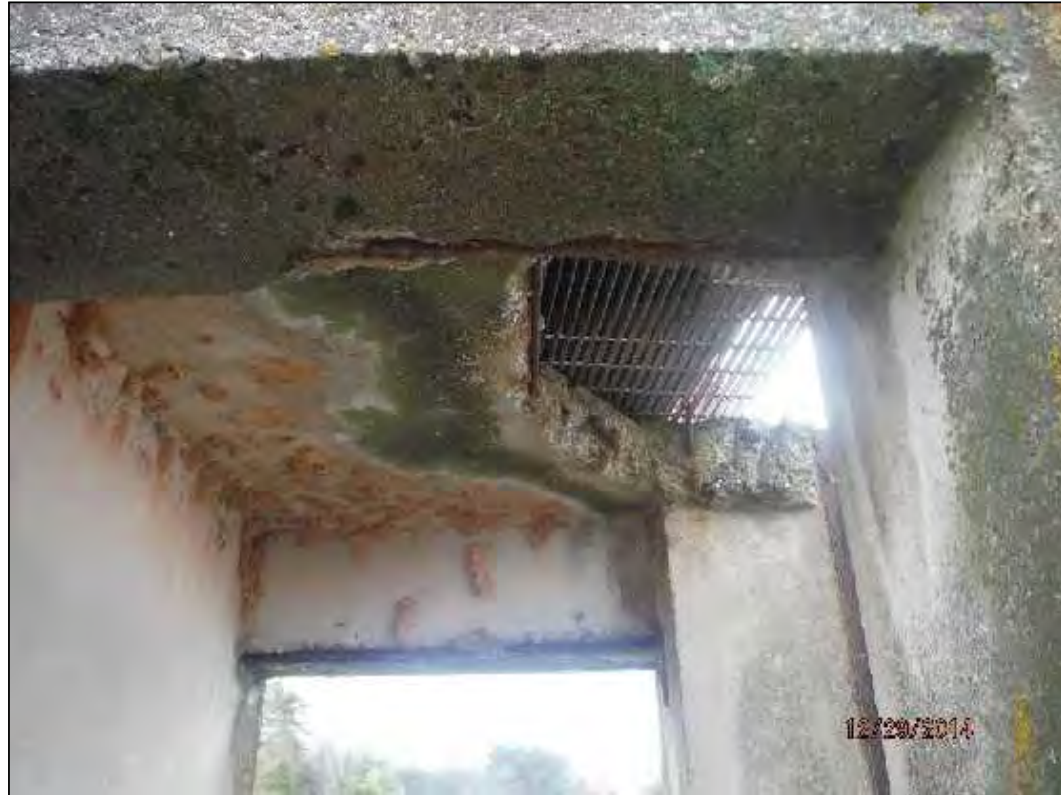
## Outlet Structures

- Obstructions
- Displacement
- Deterioration
- Cavitation or Erosion
- Seepage or Poor Drainage
- Walkways and Ladders

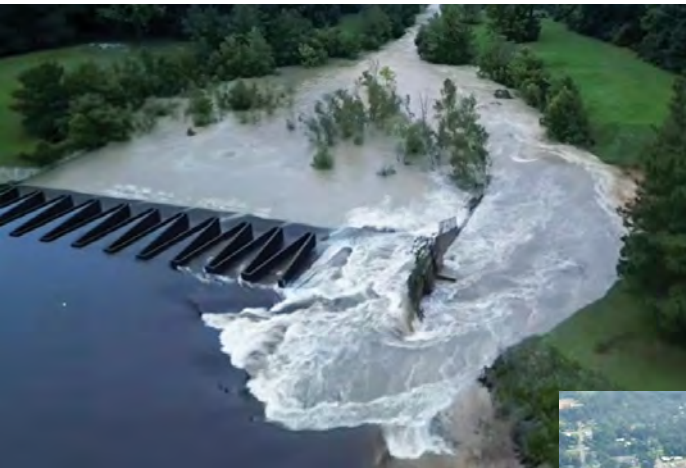
# Recent Failure in Mississippi

Archusa Lake Dam  
Quitman, Mississippi  
Failed July 16, 2023
