# STING SECTION MALLETS A PUBLICATION OF THE LADOTD MATERIALS & TESTING SECTION

# History and Renovation of LADOTD Materials & Testing Laboratory

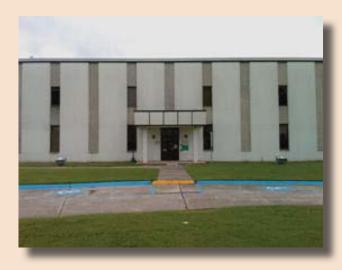
Building No. 1
Under renovation

Because of the successful move, renovation of Building No. 1 has finally begun. During the past five years, the heating, ventilation, air conditioning (HVAC) has been having problems with leaking cooling water due to the corrosion of the inside of the heat exchanger. Many repairs have been made over the years; however, the repair costs have become uneconomical to continue. Unfortunately, the cost of cooling and heating the building has also been increasing over the years due to the leak.

Funding of the renovation was granted from the Capitol Outlay Project by Operations. The scope of the work includes replacement of the duct works, new heat exchanger, new air compressor, new boiler; upgrade electrical wiring to meet current electrical building code; and replacement of the ceiling. The project was awarded to Ceres Environmental Services of Laplace, LA. The contract time is 150 working days with a projected completion date in February 2009. Asbestos abatement contract was handled in house by LADOTD Environmental Evaluation Unit.

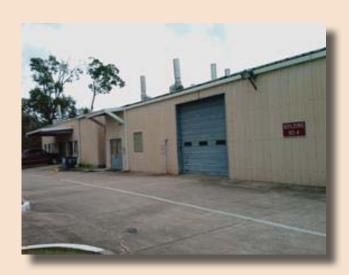
Buildings No. 4 and 6
Temporary home of Geotechnical and Cement Labs

The first meeting with LADOTD employees regarding the renovation was in April 2008. In order for the labs to continue its service to LADOTD during the renovation of Building No.1, the logical plan was to move all the lab personnel to Buildings No. 4, 5, and 6. In order to do so, Buildings No. 4 and 6 had to be repaired from having been vacated since 1997. The buildings needed

the following repairs: A/C repair, electrical wiring and outlet, ceiling tile, and lighting fixtures had to be worked on along with the installation of data and communication lines.

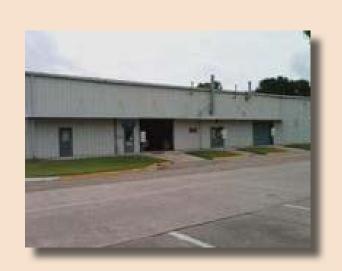
Building No. 5
Warehouse and Rubber Labs; Temporary home of Concrete,
Aggregates, and Epoxy Labs
